## **SM2.11:** Active tectonics of the Mediterranean as seen by recent seismic sequences

### **Factors controlling building damage distribution of the November 26 2019 Mw 6.4 Albania earthquake**

**Spyridon Mavroulis<sup>1</sup>, Efthymios Lekkas<sup>2</sup>, Panayiotis Carydis<sup>3</sup>, Dimitri Papa<sup>4</sup>**

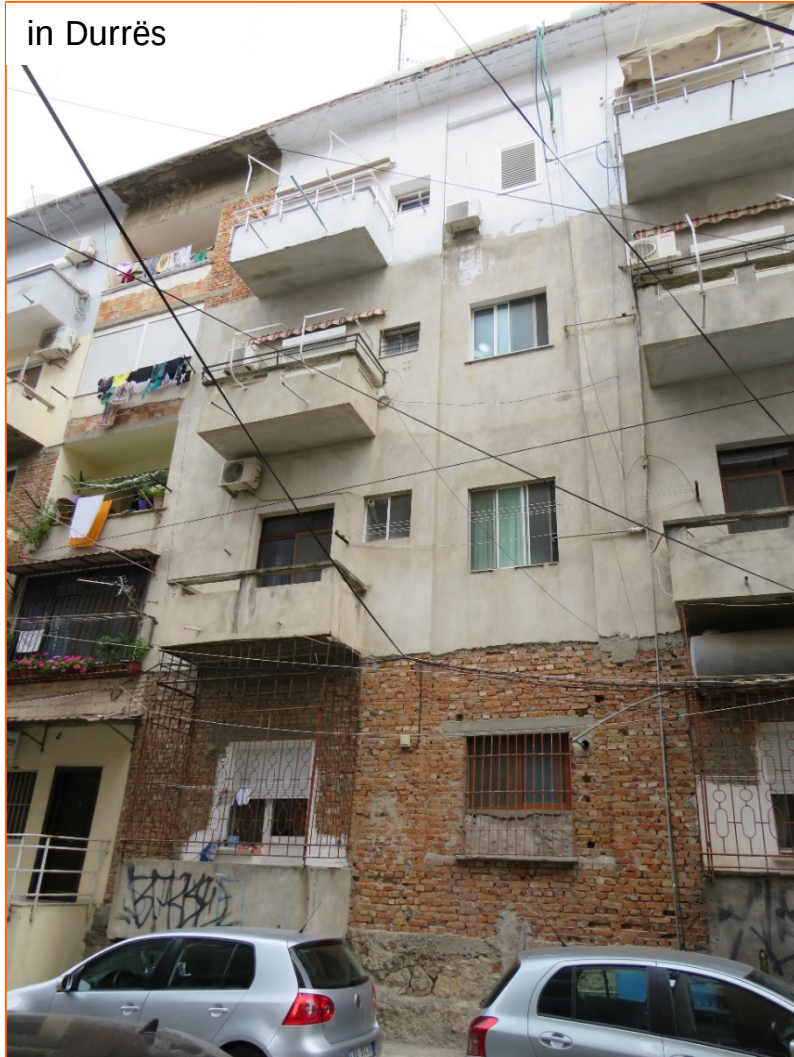
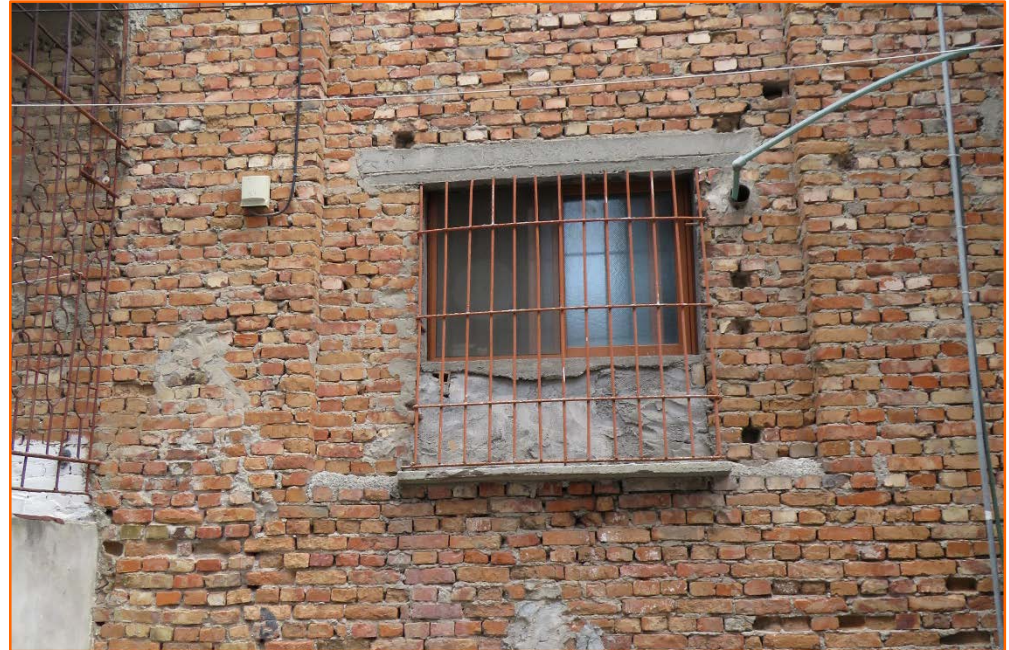
Unreinforced masonry (URM) construction should not be used today. They do not present good performance during earthquakes. It is significant to mention that the majority of fatalities induced by earthquakes around the world have attributed to collapse of unreinforced masonry buildings. They are heavy brittle structures, which usually suffer heavy structural damage.

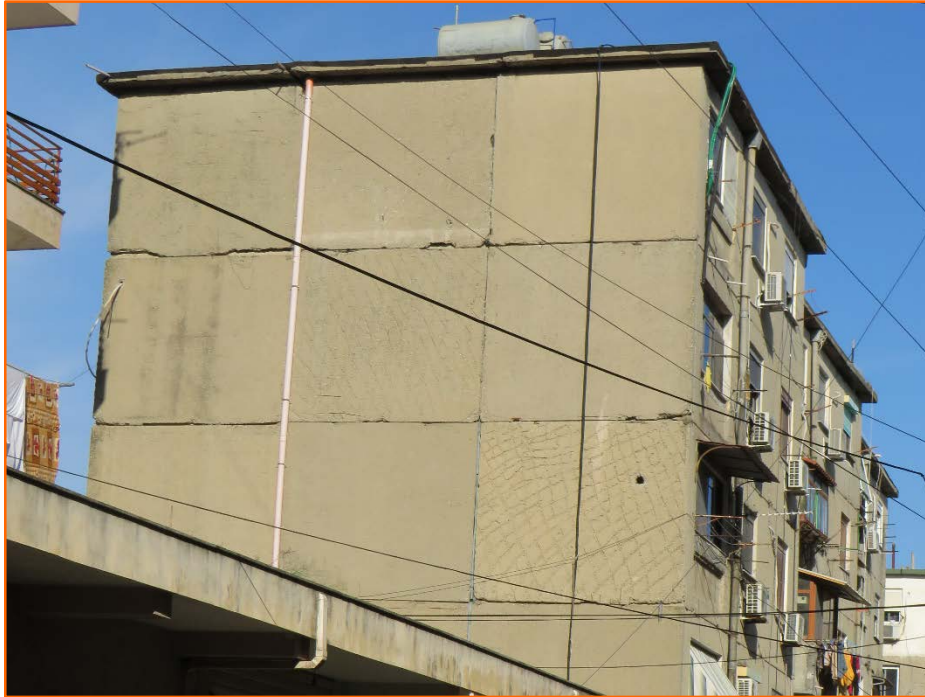
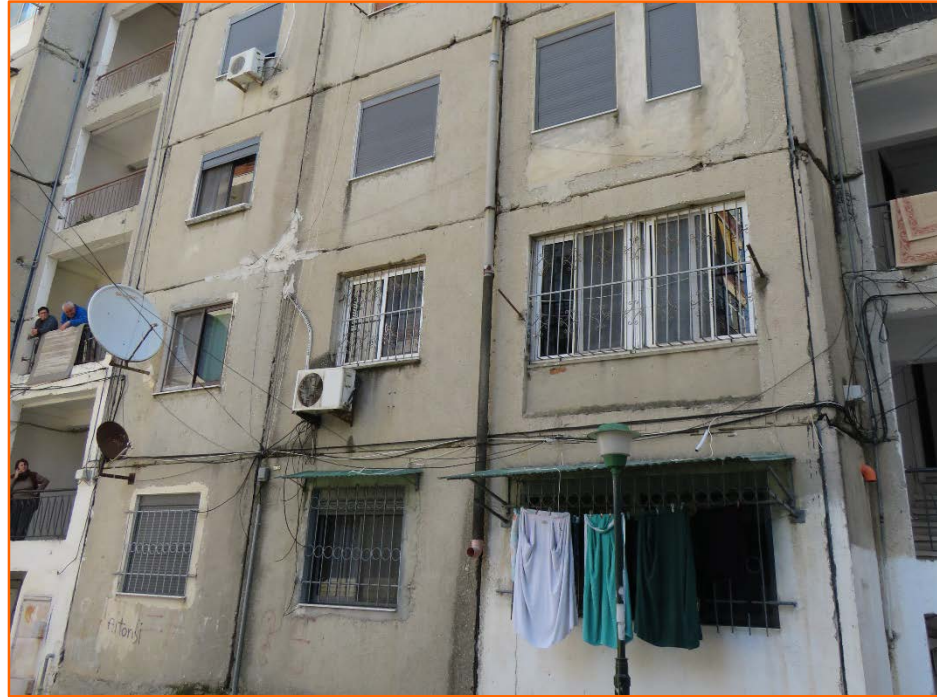
In the majority of these structures, the prefabricated concrete walls are not covered with plasters and the welding joints between the prefabricated concrete walls have not been sealed. Thus, these buildings are not protected from the aggravating environmental conditions including humidity, rainfall, temperature variations, snowfall resulting in quick and easy ageing of materials.

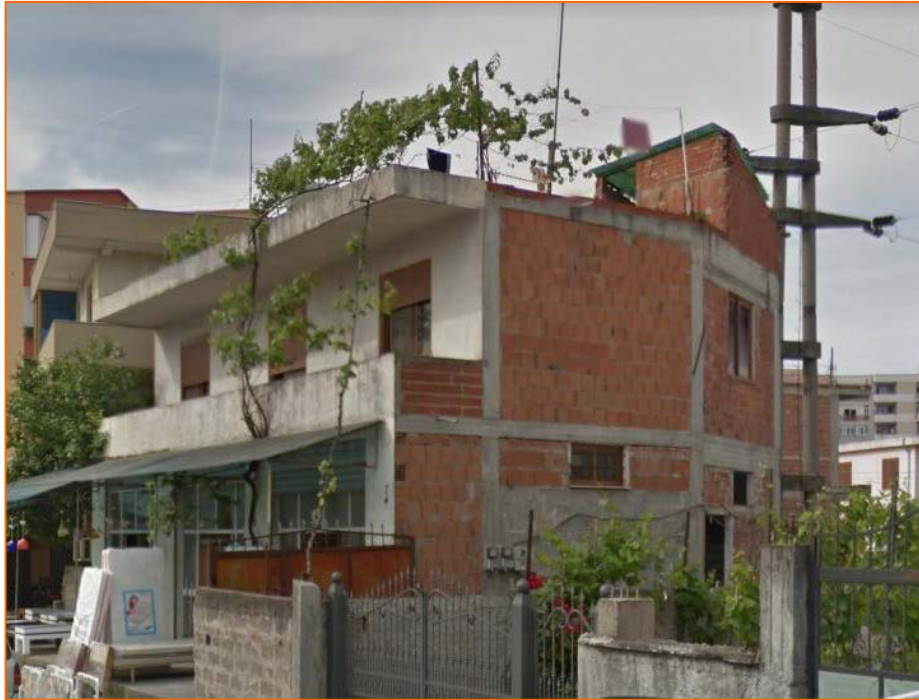
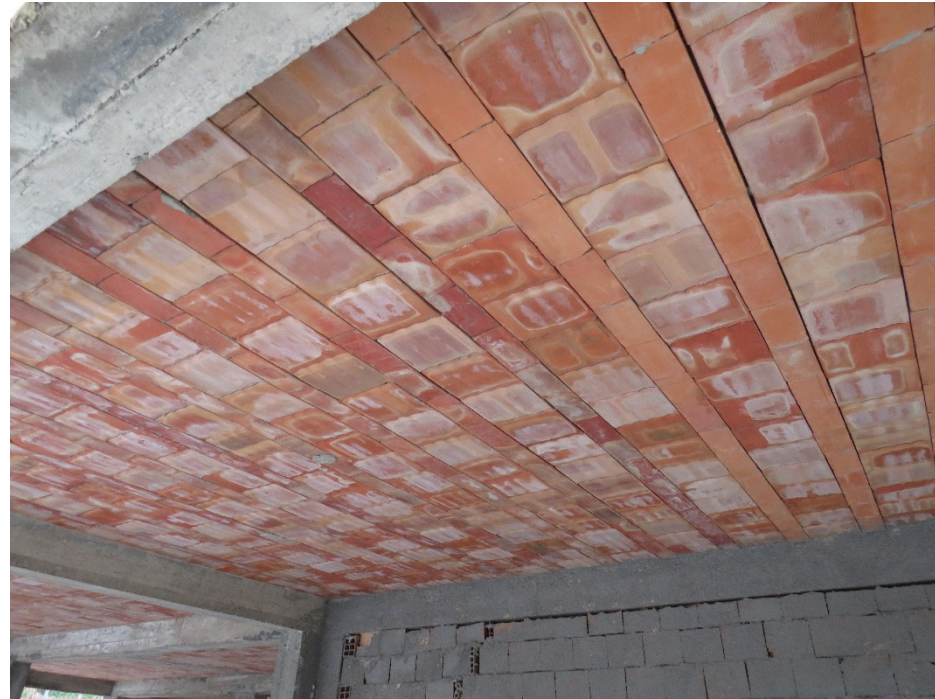
Buildings with a kind of light reinforced concrete frame and infill brick walls are also observed in the affected area. The performance of this type of buildings is strongly related to the presence or lack of strong columns and beams and the construction method of the slab. They are often multi-storey residential buildings, hotels and offices.

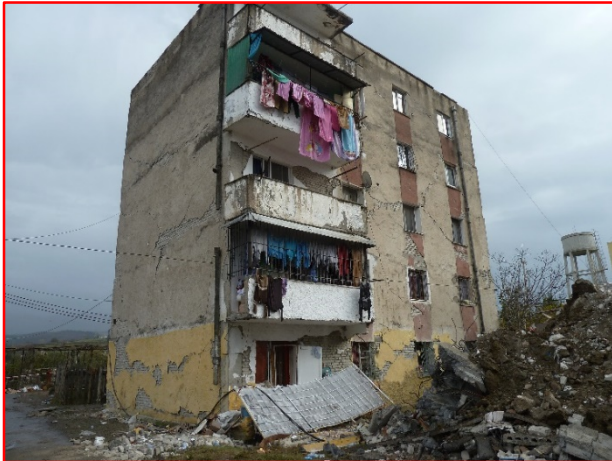
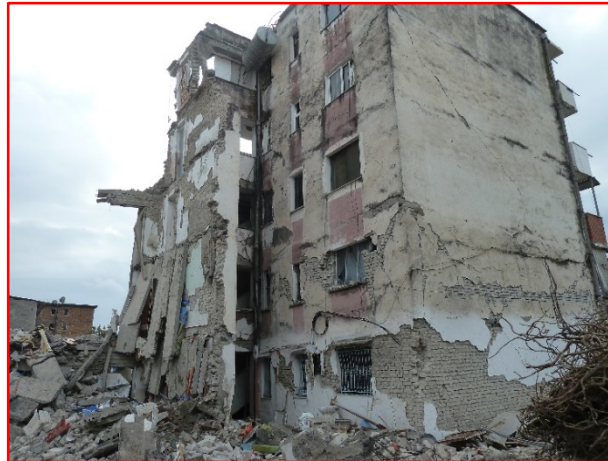
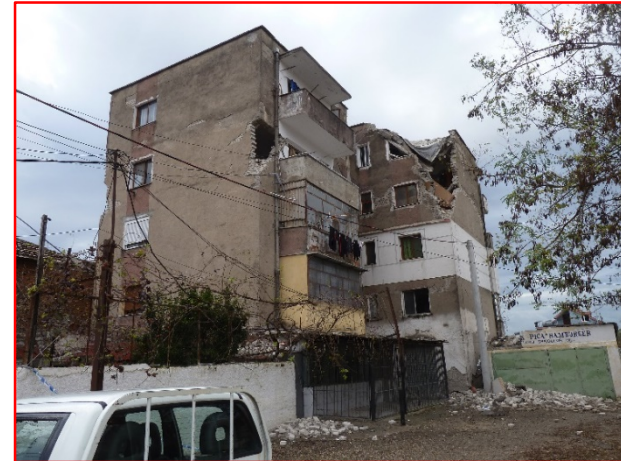
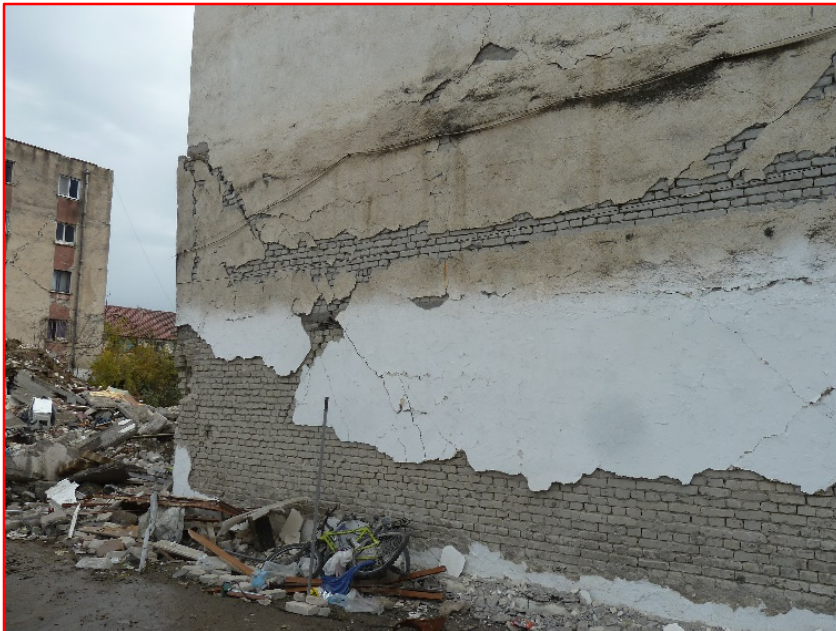
Heavy structural damage to buildings with load bearing solid brick walls and concrete floor slab in Thumanë town are presented. Damage comprised detachment of large pieces of plaster from the brick walls, cracks in brick walls and partial collapse of the building. The floor slabs were composed of simply supported prefabricated reinforced concrete hollow core strap slabs. The concrete strap slabs are not transversally connected to each other neither to the load bearing system. In this way, the diaphragmatic function of the floors, which is beneficial for the earthquake safety of the structure, is totally missing.

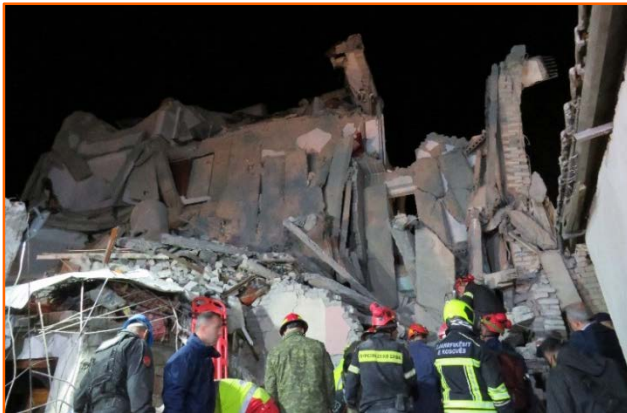
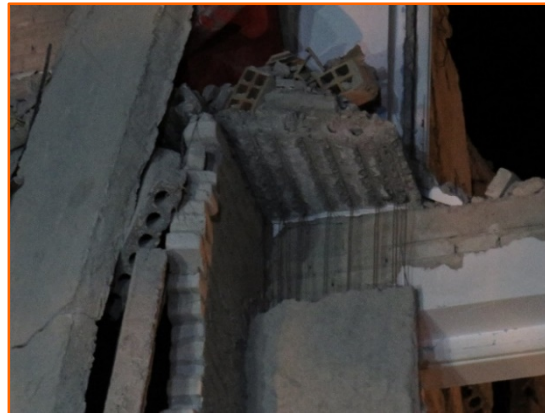
Based on the field macroseismic reconnaissance survey conducted after the September and November Durrës earthquakes, it is concluded that many buildings of all observed construction types used precast floor slabs. These slabs are prefabricated and then lifted with cranes or elevators. The slabs that were usually observed in collapsed or heavily damaged buildings mainly in Thumanë and secondarily in Durrës were simply supported prefabricated reinforced concrete hollow core strap slabs, not transversally connected to each other neither to the load bearing system. In this way, the diaphragmatic function of the floors, which is beneficial for the earthquake safety of the structure, is totally missing. These elements were subjected to the earthquake motion resulting in destruction.

The simple support of these precast elements is not allowed by modern earthquake codes due to the fact that in most cases the existing joints are not adequate and/or strong enough to undertake the vertical and horizontal seismic actions. The joints at the supports must be constructed in order to rigidly withstand the up-down jumping movement of the slabs and the differential horizontal displacements, i.e diaphragmatic function. The lack of these provisions in the joints may be the basic reason for numerous heavy structural damage and collapses of the buildings with precast floor slabs. Recent examples of this performance were also observed in buildings affected by the 2009 L' Aquila and 2012 Emilia - Romagna earthquakes in Italy (*Carydis et al., 2009, 2012*).

A collapsed building in Thumanë with load bearing brick walls and simply supported reinforced concrete hollow core slabs.

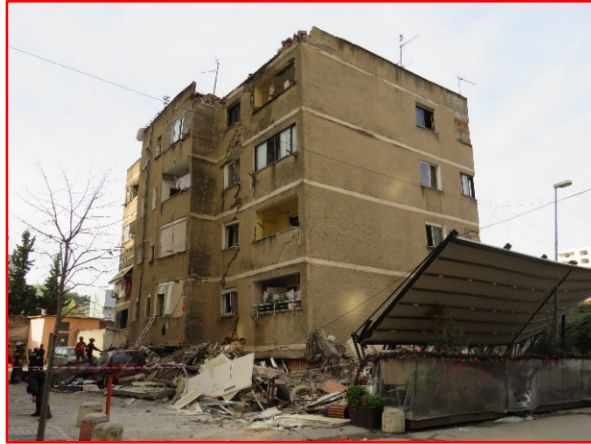
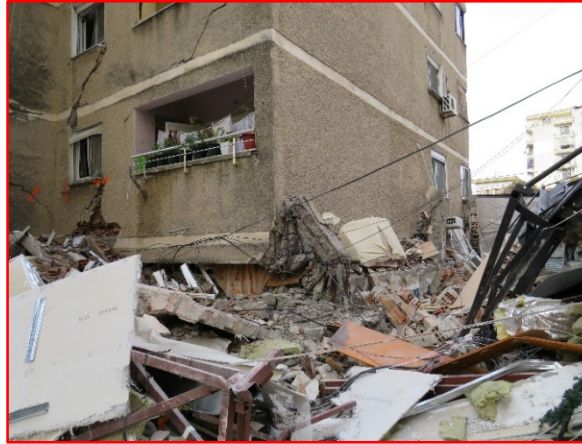
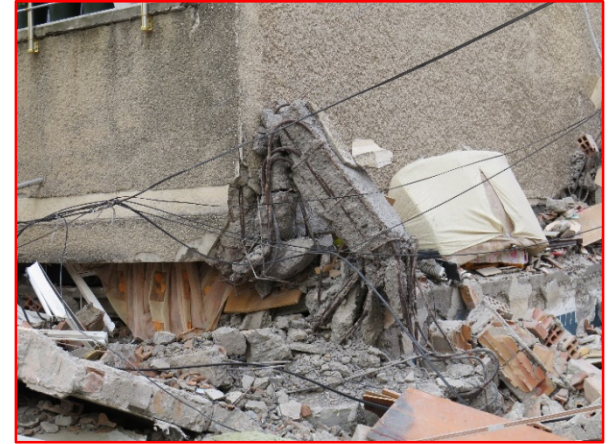
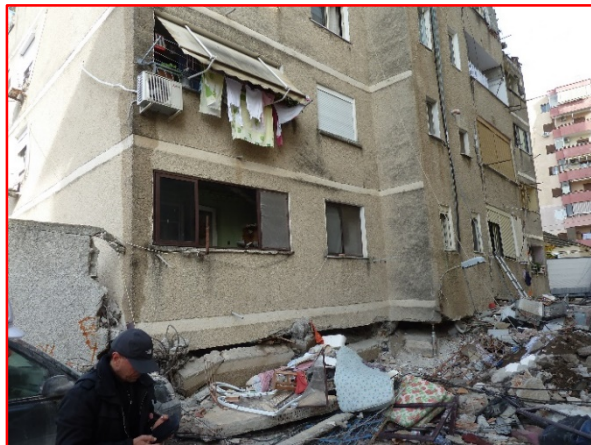
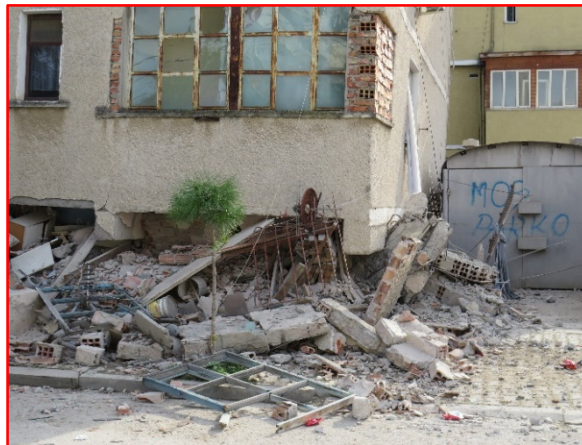
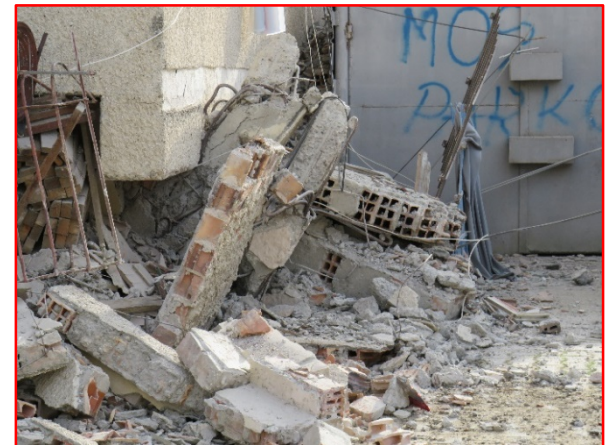
Collapse of the two lower floors of the building. The deformation of the steel bars of the columns is attributed to the movement of the building under the effect of the dominant vertical component of the earthquake ground motion. This building is located in the area of the macroseismic epicenter, where the vertical component prevails over the horizontal one.

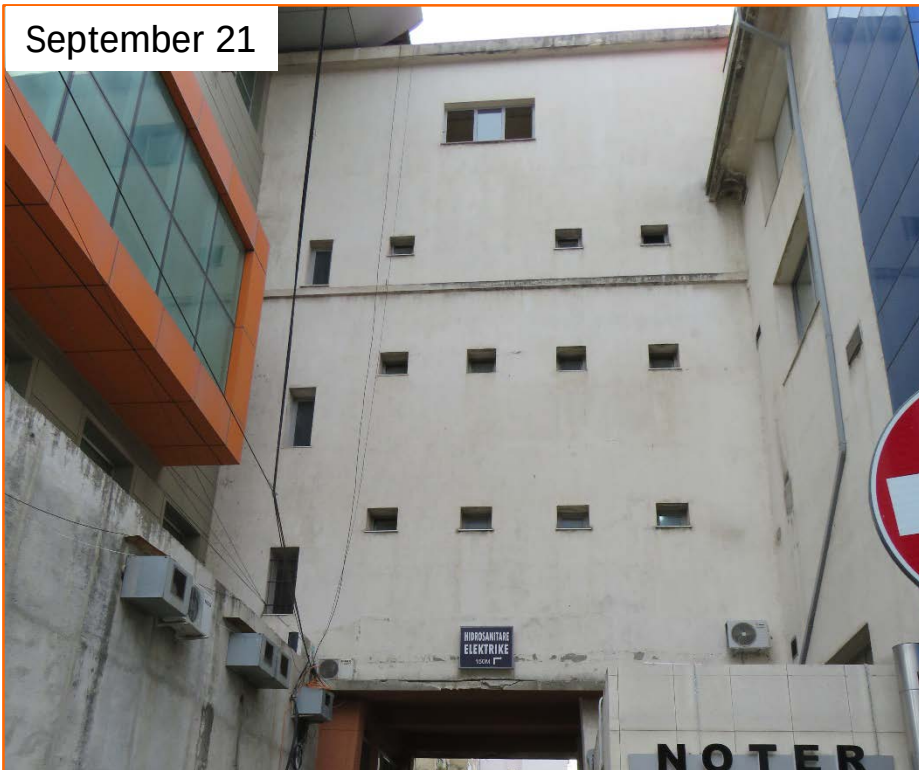
September 21

The building in Durrës remained almost intact from the September earthquake.

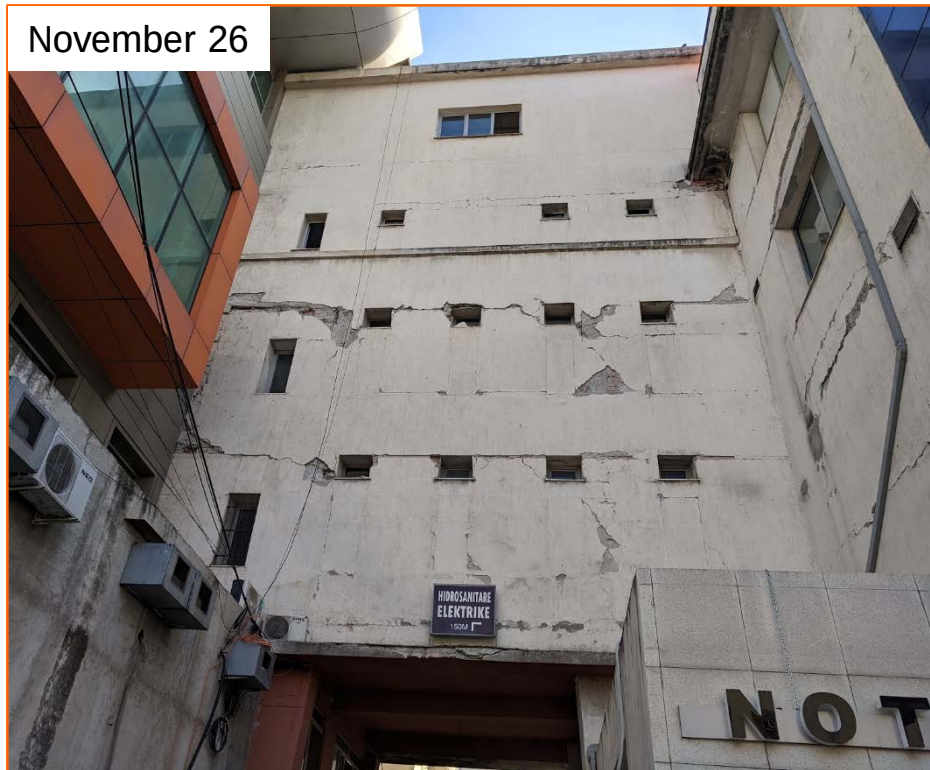
November 26

The building suffered non-structural damage from the November earthquake including cracks in the brick wall, detachment of pieces of plaster from the wall and detachment of the brick wall from the surrounding slabs. No damage was observed in the upper level of the building. This type of damage (horizontal and no X-formed cracks) indicates the prevalence of the vertical component of the earthquake ground motion.

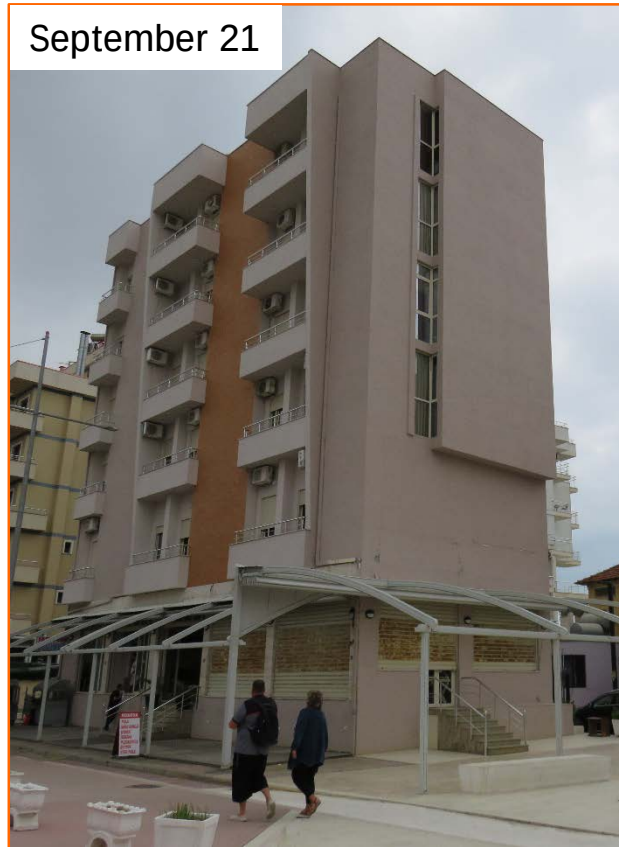
Separation of brick walls from the members of the RC framing system, which is a common phenomenon due to the deformational incompatibility between the two structural elements.

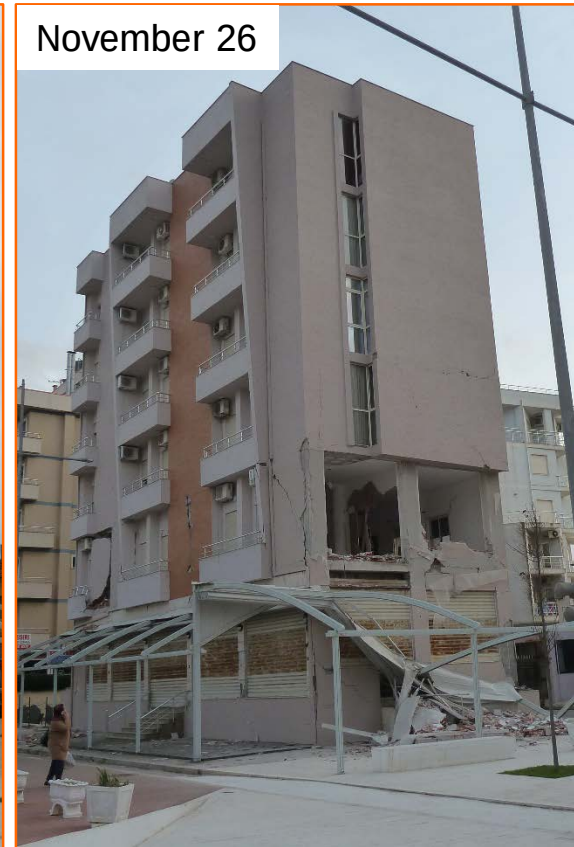
Total collapse of infill and partition brick walls from the members of the RC framing system. Damage are limited to the three lower storeys of the building.

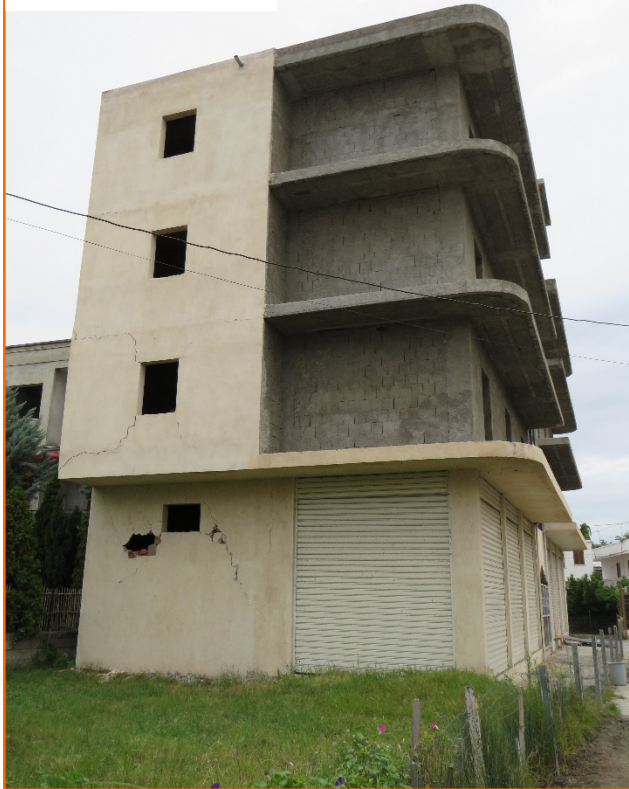
September 21

Effect of the vertical component of the earthquake ground motion in combination with the horizontal one on brick walls on an RC cantilever.

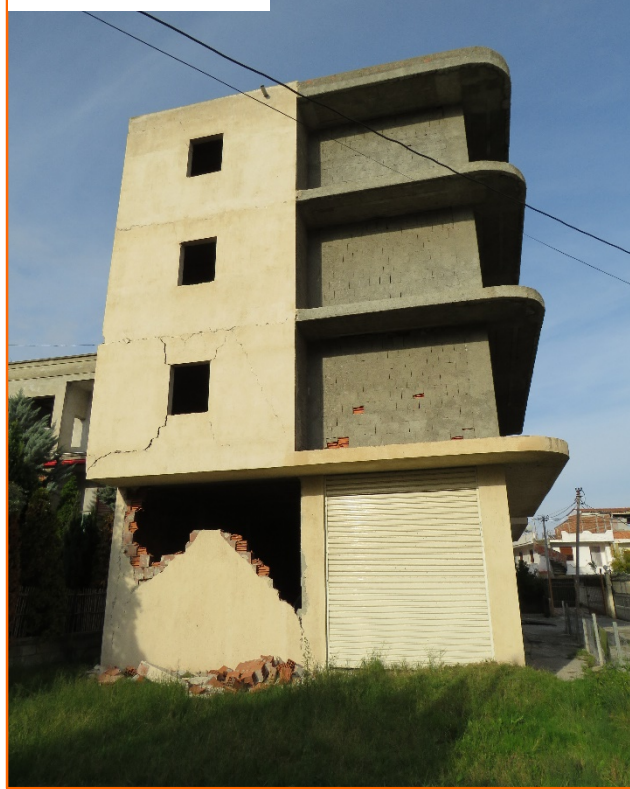
November 26

Partial collapse of the brick wall of the ground floor and light cracks.

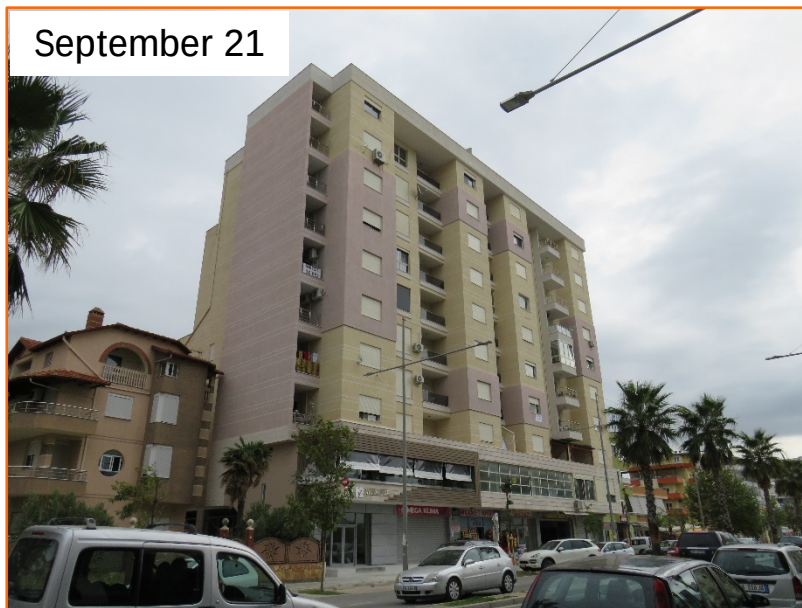
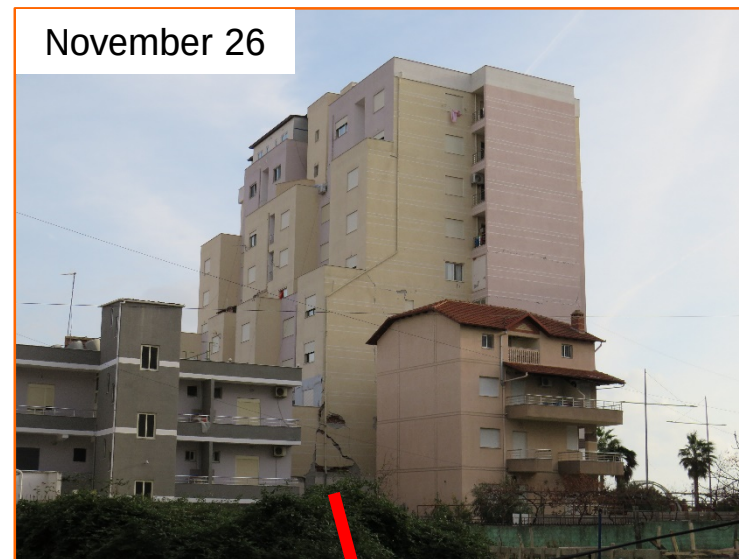
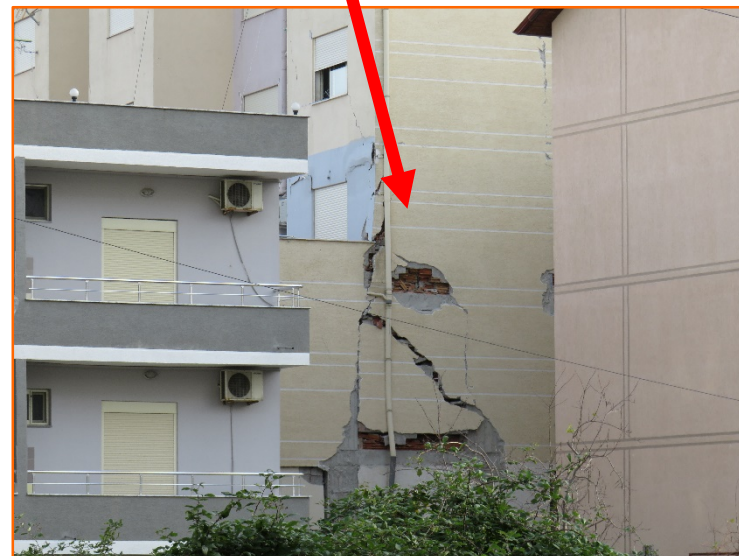
▲ No damage was induced to this building during the September earthquake.

► The lower floors suffered heavy damage by the November 26 earthquake including partial collapse of the brick walls at the lower floors.

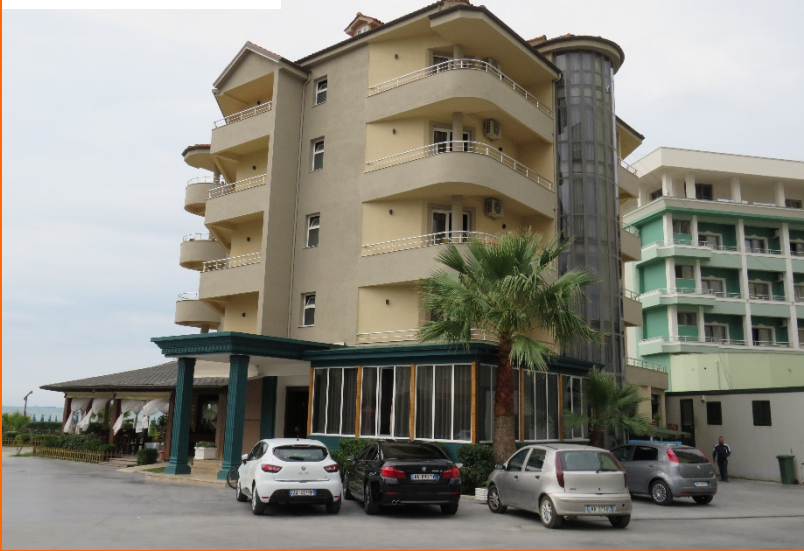
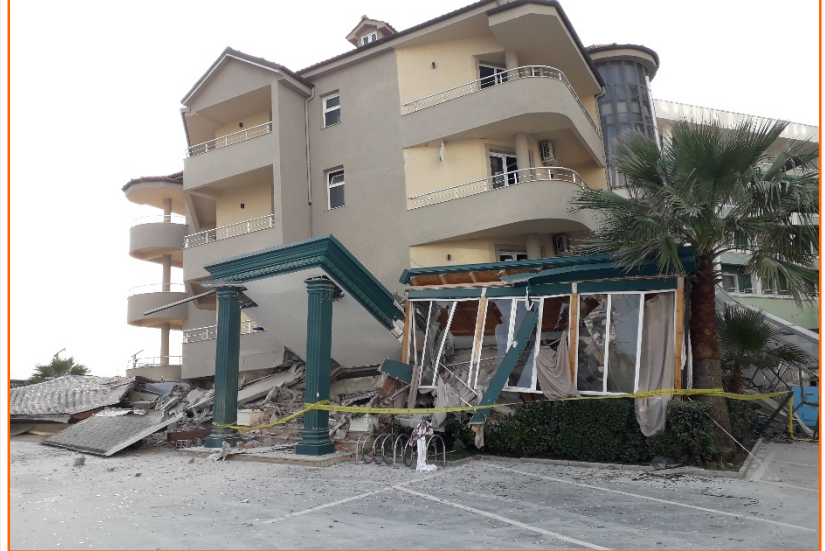
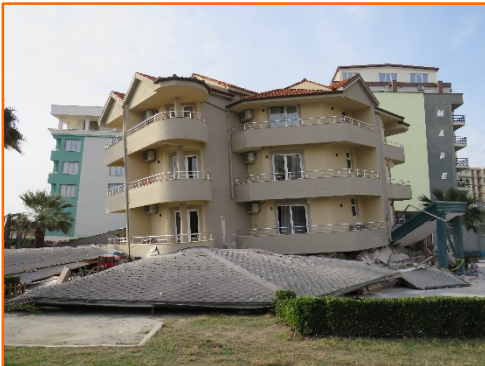
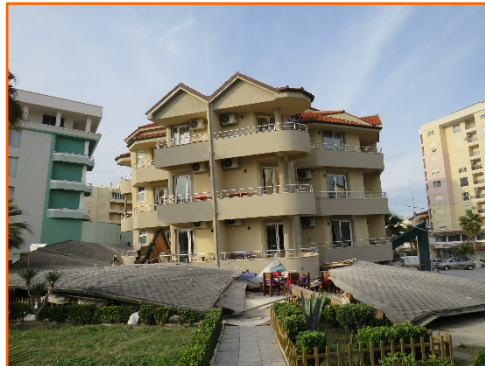
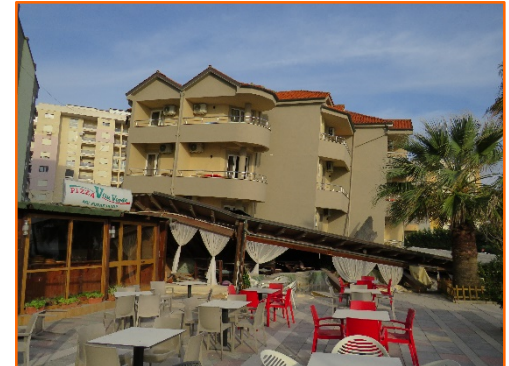
Hotel Vila Verde was founded on the coastal zone of Durrës, few meters from the sea. No damage was induced to the hotel during the September earthquake. The two lower floors totally collapsed during the November earthquake, while the structure above remained almost intact.

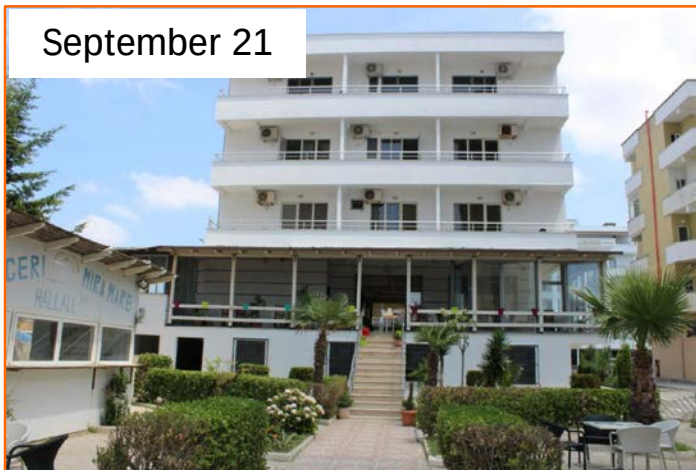
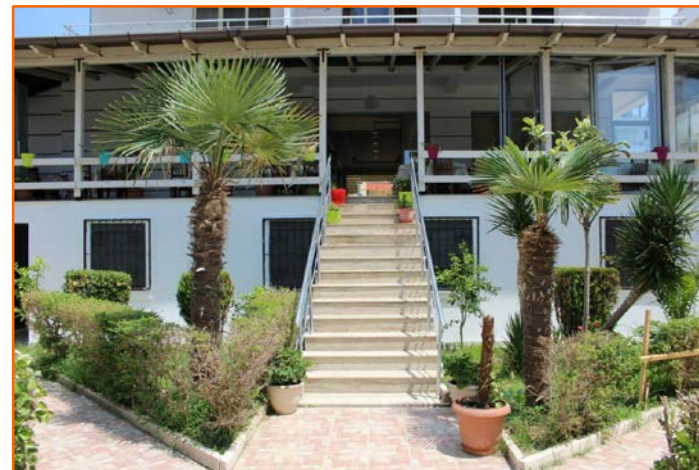
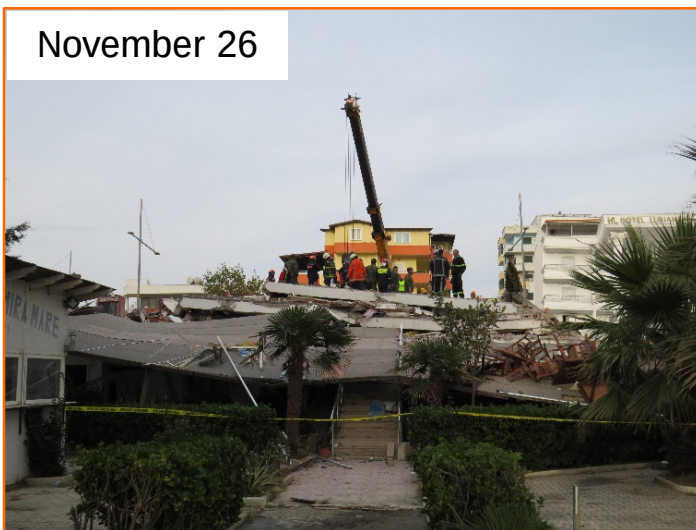
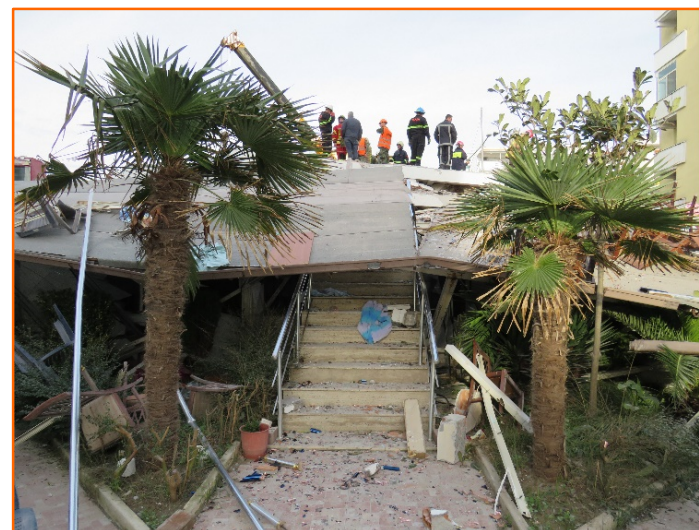
Mira Mare hotel was founded on the coastal zone of Durrës, few meters from the sea. No damage was induced to the hotel by the September earthquake. During the November 26 earthquake, it totally collapsed.

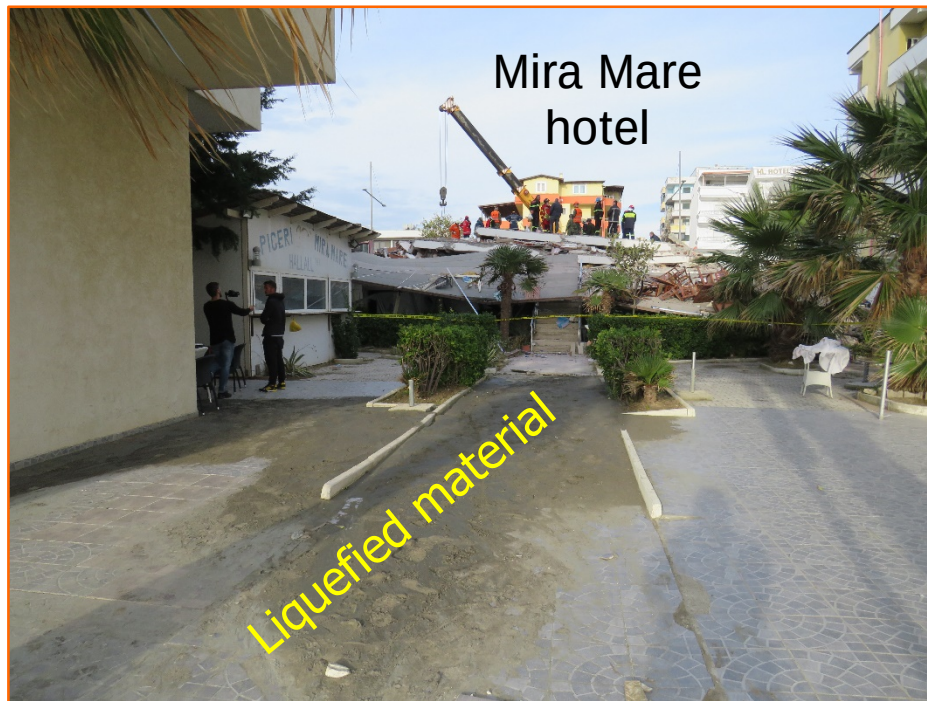
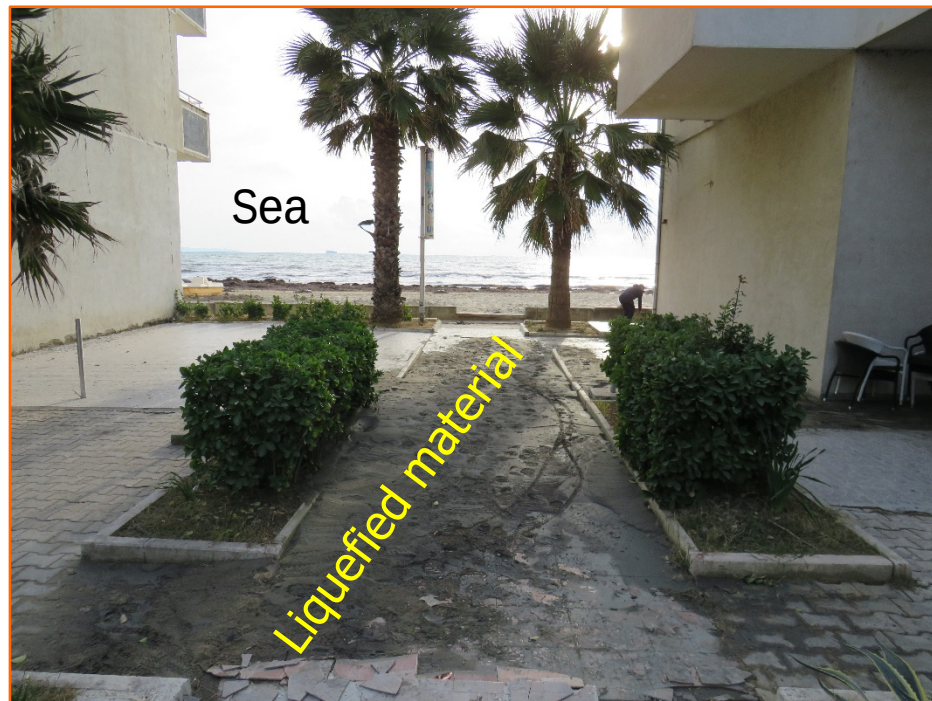
Few meters from the collapsed hotel Mira Mare, liquefaction phenomena were generated. Sand boils erupted during the earthquake from ground cracks resulting in the formation of small sand volcanoes and silt-covered pavements. The liquefaction phenomena observed in this site may contribute to the initial sinking and tilting of the building that led to its final collapse.

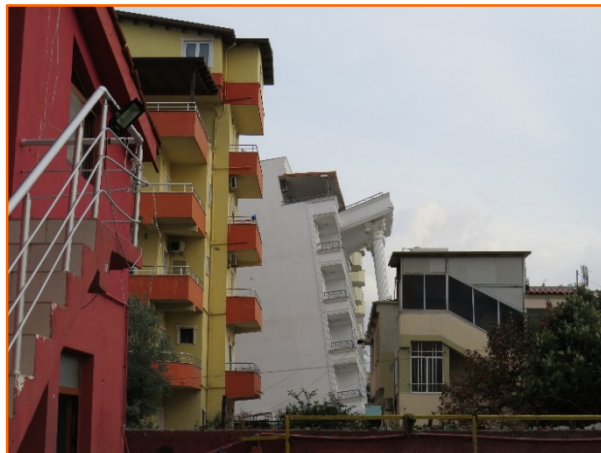
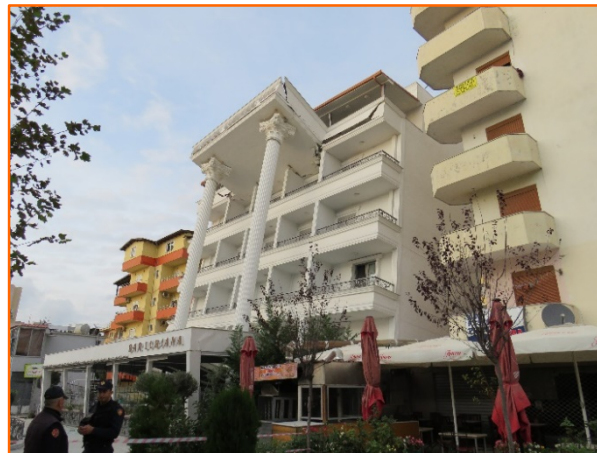
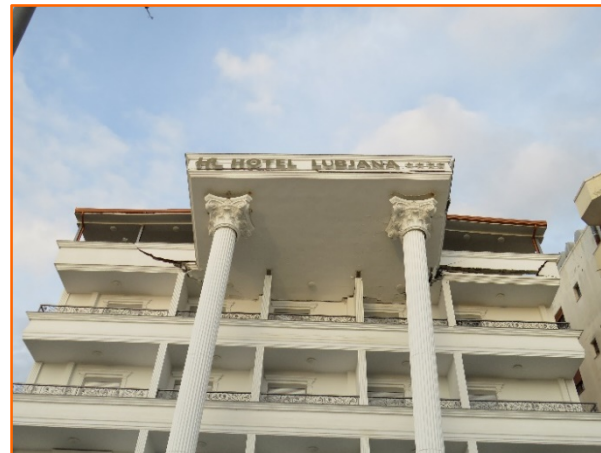
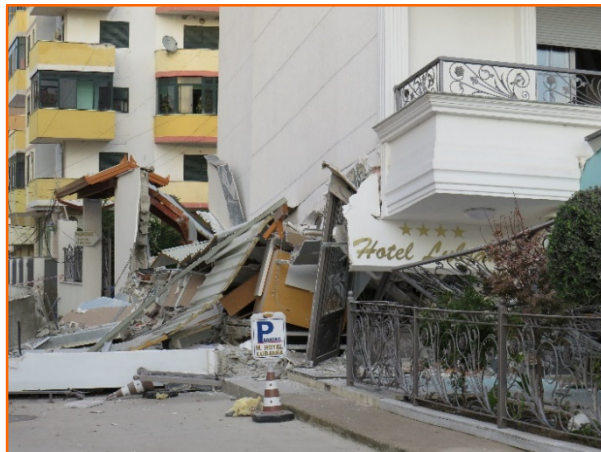
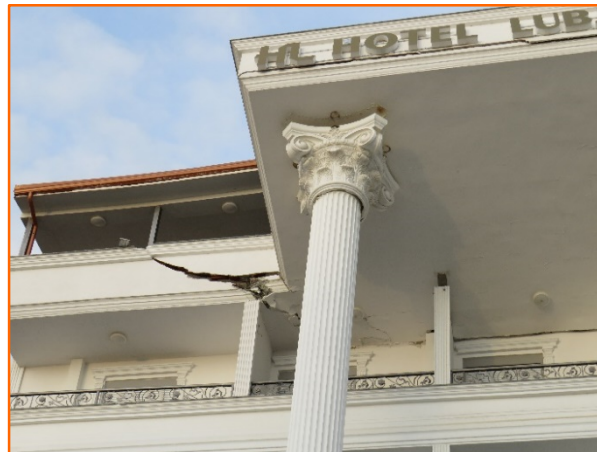
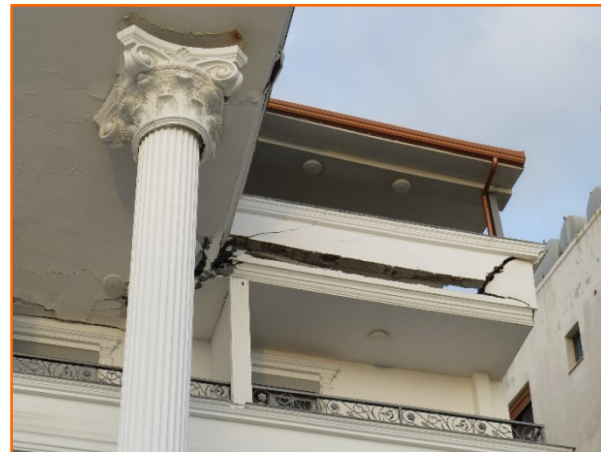
It is significant to note that the hotel Lubjana, located few meters from Mira Mare, presented tilting that might be attributed partially to the failure of the columns of the ground floor and partially to liquefaction phenomena, but it did not collapse.

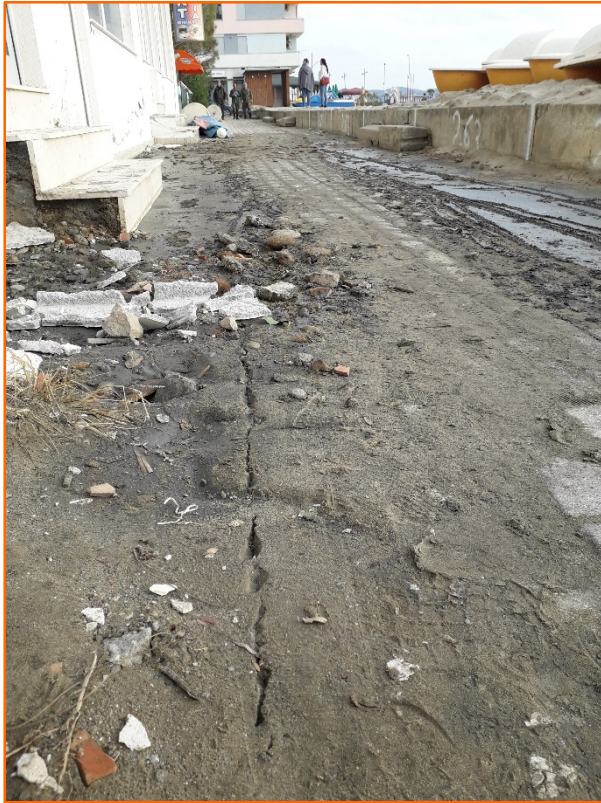
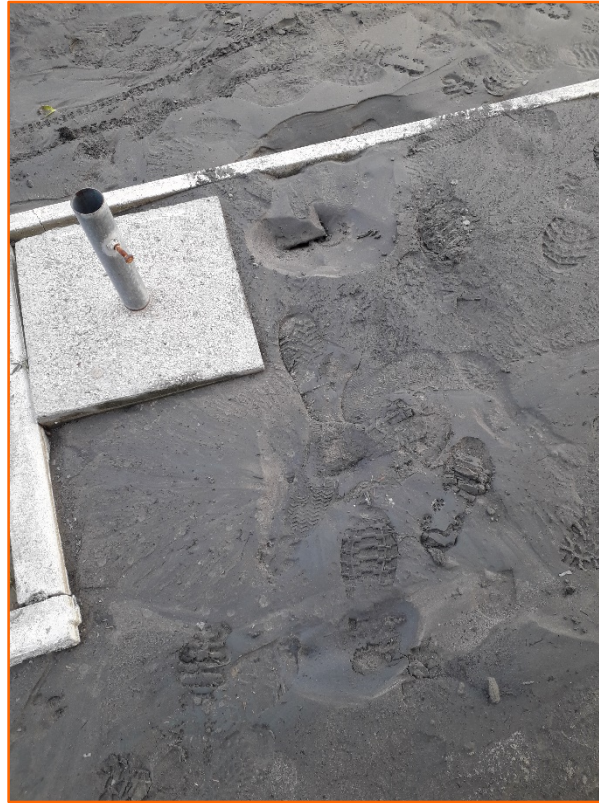
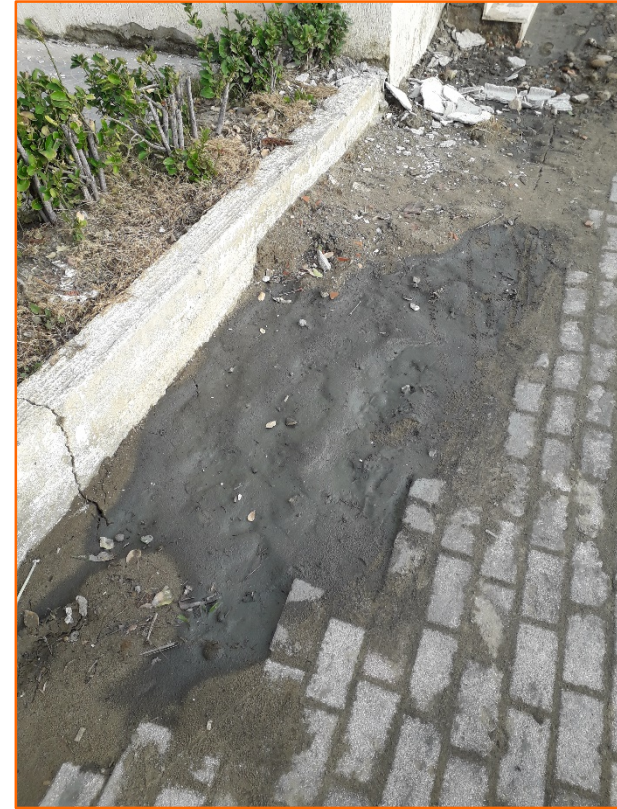
Ejection of liquefied material through cracks resulting in small sand volcanoes and covered pavements. These liquefaction phenomena took place few meters away from the collapsed Mira Mare Hotel and other tilted buildings in the coastal Durrës. Small scale liquefaction phenomena were also generated in the coastal area of Durrës by the September 21, 2019 Mw 5.6 earthquake ([Lekkas et al., 2019](#), Newsletter of Environmental, Disaster, and Crises Management Strategies, Vol. 13)

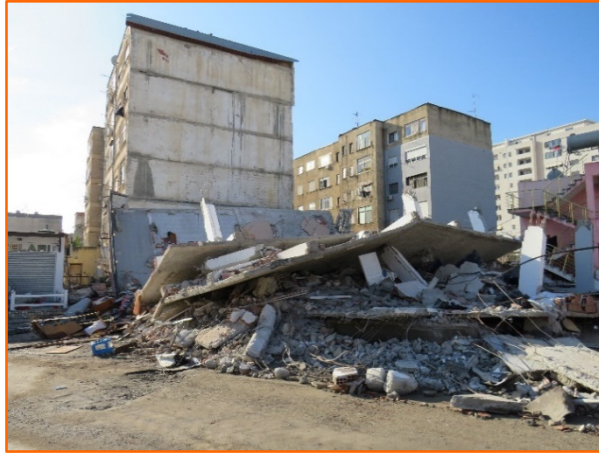
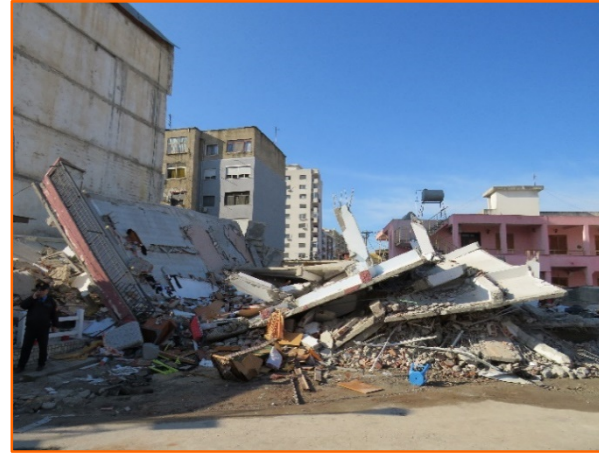
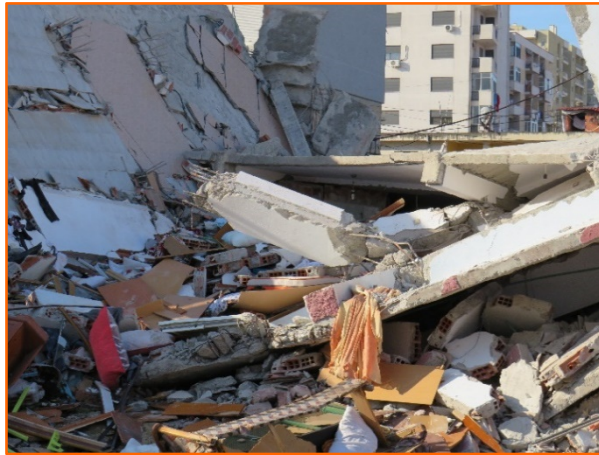
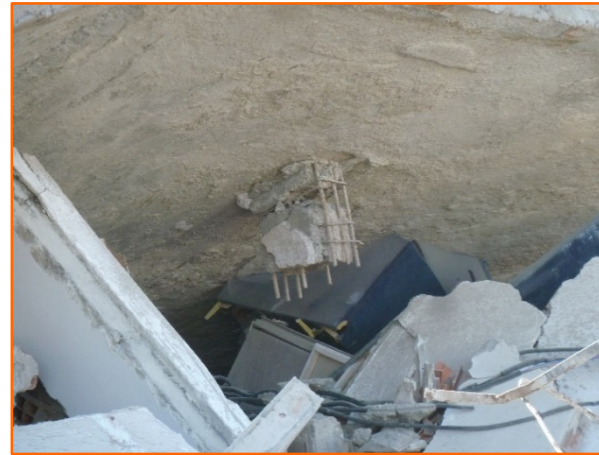
A total collapse of a 5-storey building in Durrës. The short extensions of rebars in the columns of the first floor were only 30-40 cm long and adversely affected the performance of the building during the earthquake resulting in its collapse. The upper floors of the structure were overturned and crushed.
