## **SM2.11:** Active tectonics of the Mediterranean as seen by recent seismic sequences

### **Factors controlling building damage distribution of the November 26 2019 Mw 6.4 Albania earthquake**

**Spyridon Mavroulis<sup>1</sup>, Efthymios Lekkas<sup>2</sup>, Panayiotis Carydis<sup>3</sup>, Dimitri Papa<sup>4</sup>**

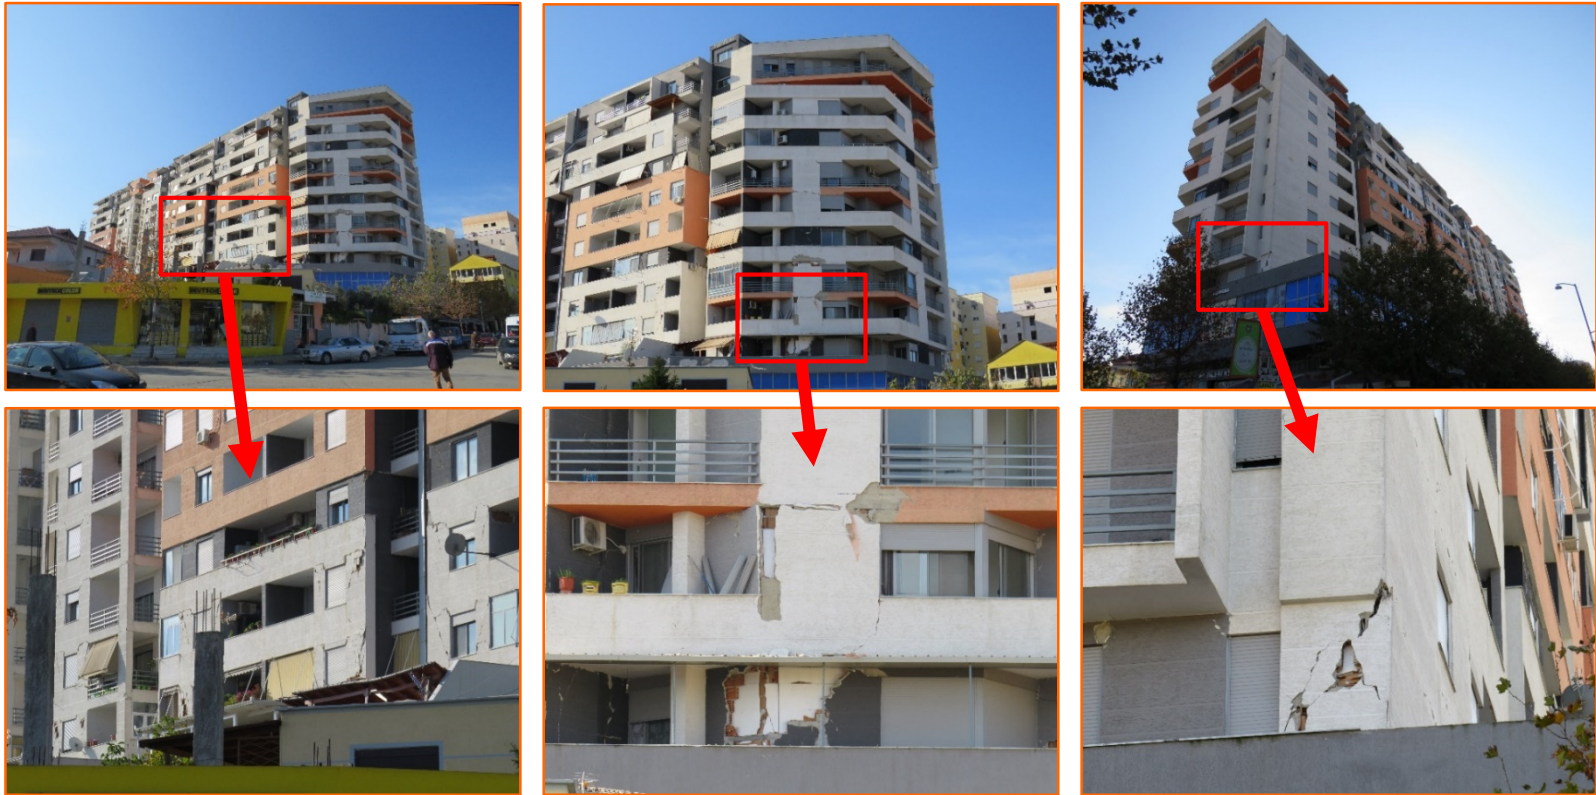
A multistorey building in Durrës with damage observed only in the three lower storeys, while the upper storeys remained intact by the earthquake. Cracking of plaster, detachment of plaster from the brick walls, cracking and partial collapse of brick walls were mainly observed. The adverse characteristics of this building comprise cylindrical and thin columns and almost triangular shape of the building in top view. Moreover, beams are totally missing, especially in the interior of the structure. This lack constitutes a rule in the affected area. The slabs are prefabricated reinforced concrete hollow core slabs with no connections between them.

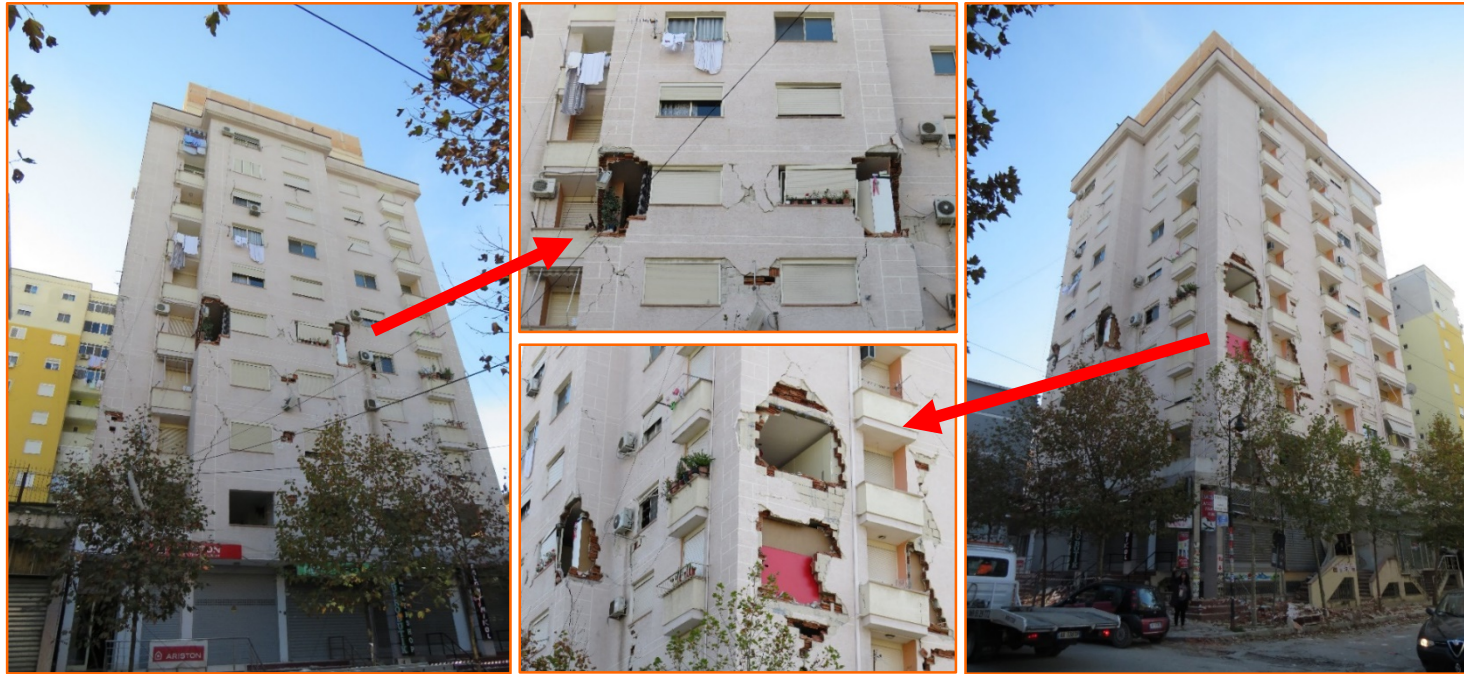
A multistorey building in Durrës with damage observed only in the four lower floors, while the upper floors remained intact by the earthquake. Cracking of plaster, detachment of plaster from the brick walls, cracking and total collapse of brick walls between slabs were mainly observed. Moreover, the equipment of the apartments including furniture and electric devices among others overturned and slid. The equipment of the apartments was overturned and slid. This fact is attributed to high internal accelerations of the floors (floor accelerations). This is a rare phenomenon around the world and it is in accordance with all the seismic regulations of several countries. It is attributed to the action of a strong vertical component of the earthquake ground motion, which prevails in epicentral areas. However, this phenomenon is not rare in Greece and Italy due to the fact that most of the earthquakes that have struck these countries during the last decades have been shallow, moderate to strong seismic events with their epicenters located close to large urban areas.

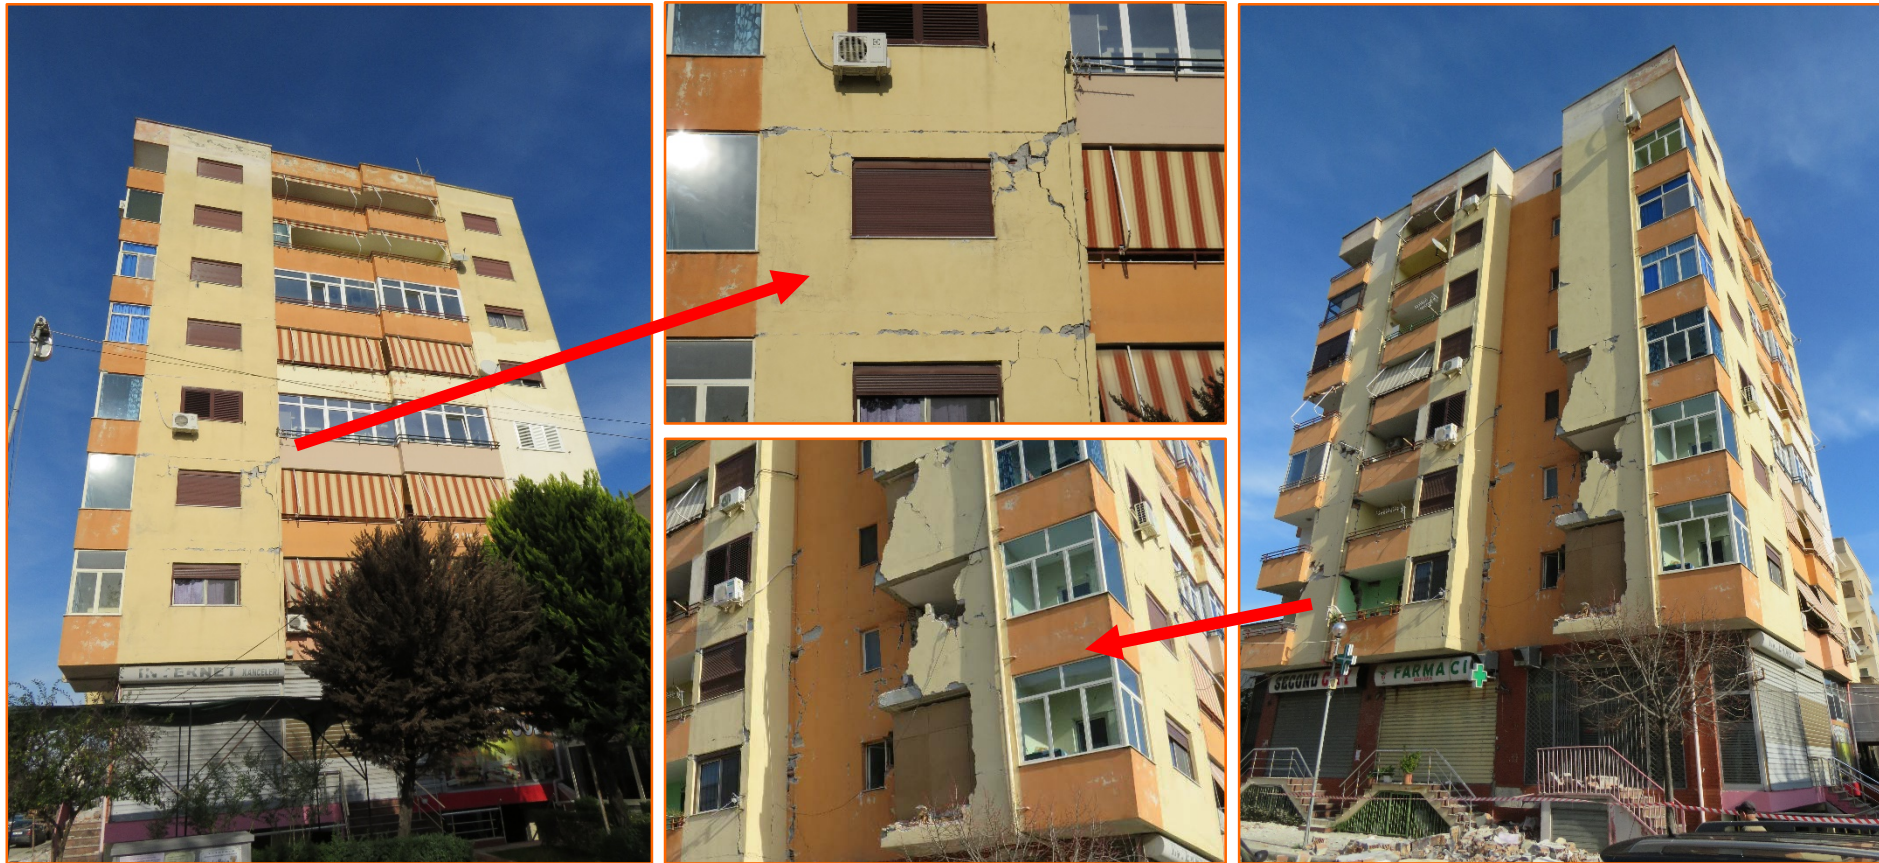
A multistorey building in Durrës with damage observed only in the four lower floors, while the upper floors remained intact by the earthquake. Cracking of plaster, detachment of plaster from the brick walls, cracking and total collapse of brick walls between slabs were mainly observed. Moreover, the high plaster thickness generated sandwich walls and attracted seismic load that they could not resist.

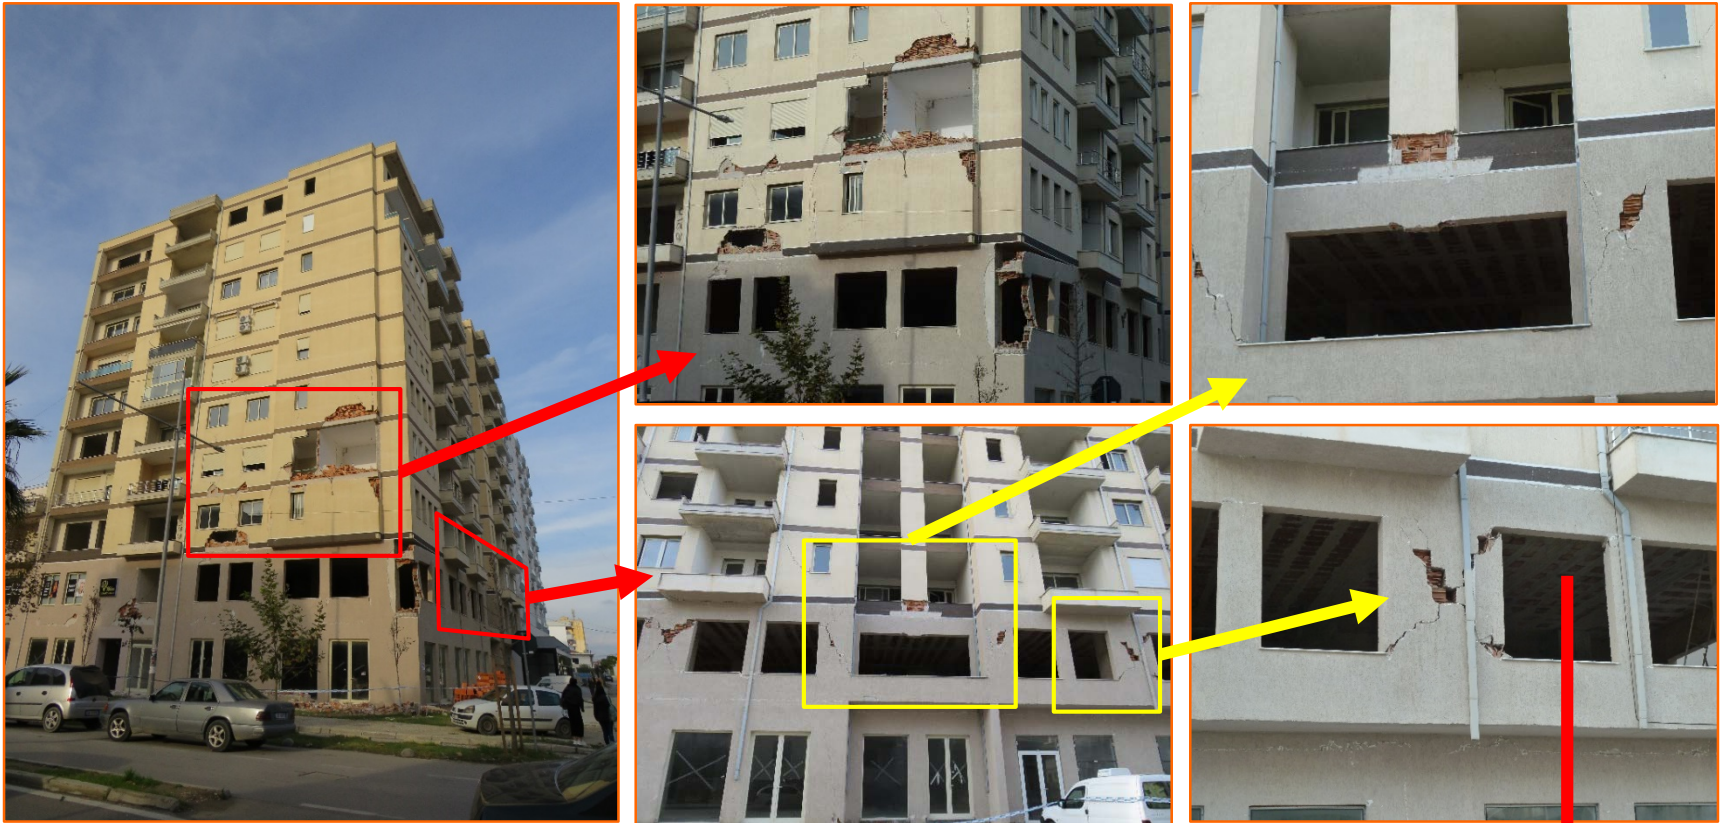
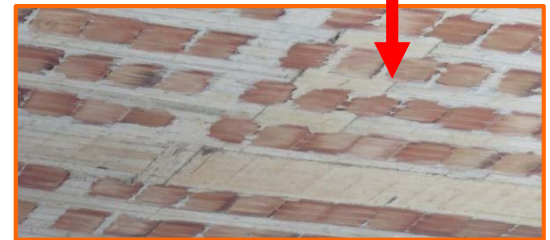
A multistorey building in Durrës with damage observed only in the lower floors, while the upper floors remained intact. Cracking of plaster, detachment of plaster from the brick walls, cracking and total collapse of brick walls between slabs were mainly observed. Exterior non-structural walls made of hollow clay bricks outside the reinforced concrete frame suffered damage. Floor systems consist of brick units and concrete beams.

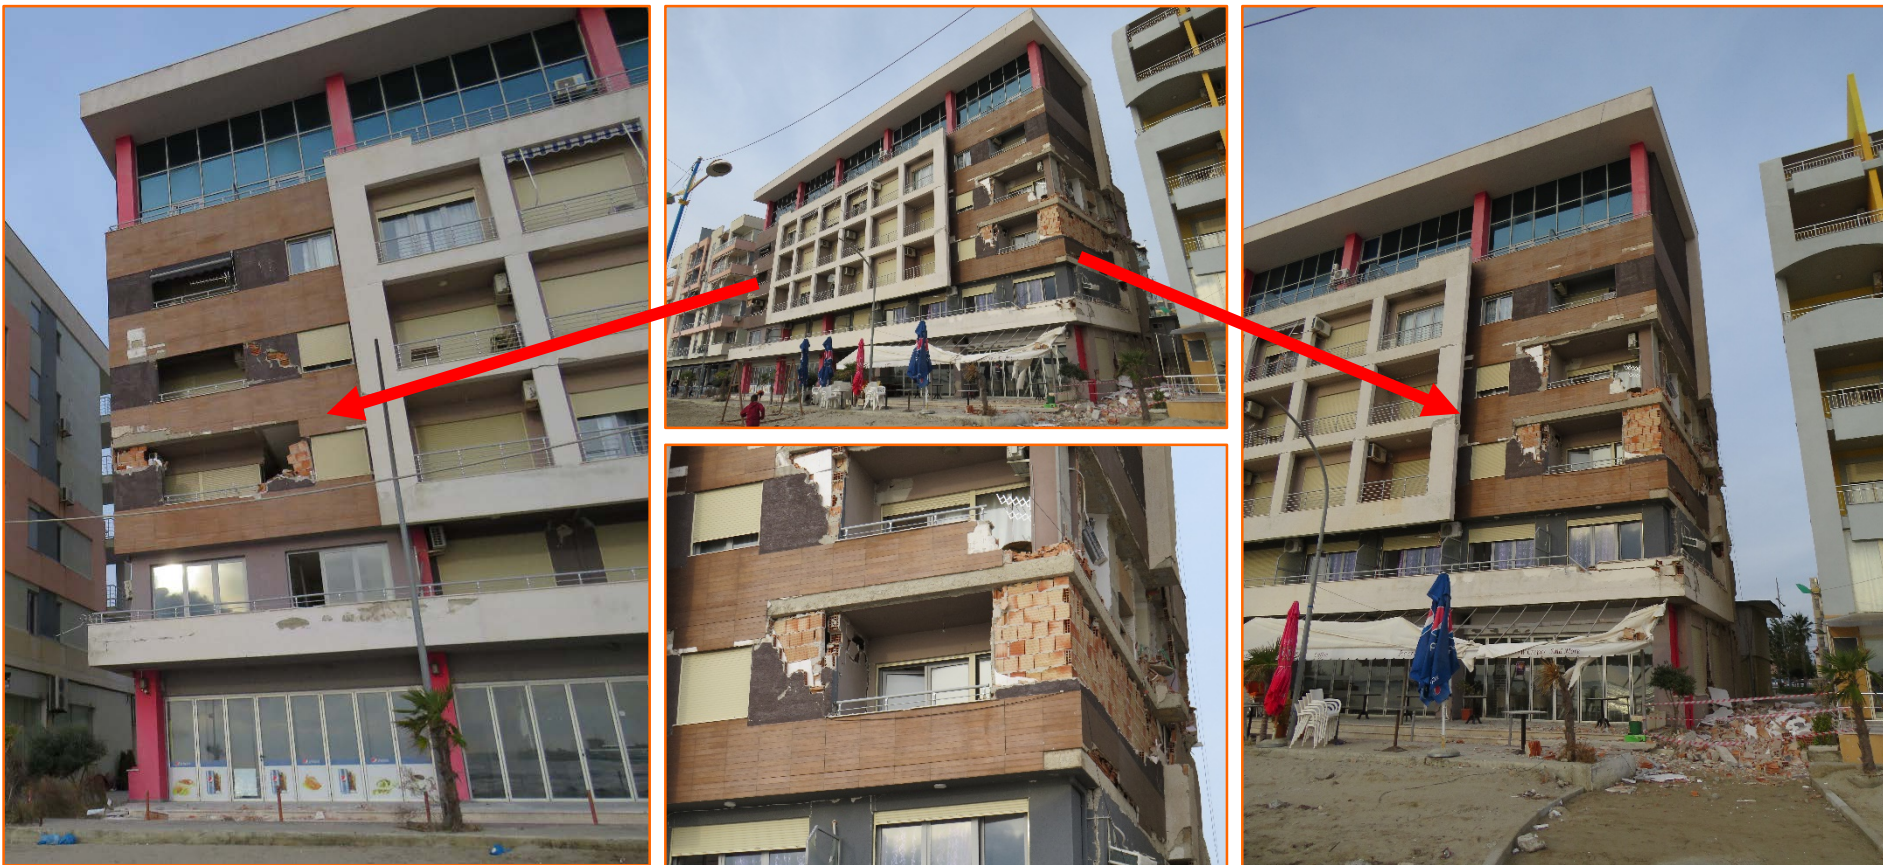
Exterior non-structural walls made of hollow clay bricks outside the reinforced concrete frame suffered damage

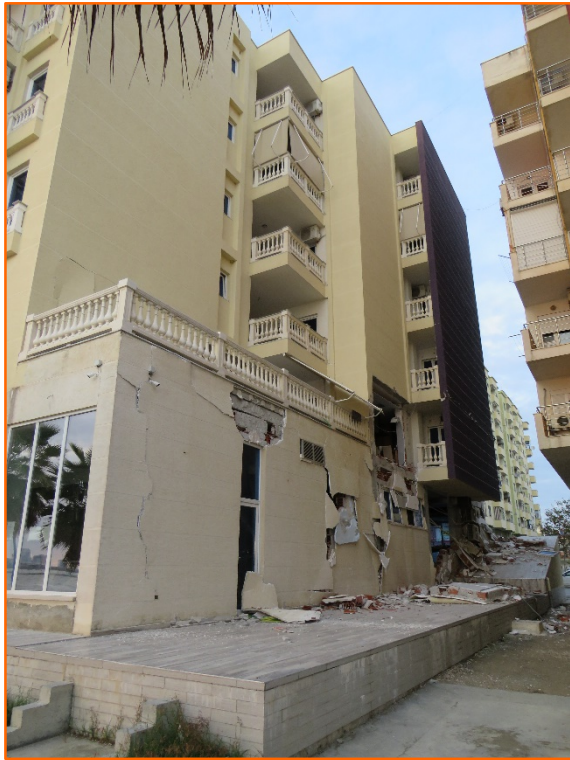
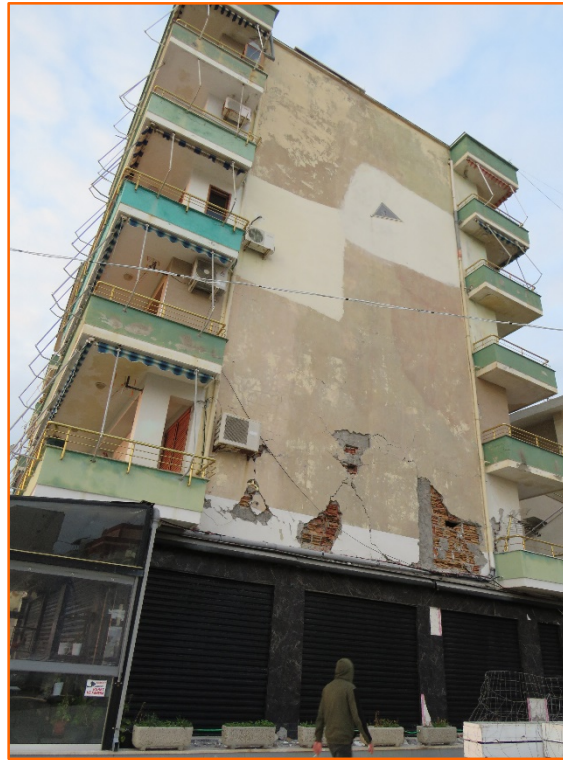
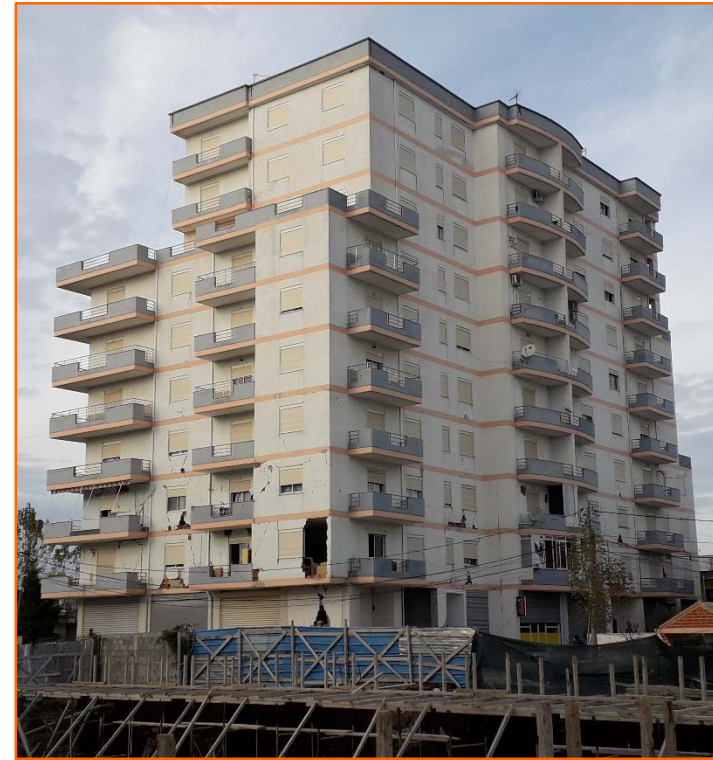
It is significant to note that the high-rise buildings were damaged on their lower floors. Moreover, the same floors have been destroyed, indicating high floor accelerations, which is a rare phenomenon in relation to the intact upper floors. This is probably due to the action and prevalence of a strong vertical component of the earthquake ground motion in the affected areas. In this case, due to the shallow water table, the S waves are not easily propagated, while the P waves in the water are easily propagated with very small attenuation. In addition, such buildings have large fundamental period with a high base height ratio.

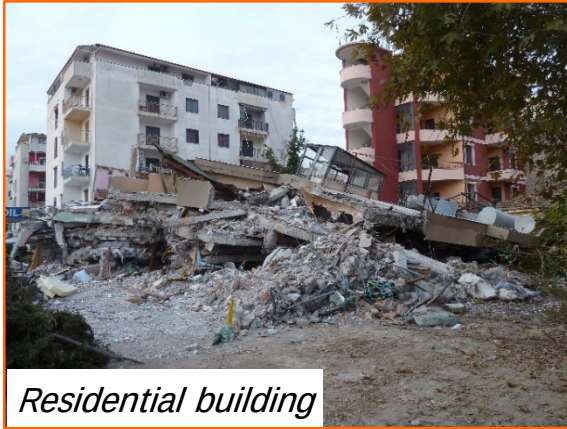
*Residential building*

The presented residential building (upper photos) and the hotel (lower photos) were among the totally collapsed buildings in Durrës. The destruction was almost complete with collapsed slabs leaving no gaps and empty spaces between them. The tangled mass of earthquake building debris reflects not only the strong seismic motion but also the poor construction of buildings and the inadequate quality of construction materials.
