# **COMBINED AERIAL AND GROUND-BASED SFM MODELING FOR A VERTICAL ROCK WALL FACE TO ESTIMATE VOLUME OF FAILURE**

**Helge C. Smebye, Sean E. Salazar, Asgeir O.K. Lysdahl**  
Norwegian Geotechnical Institute, Oslo

# Rock wall failure on E18 highway between Oslo and Kristiansand

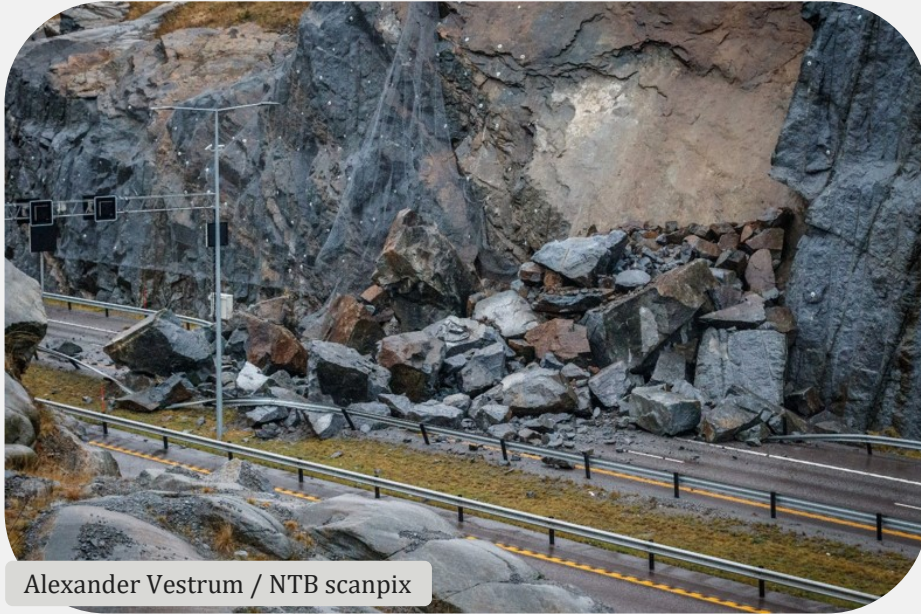
Following Dec. 13, 2019 failure

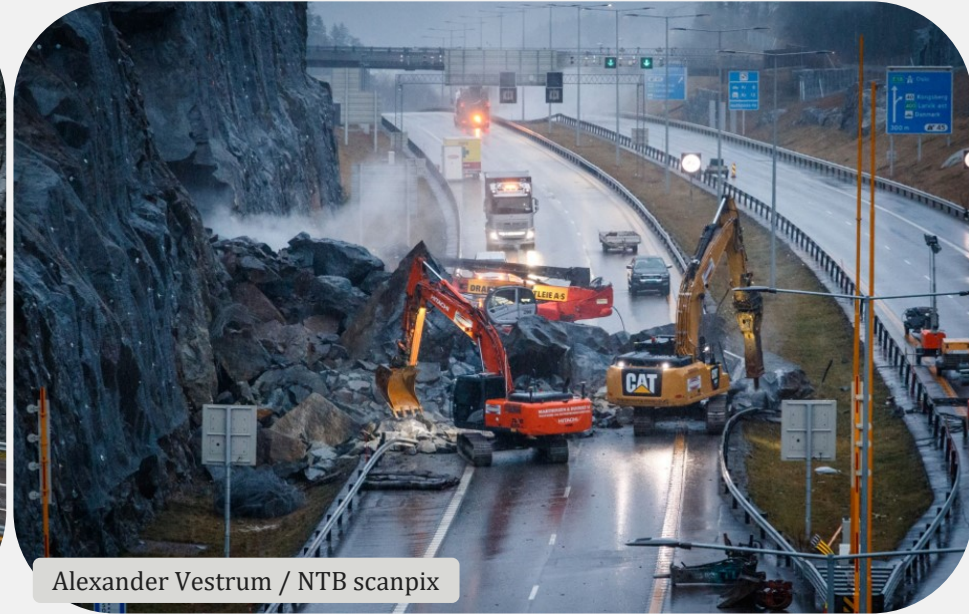
Cleanup and securing operation closed two lanes of traffic for many weeks

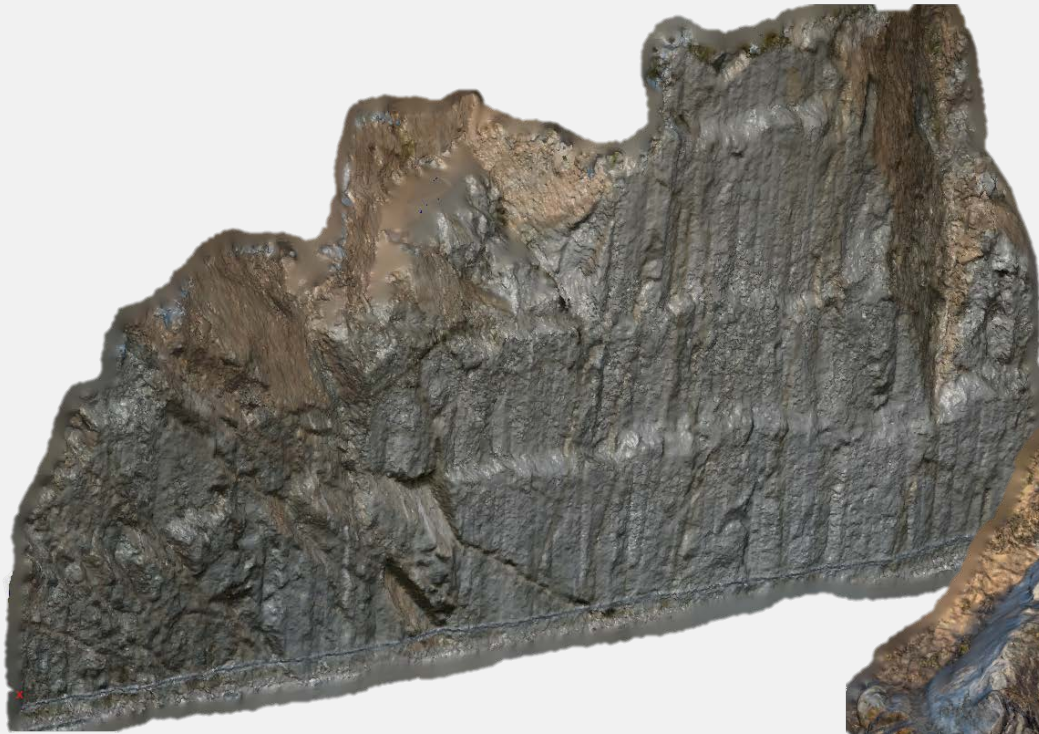
Post-failure reconstruction  
(Jan. 2020)

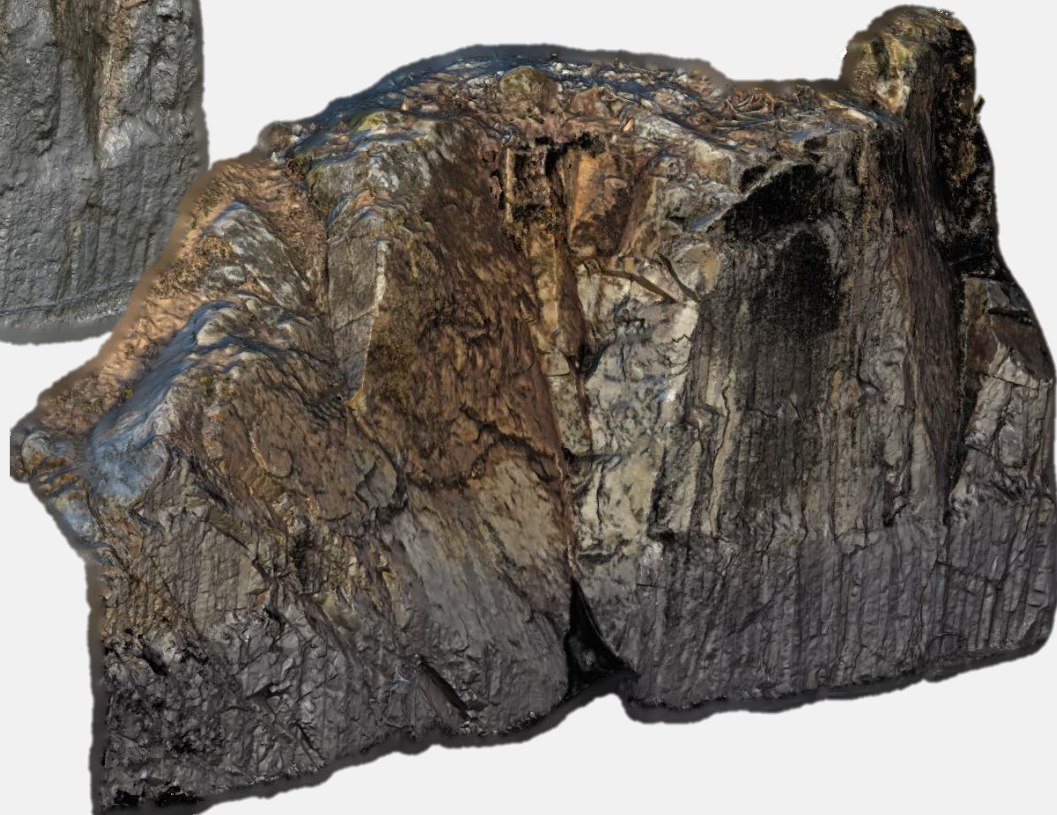
Pre-failure reconstruction  
(historical imagery)

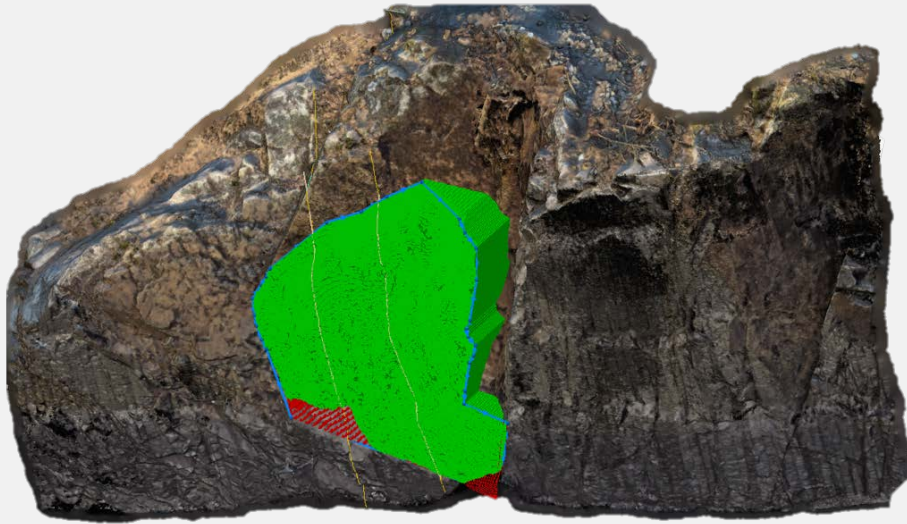
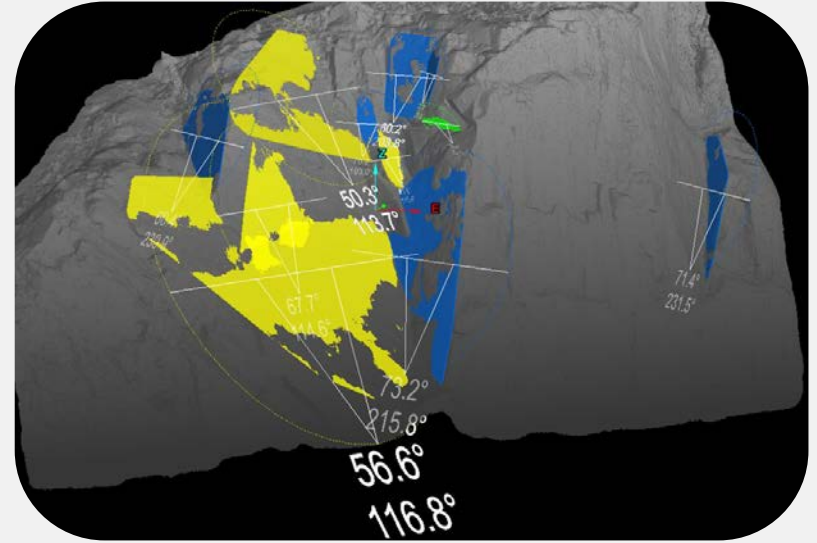
Failure volume estimate

Strike and dip measurements
