A Case Study for Infrastructure Scour Management

A Reactive Structures Safety Inspection was carried out at the A68 Galadean Bridge, which is carrying the A68 Road across Leader Water, between the towns of Lauder and Earlston, in the Scottish Borders (Fig.1).

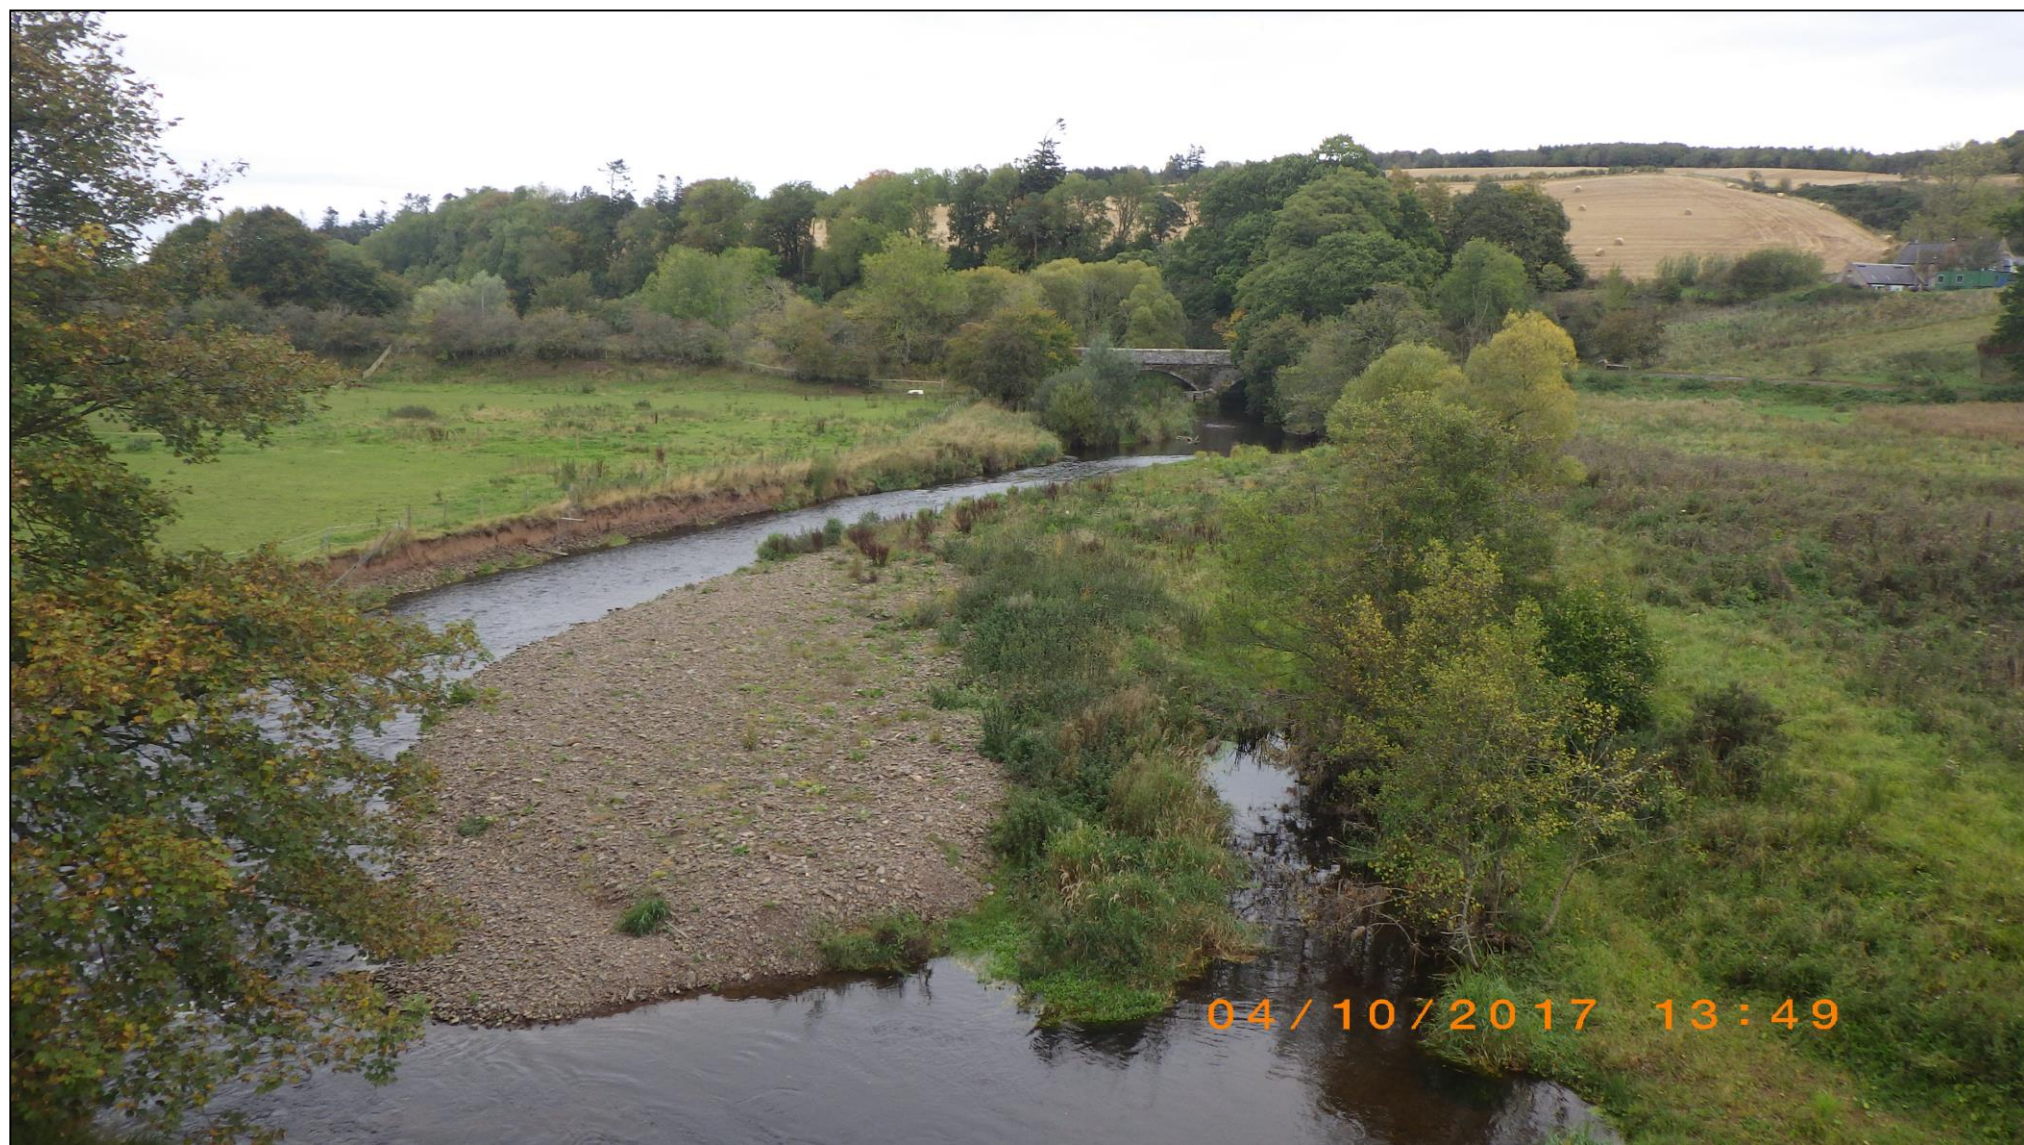
Figure 2 Upstream View 2017

- Sediment transport has been the cause of the formation of an ‘island’ from depositing sediment, upstream of the structure (Fig.2).
- The course of the river has been redirected towards the western river bank, significantly eroding it, forming a bend (Fig.2 & 3).
- The flow has been directed on to the northwest embankment of the A68, deteriorating it and compromising the stability of the road (Fig.3).

- Rock rolls chosen as best solution.
- Three rows of rock rolls placed in front of the eroded embankment, 30 metres length.
- Sediment from the ‘island’ used to fill the rock rolls.

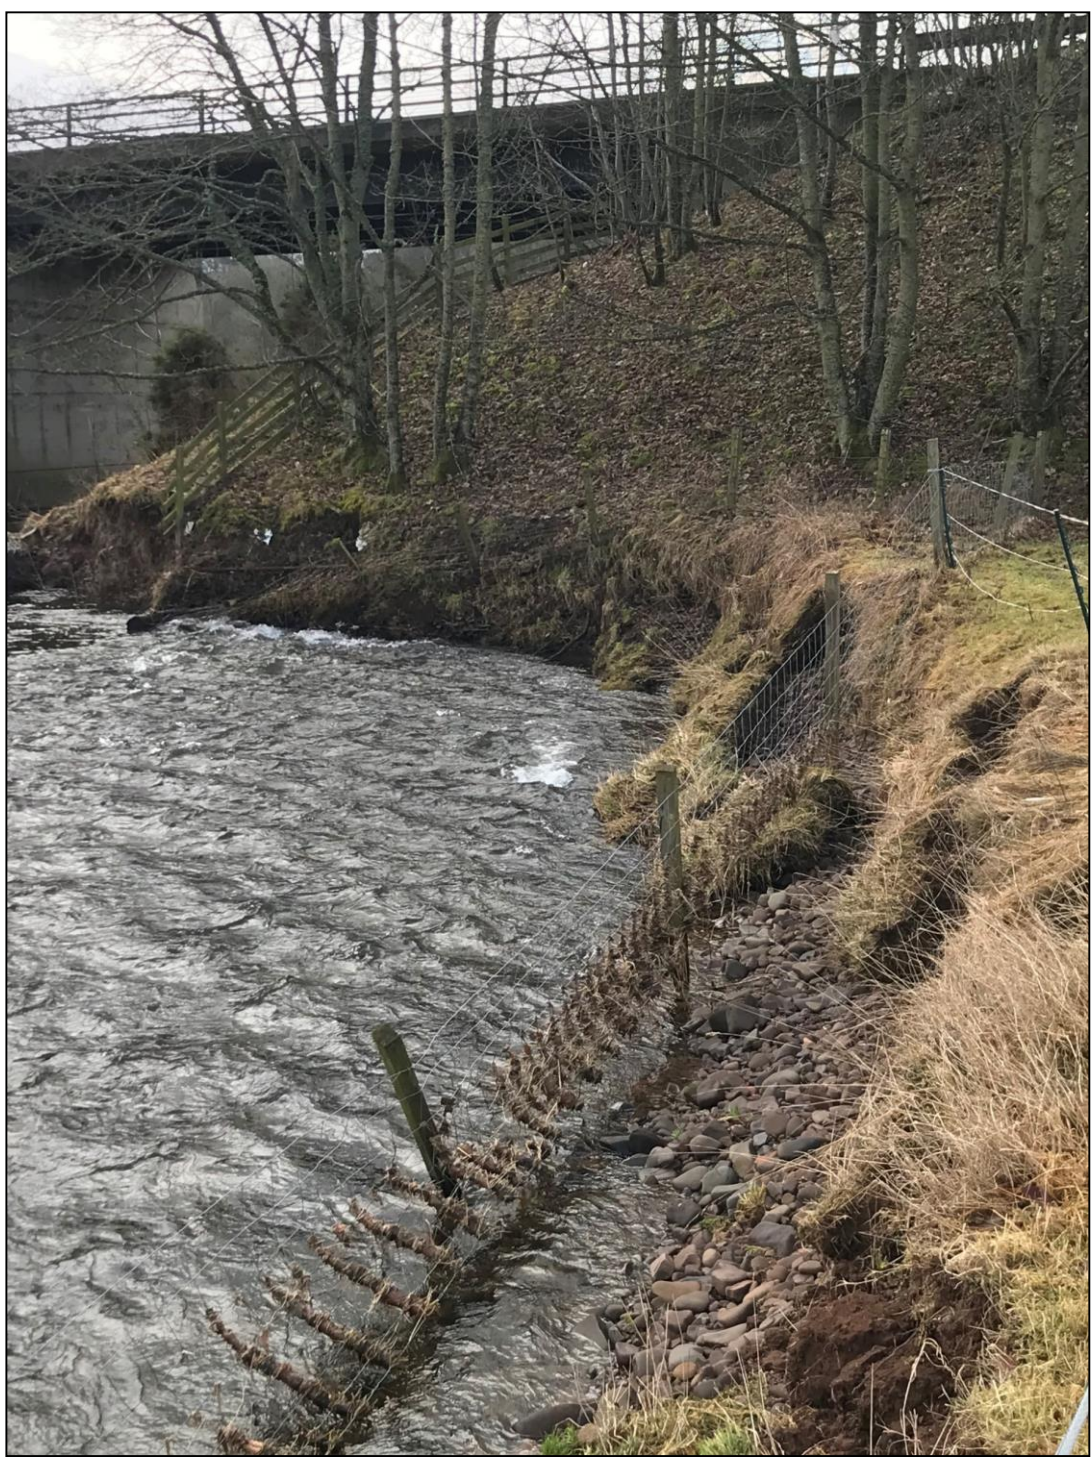
Figure 4 Eroded Embankment (Feb 2018)

Scour Exacerbation
