- UNESCO Chair on the Prevention and
- Sustainable Management of Geo-Hydrological Hazards,
- University of Florence, Italy

# Characterization and monitoring of a riverbank failure in a UNESCO World Heritage Site: the 2016 Florence (Italy) case study

Tofani V., Morelli S., Pazzi V., Tanteri L.,  
Nocentini M., Lombardi L., Gigli G., Casagli N.

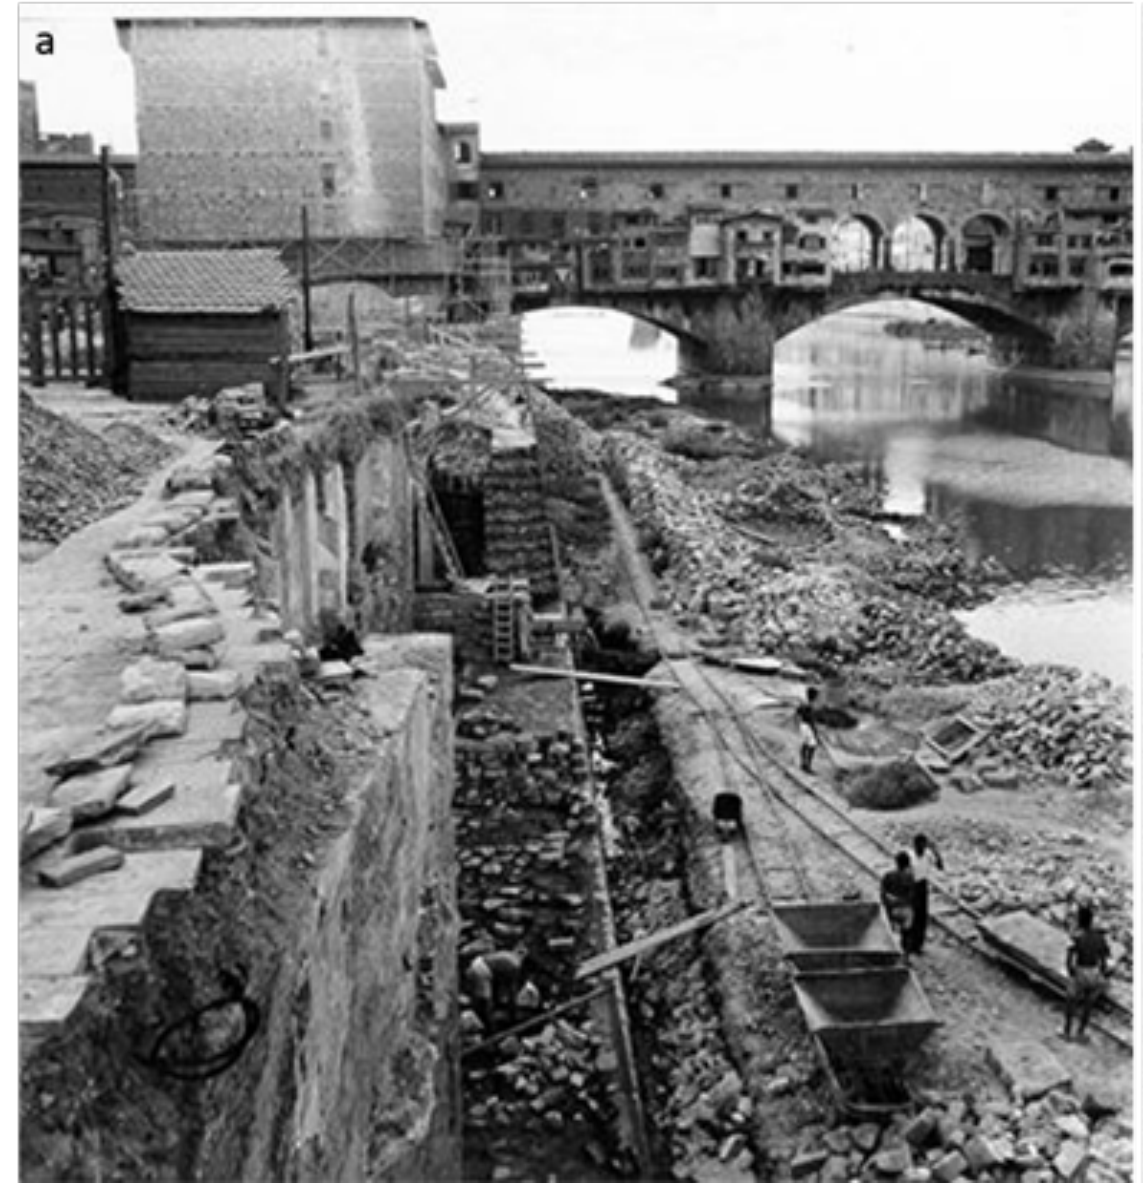
- 1) increase of destabilizing factors typical of slope landslides** (rainfall infiltration, anthropic pressure on soil strain, etc.)
  - *from the foundation in 56 BC to nowadays*
- 2) exceptional river dynamics (floods)**
  - *low impact from the foundation in 56 BC to 1175 (urban enlargement up to the river)*
  - *high impact from 1175 to nowadays with the riverbed narrowings*
- 3) high loss of water from subterranean pipes of the modern aqueduct**
  - *last 70 years (after the second world war)*

**Firenze capital of Italy**  
Modern riverbank construction  
**(1865-1871)**

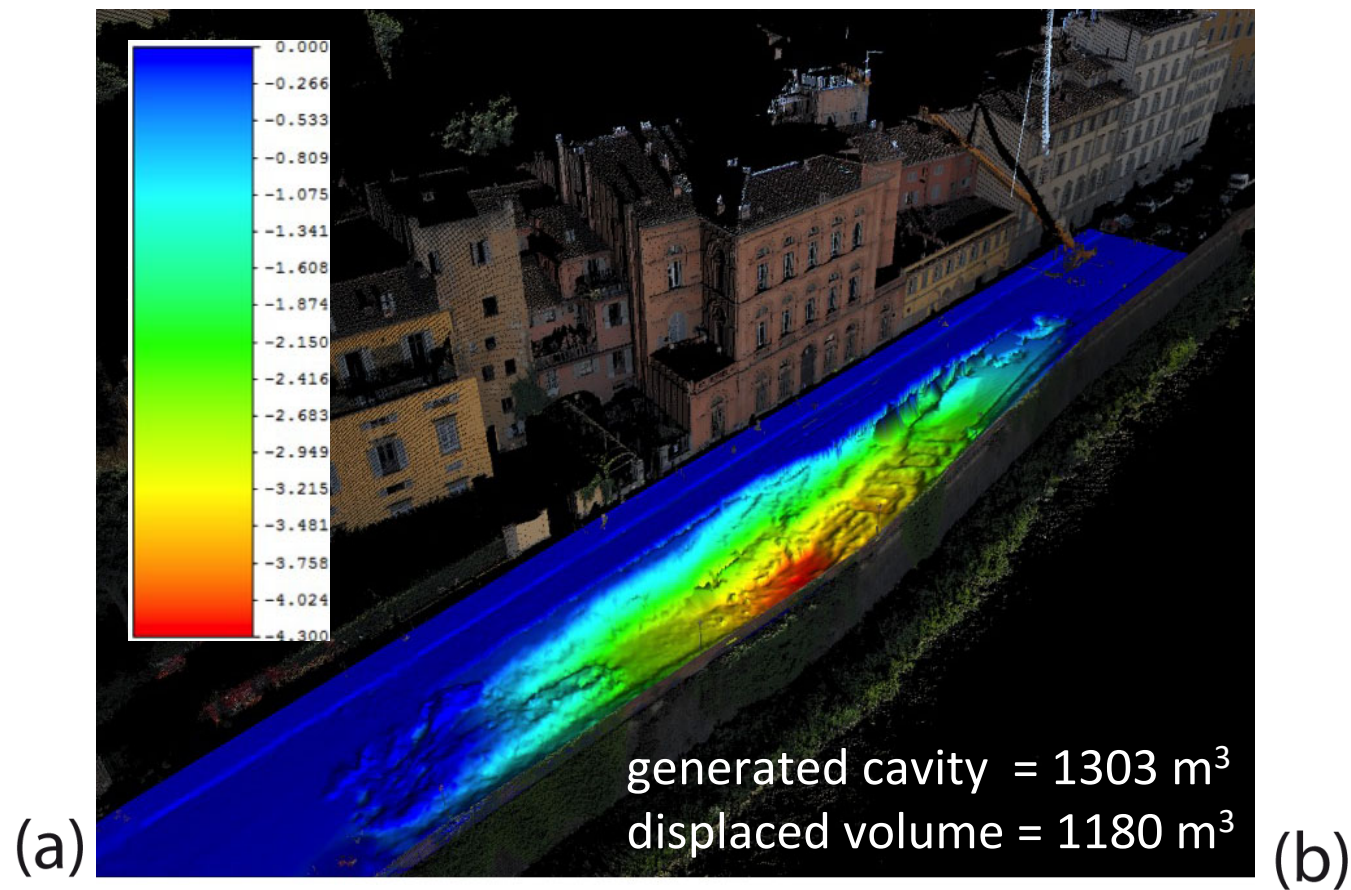
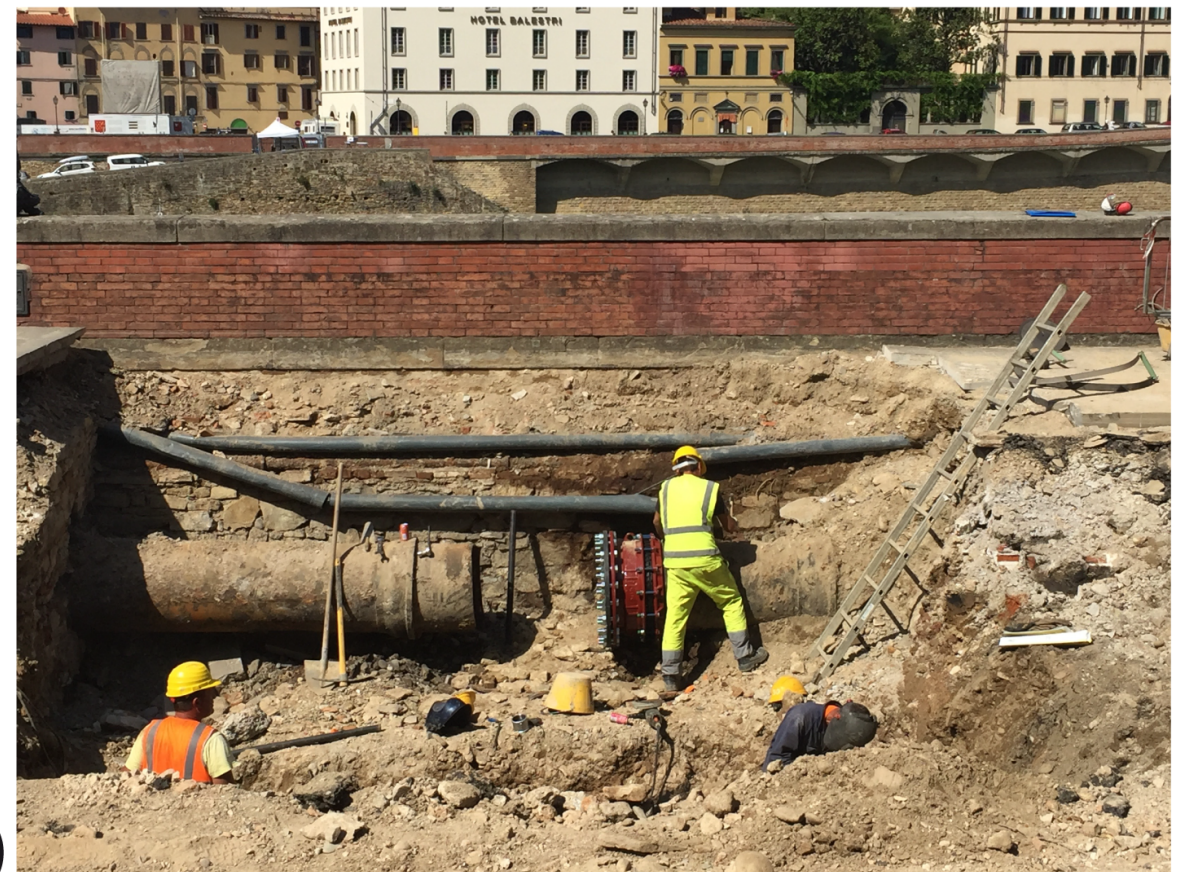
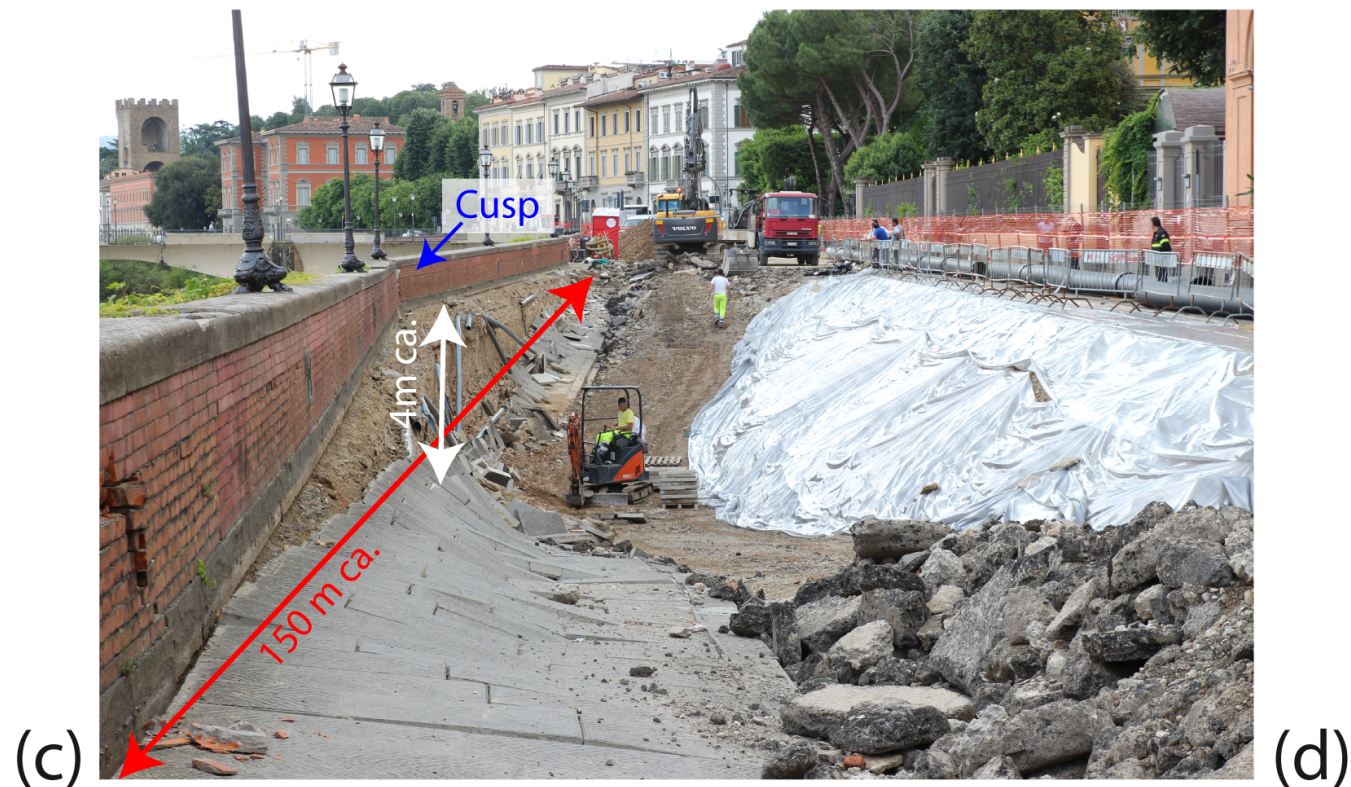
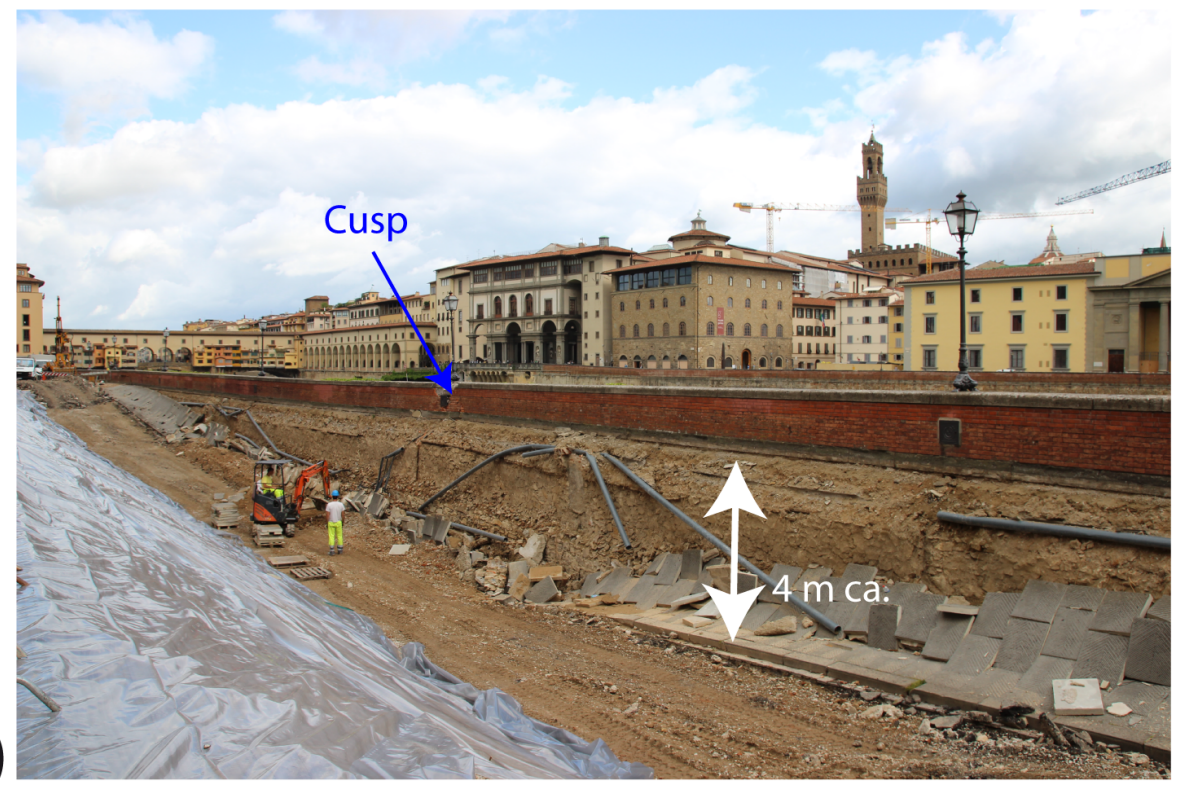
# The 2016 collapse

- On May 25<sup>th</sup>, 2016, a portion of the artificially built riverbank (1865-1871) collapsed next to the historic centre of Florence (Italy).
- To preserve the cultural heritage site and the emergency activities a real time monitoring system was installed.
- The instruments used for the control of the possible scenario evolution was also use to study the area and to reconstruct the event.
- The riverbank stability analysis result demonstrates that a lower safety factor was obtained with the complete saturation of the filling material and a low level of the river.
- The satellite analysis showed absence of movement in the days preceding the collapse.
- The major cause of the collapse can be attributed to the loss of water from the local subterranean pipes in the moments preceding the event.

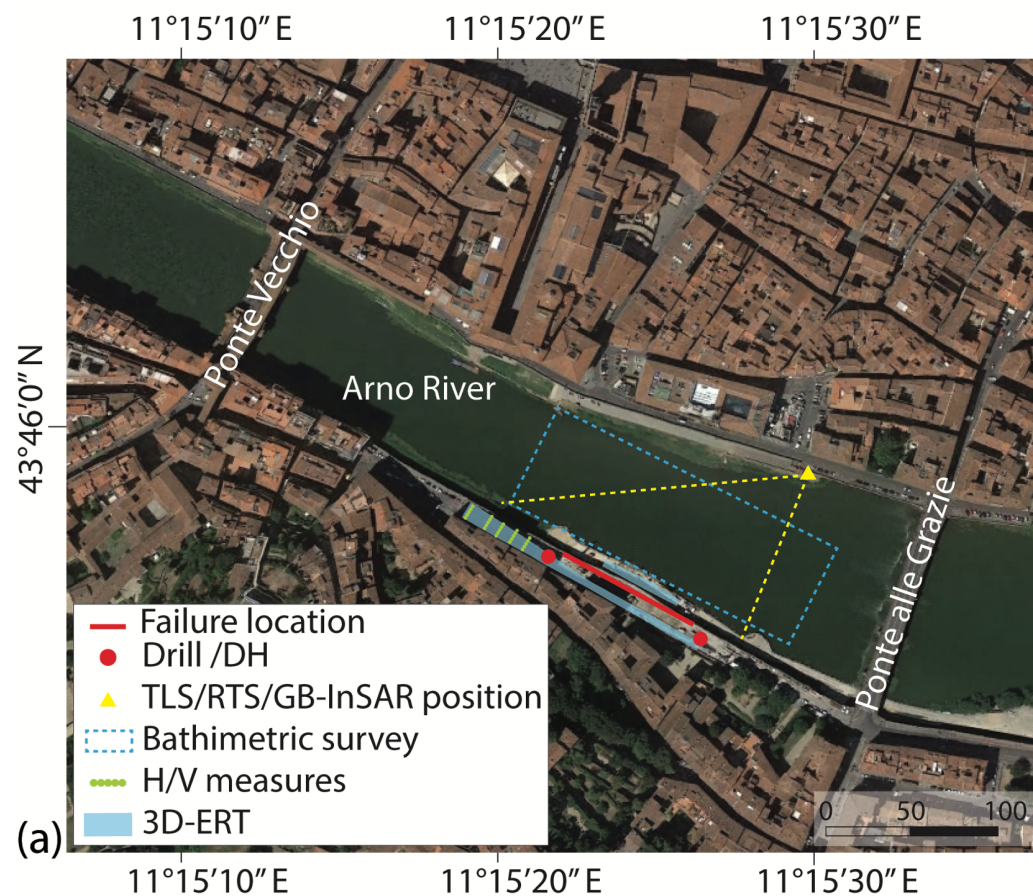
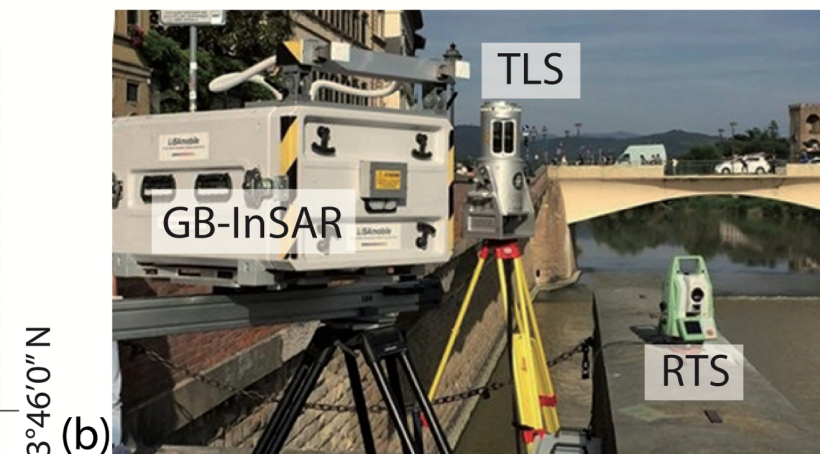
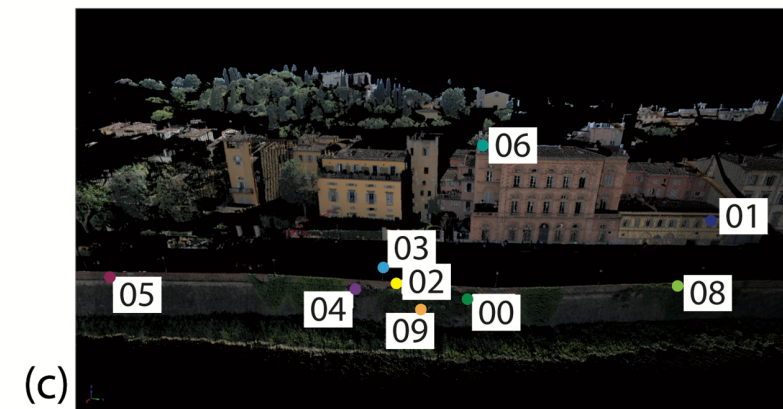
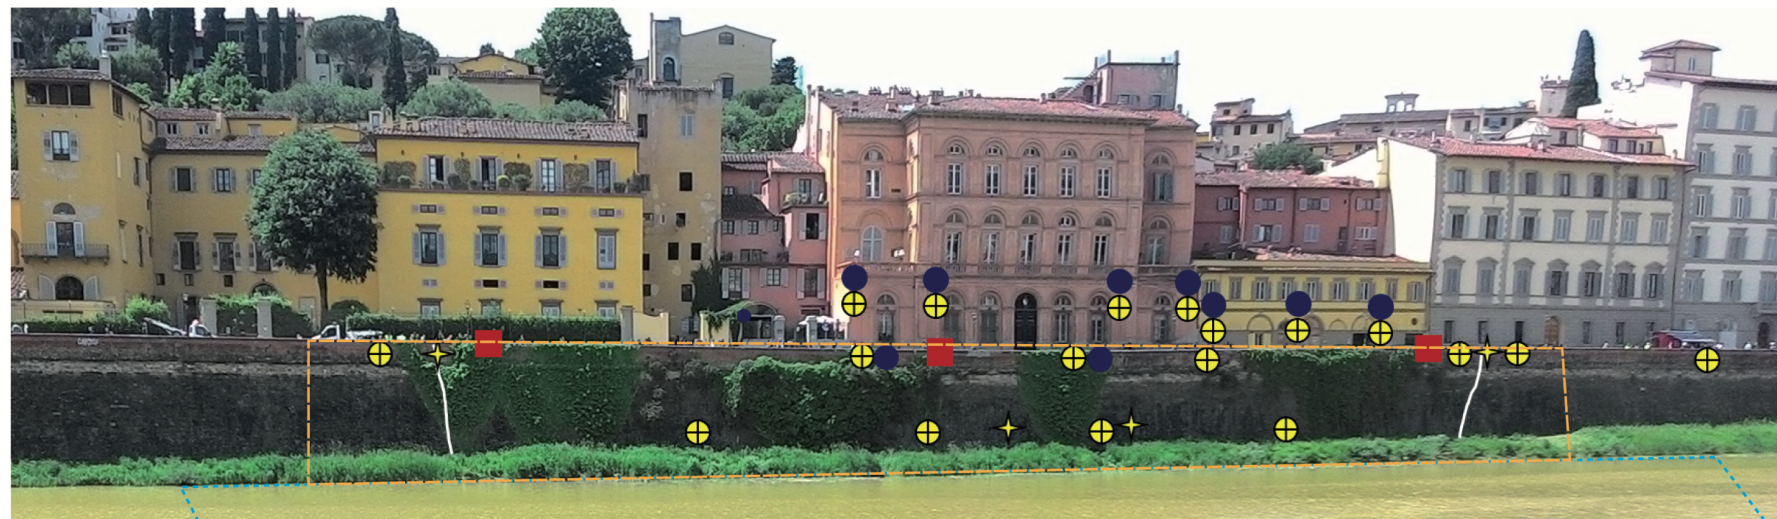
# Monitoring and study

Double approach  $\begin{cases} \text{Emergency management (increasingly targeted observation)} \\ \text{Event study and search for motivations} \end{cases}$

(d) ■ Seismic station ⊕ RTS target ★ Crackmeter ● Tiltmeter ▭ Bathimetric survey ▭ Photogrammetric survey

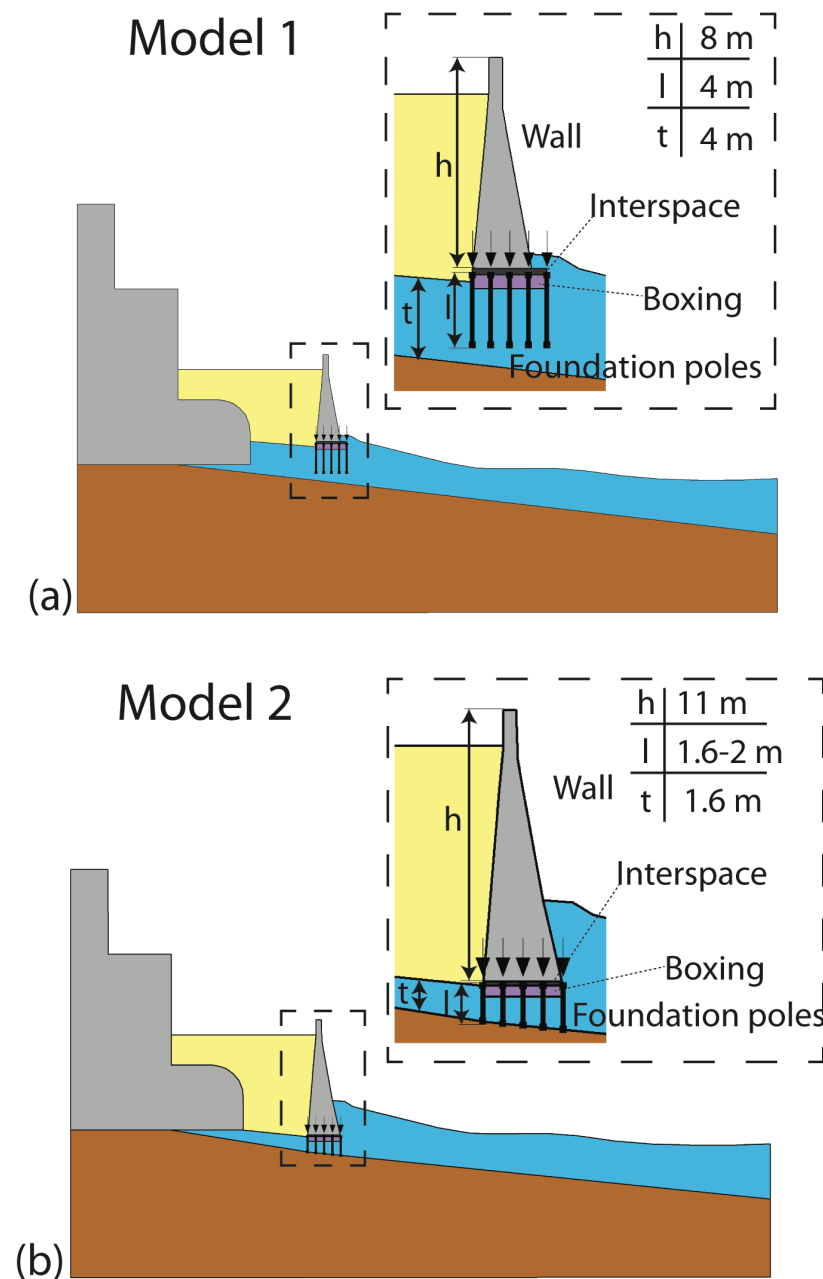
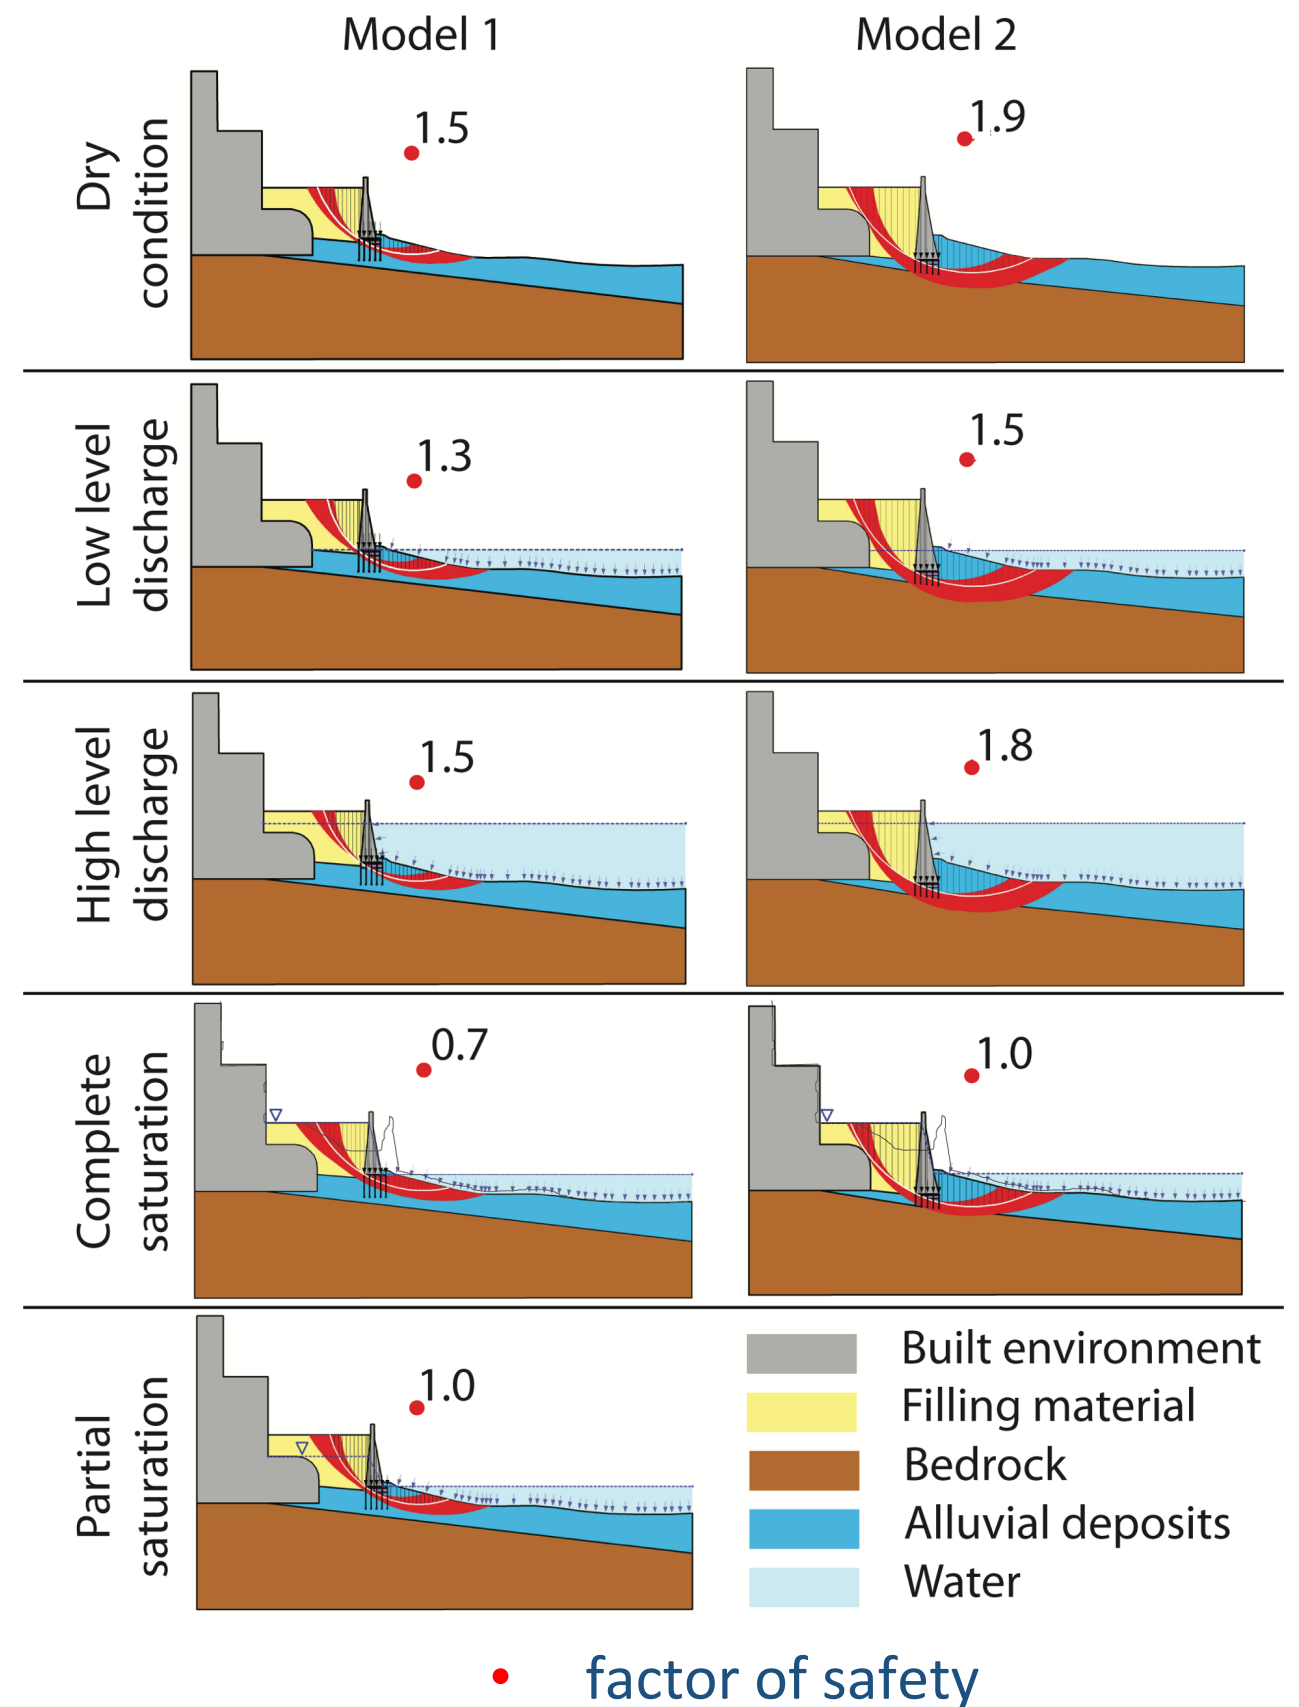
# Stability analysis

Software: Slope/W - Geostudio 2012

The analyses was conducted considering the limit equilibrium method outlined by Morgenstern and Price (1965)

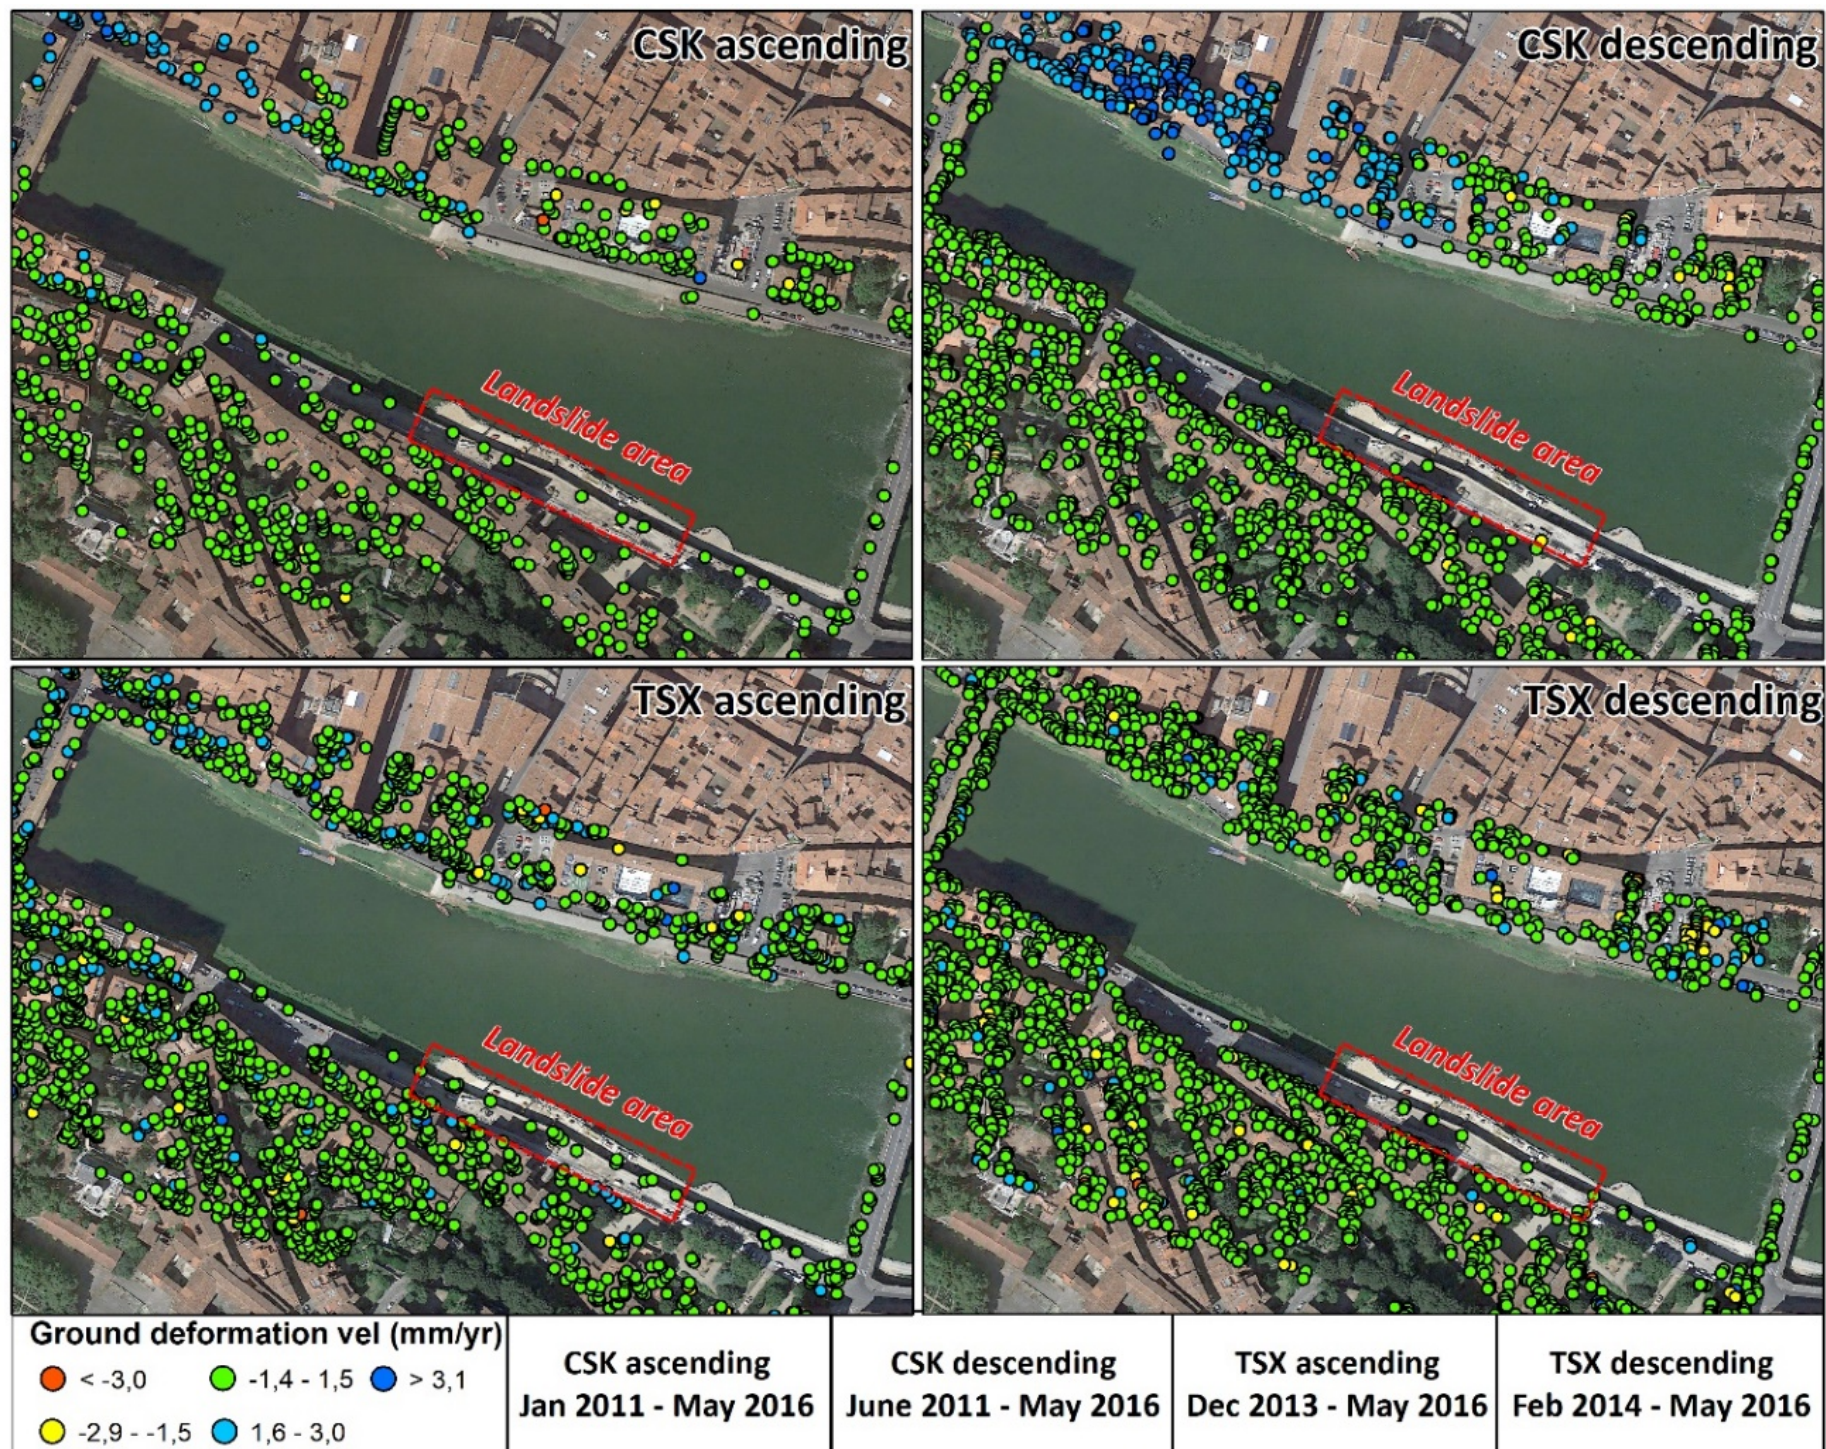
# Radar satellite analysis

COSMO-SkyMed and TerraSAR-x satellite acquisitions  
(pre-collapse conditions)
