# Large amplitude edge waves on a beach

Antonio Lechuga, CEDEX, Ministry of Fomento, Spain Antonio.Lechuga@cedex.es

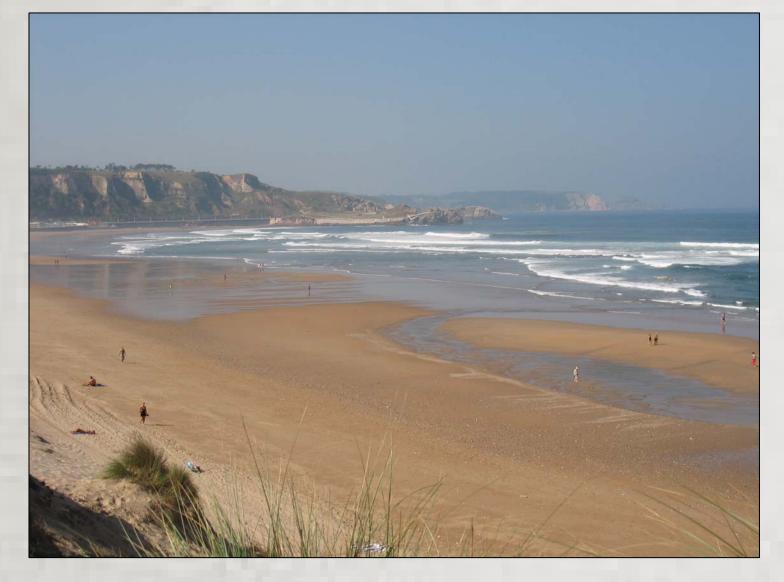
Figure 9. Low tide rhythmic pattern

Low tide sand features on Salinas Beach showing a remarkable tridimensional structure.
