THE ANÇÃ LIMESTONES COIMBRA, PORTUGAL

Mário Quinta-Ferreira Geosciences Center, Dep. Earth Sciences, University of Coimbra, Portugal (mqf@dct.uc.pt)
Lídia Gil Catarino Geosciences Center, Dep. Earth Sciences, University of Coimbra, Portugal (lidiagil@dct.uc.pt)
José Delgado Rodrigues Laboratório Nacional de Engenharia Civil (ret.), 1700-066 Lisbon, Portugal

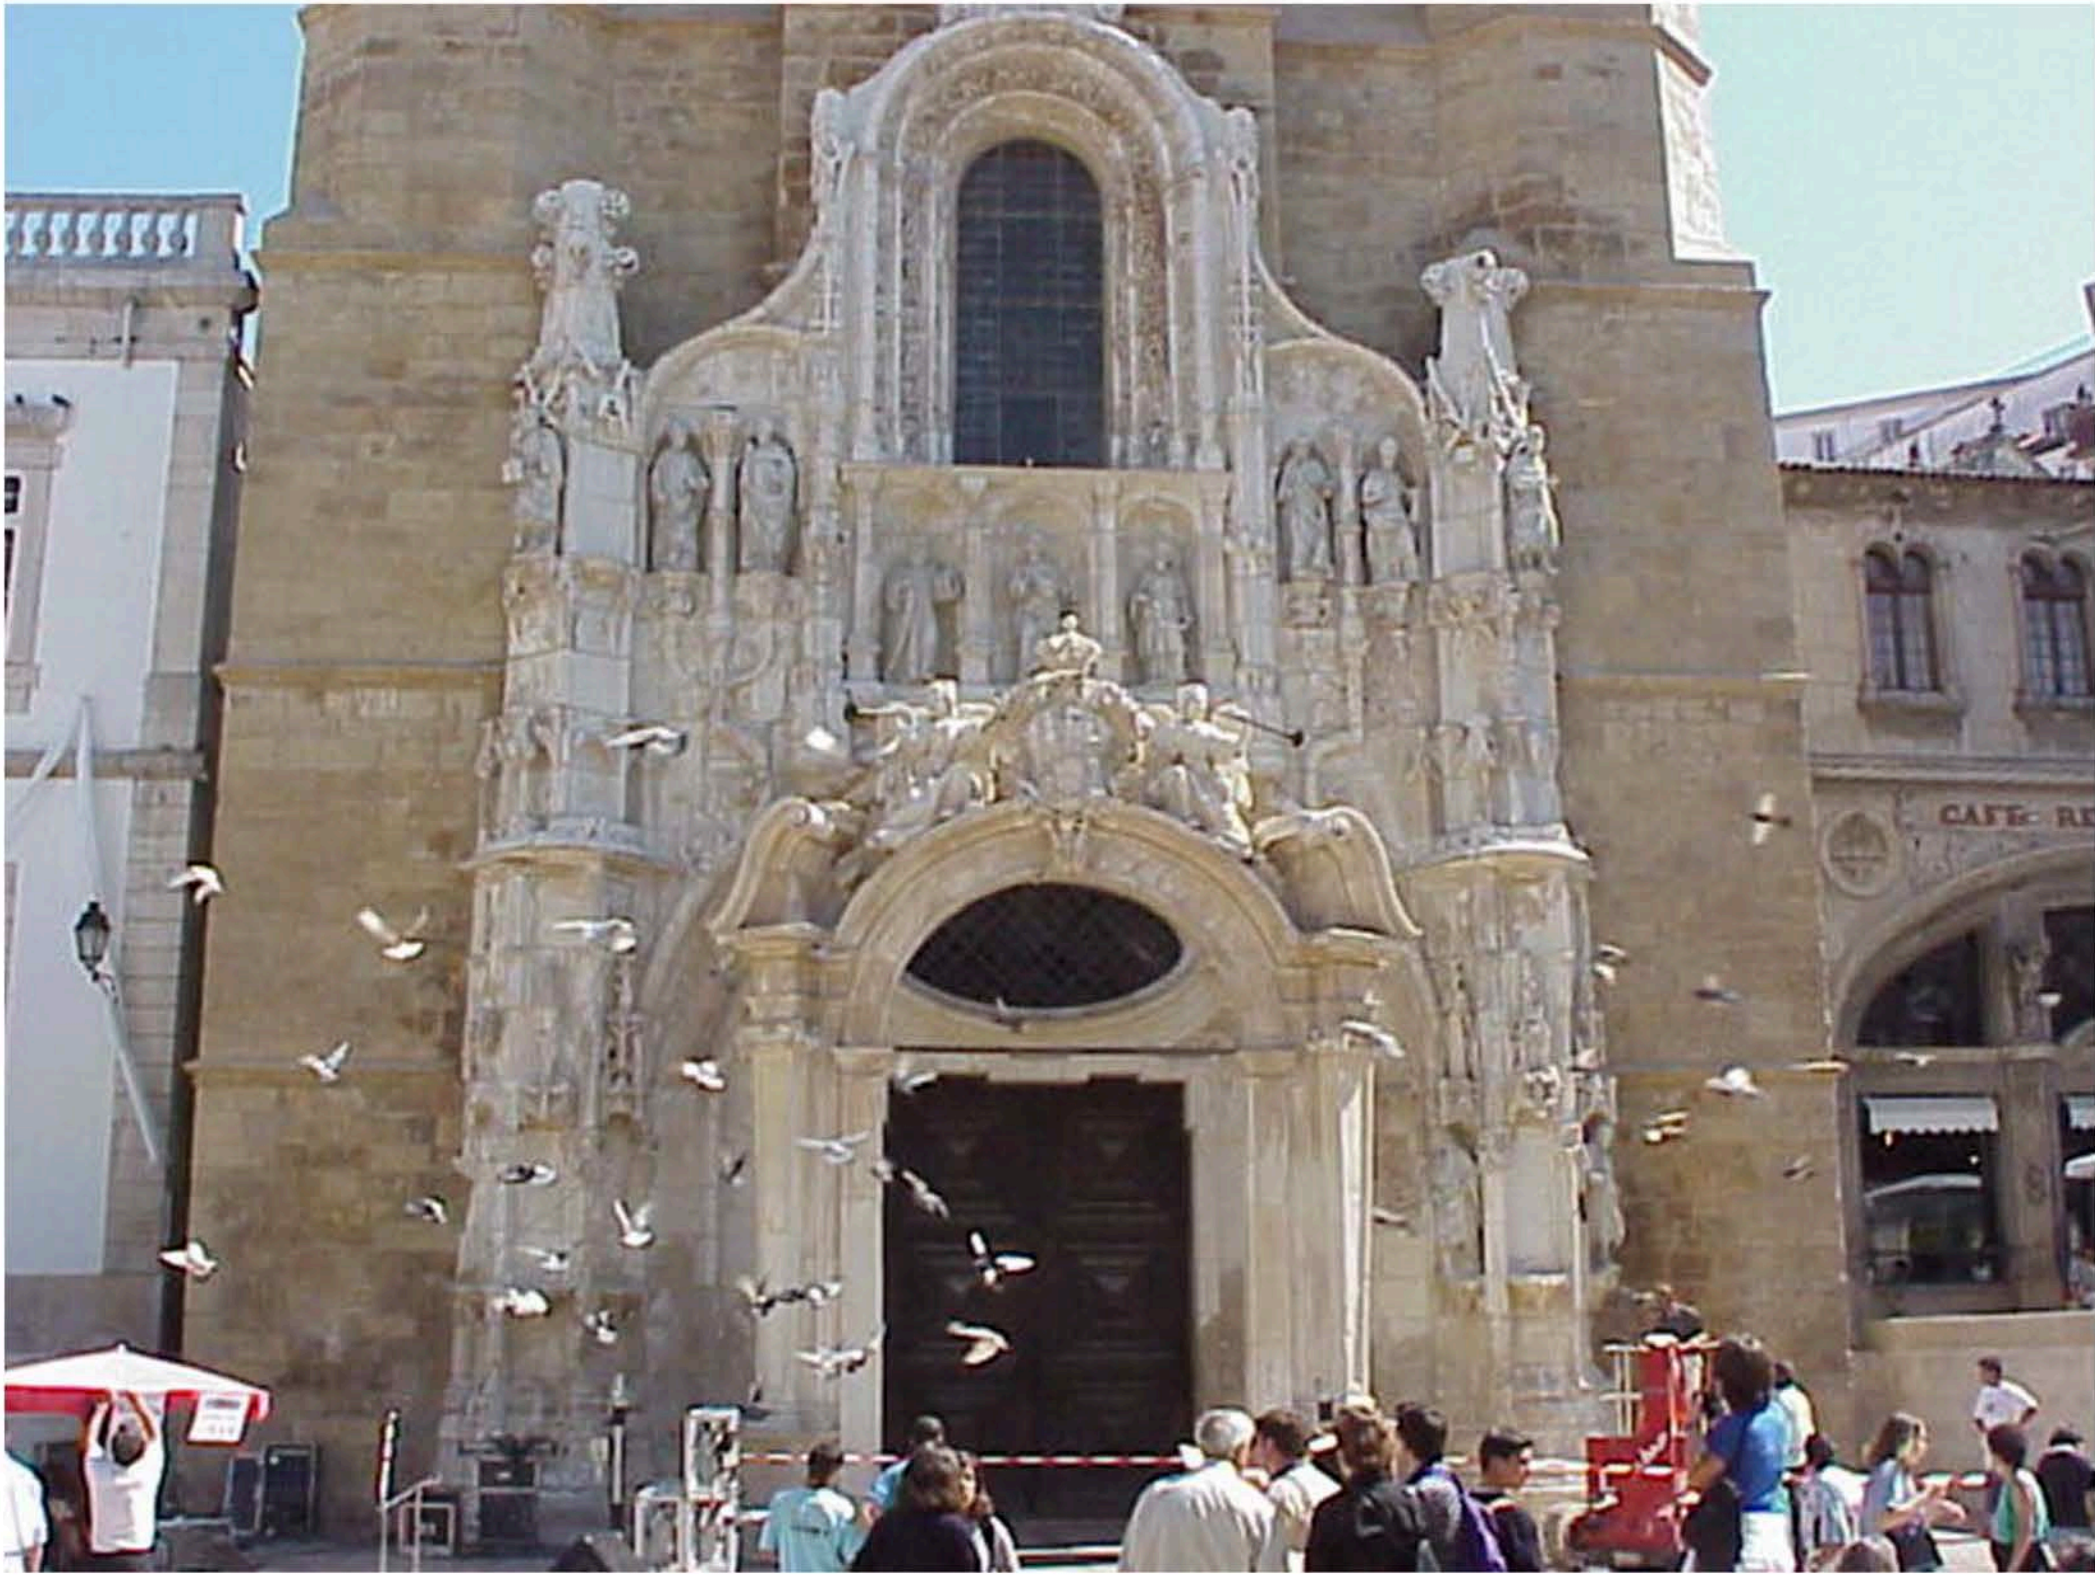
Fig. 2. Portal of the Saint Cross Church in Coimbra.

Some examples of heritage in Coimbra using the “Pedra de Ançã” are the renaissance portal of the Saint Cross Church (Fig. 2), the tombs of the first two Portuguese kings located in this church, the altar of the Saint Cross Church or of the Old Cathedral Porta Especiosa (Fig. 3), or in sculptures at the University of Coimbra.

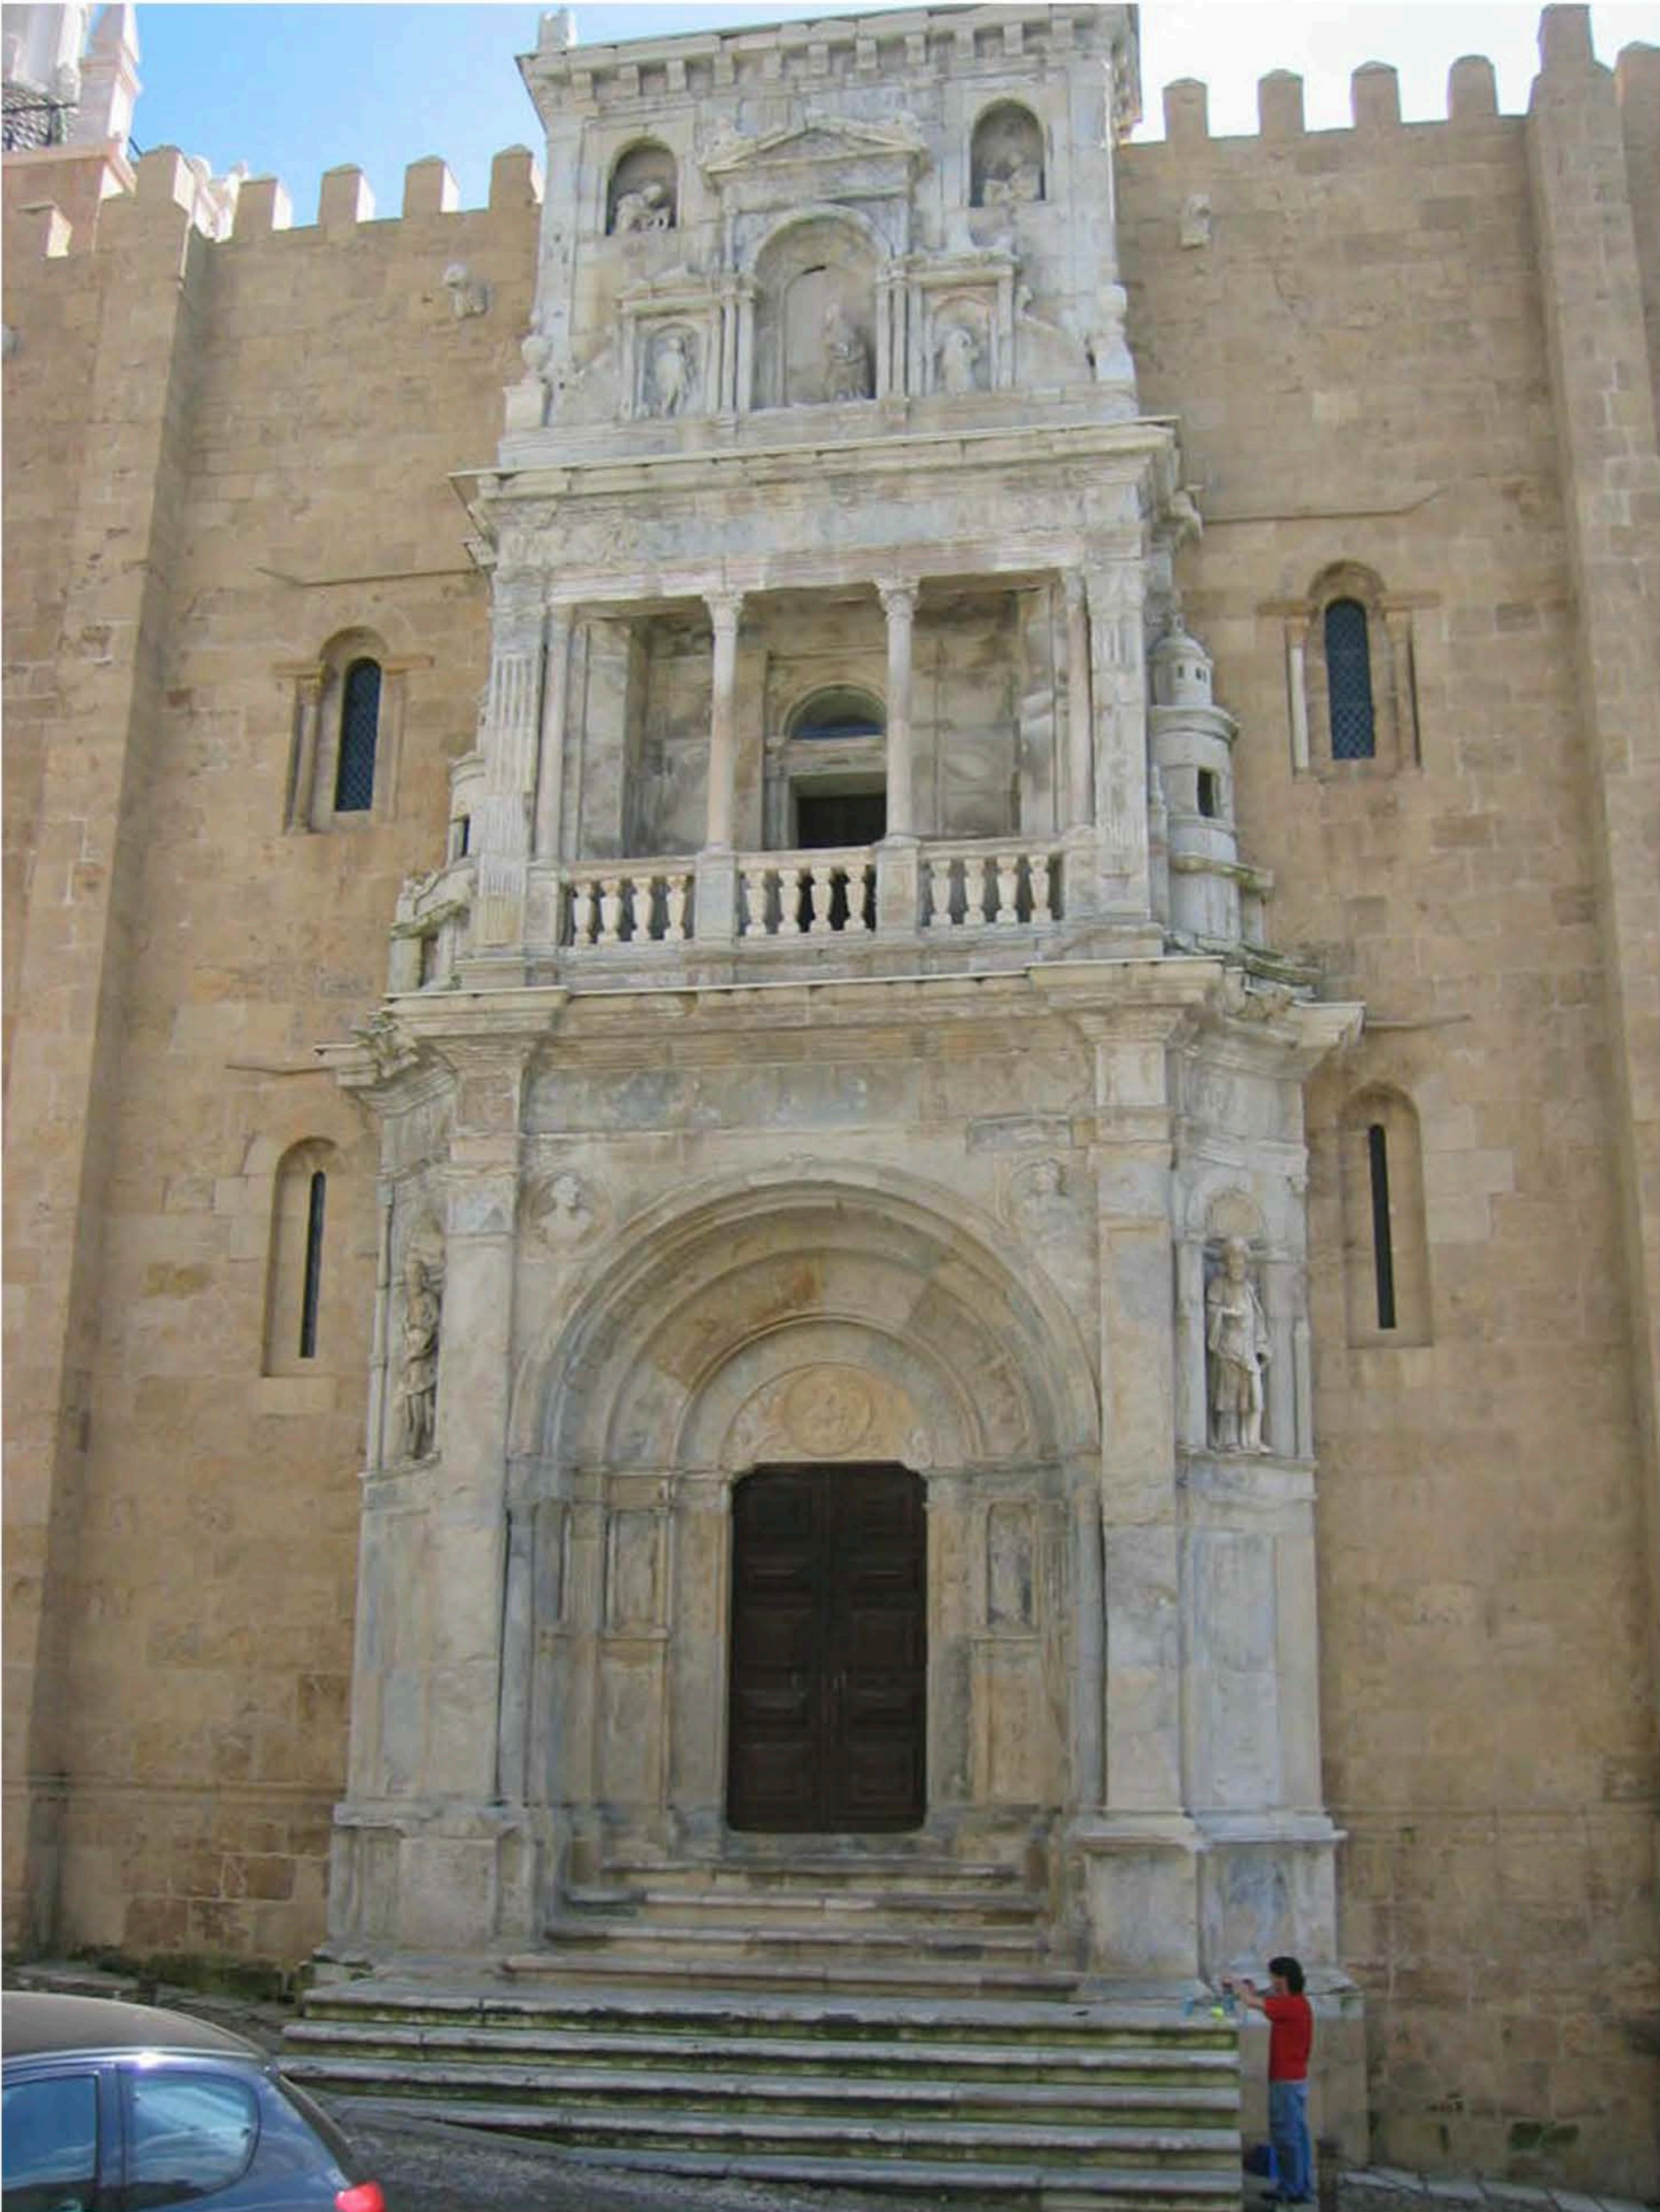
Fig. 3. Portal (Porta Especiosa) of the old Cathedral of Coimbra.

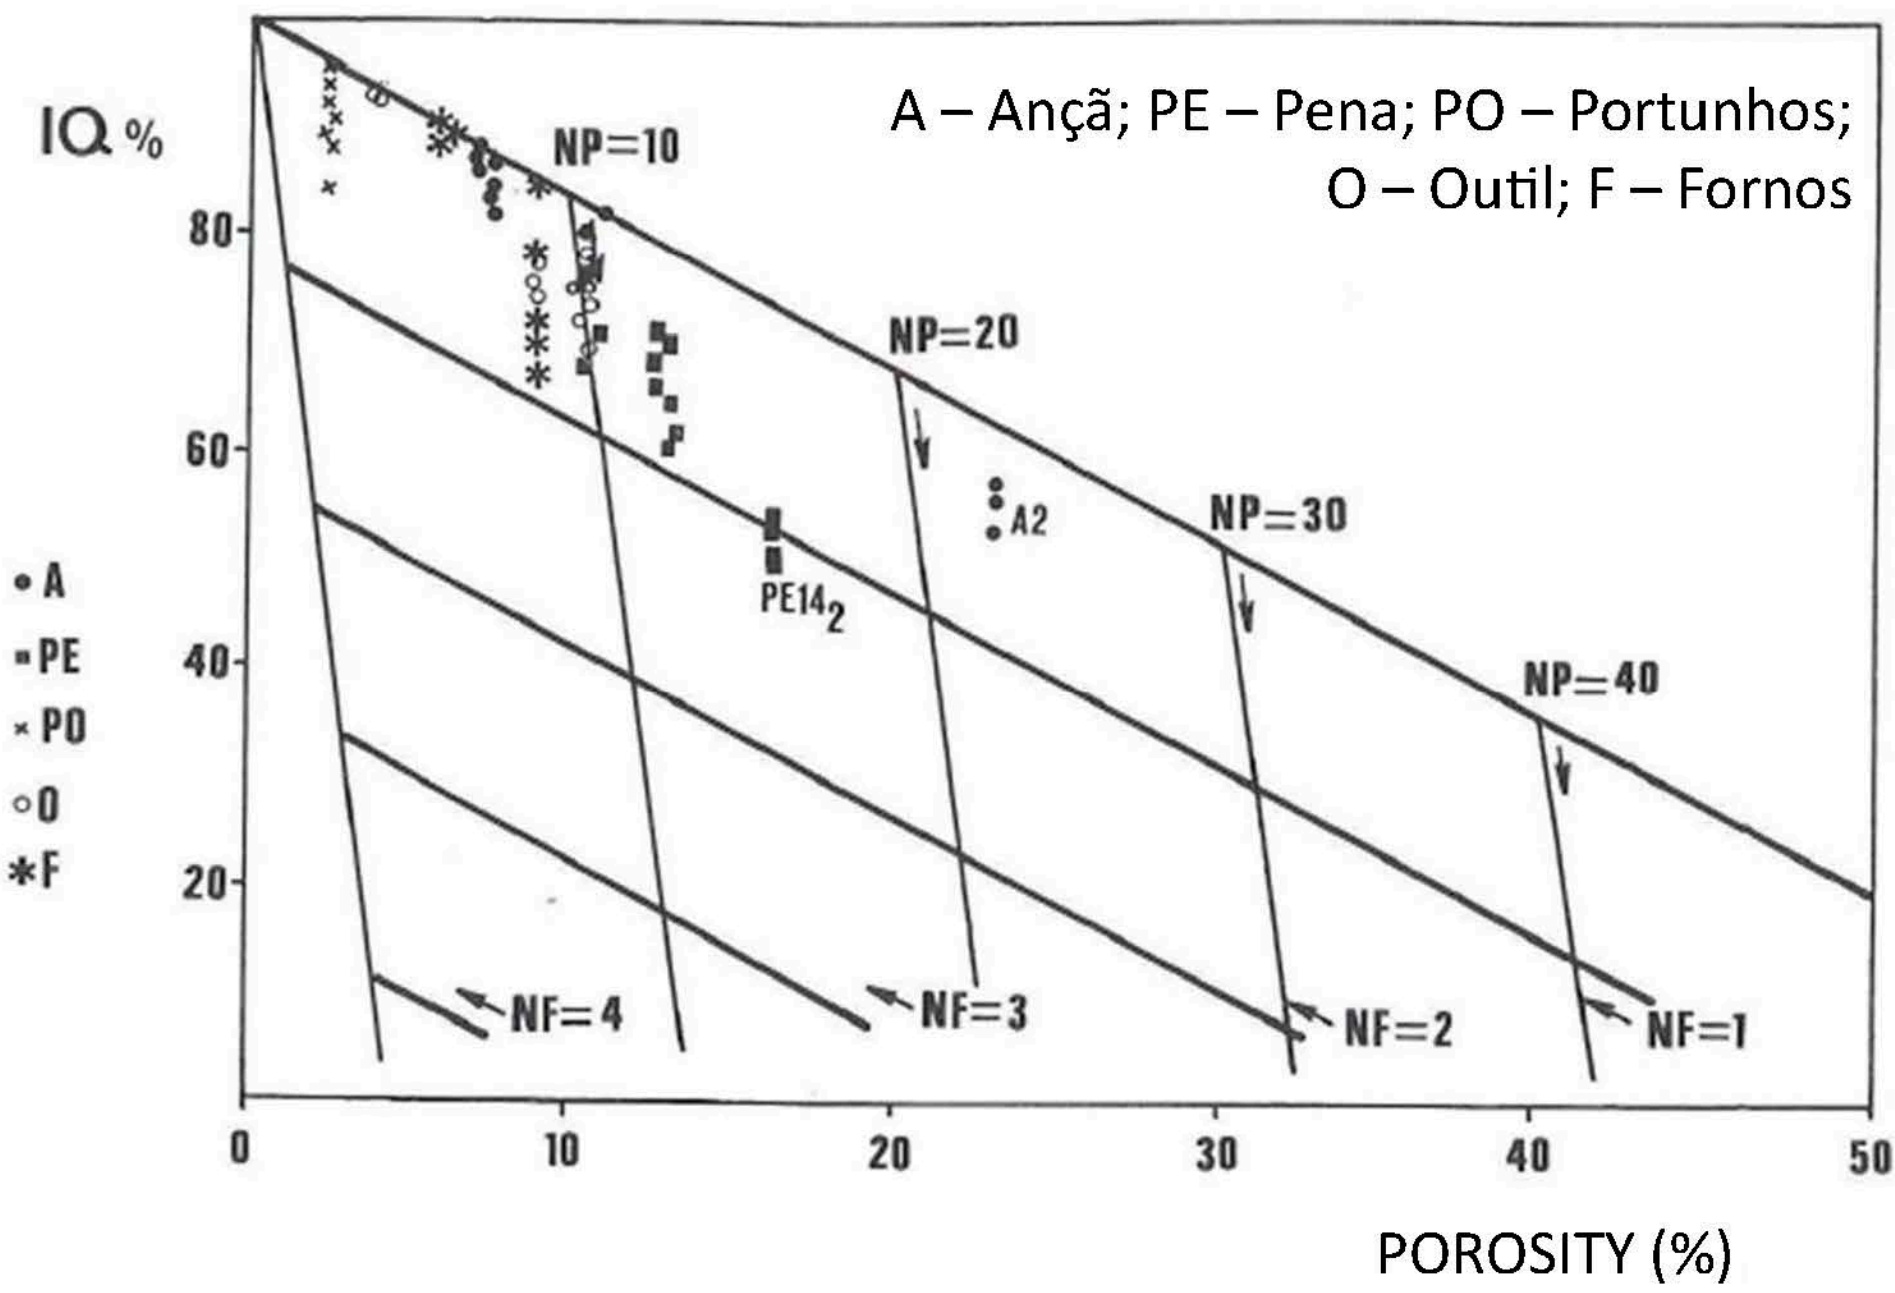
Fig. 4. Separation of pore porosity and fissure porosity based on the Index of quality (IQ) and porosity (n) using the graph proposed by Tourenq et al. (1974) and the data of Trindade (1994).

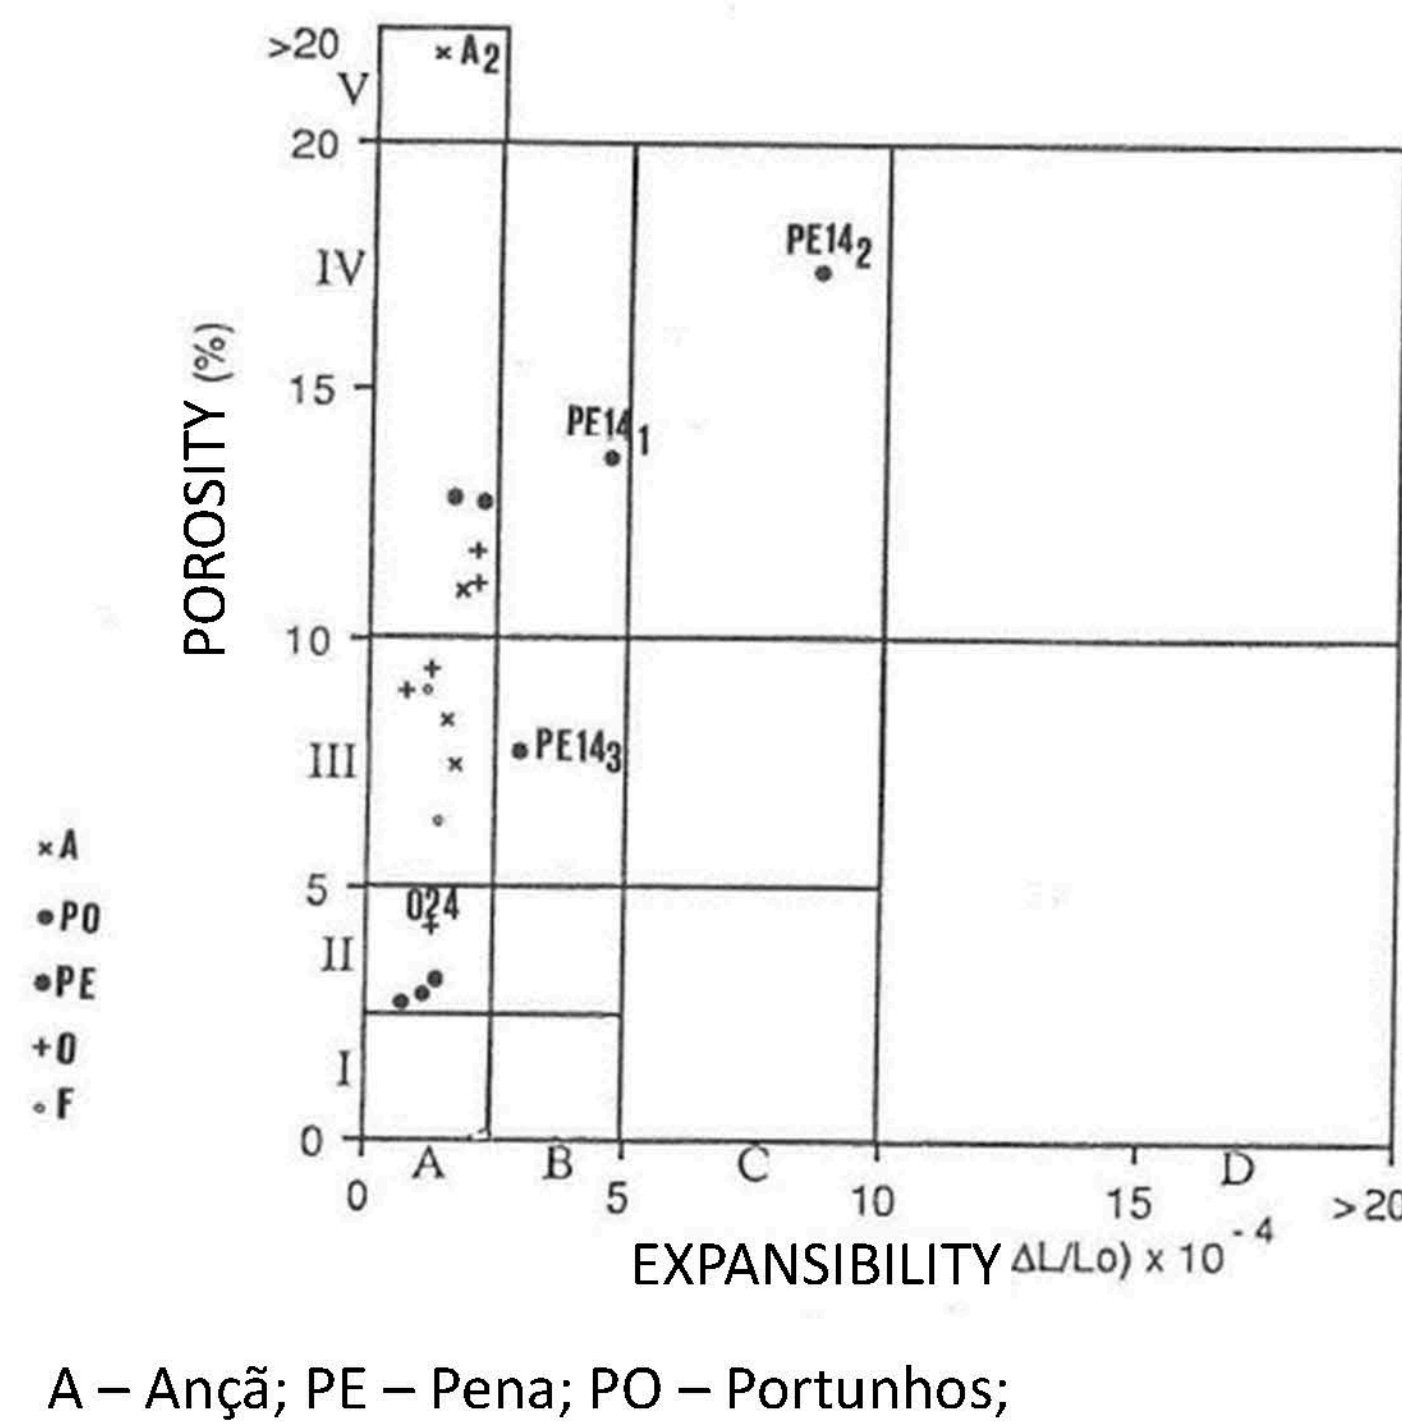
Fig. 5. Classification of limestone rocks from the area of Ançã, using the graph of Delgado Rodrigues (1988) and the data of Trindade (1994).

Several varieties were already identified: A – Ançã; PE – Pena; PO – Portunhos; O – Outil; F – Fornos. The Typical values for Ançã limestone is presented in Table 1.

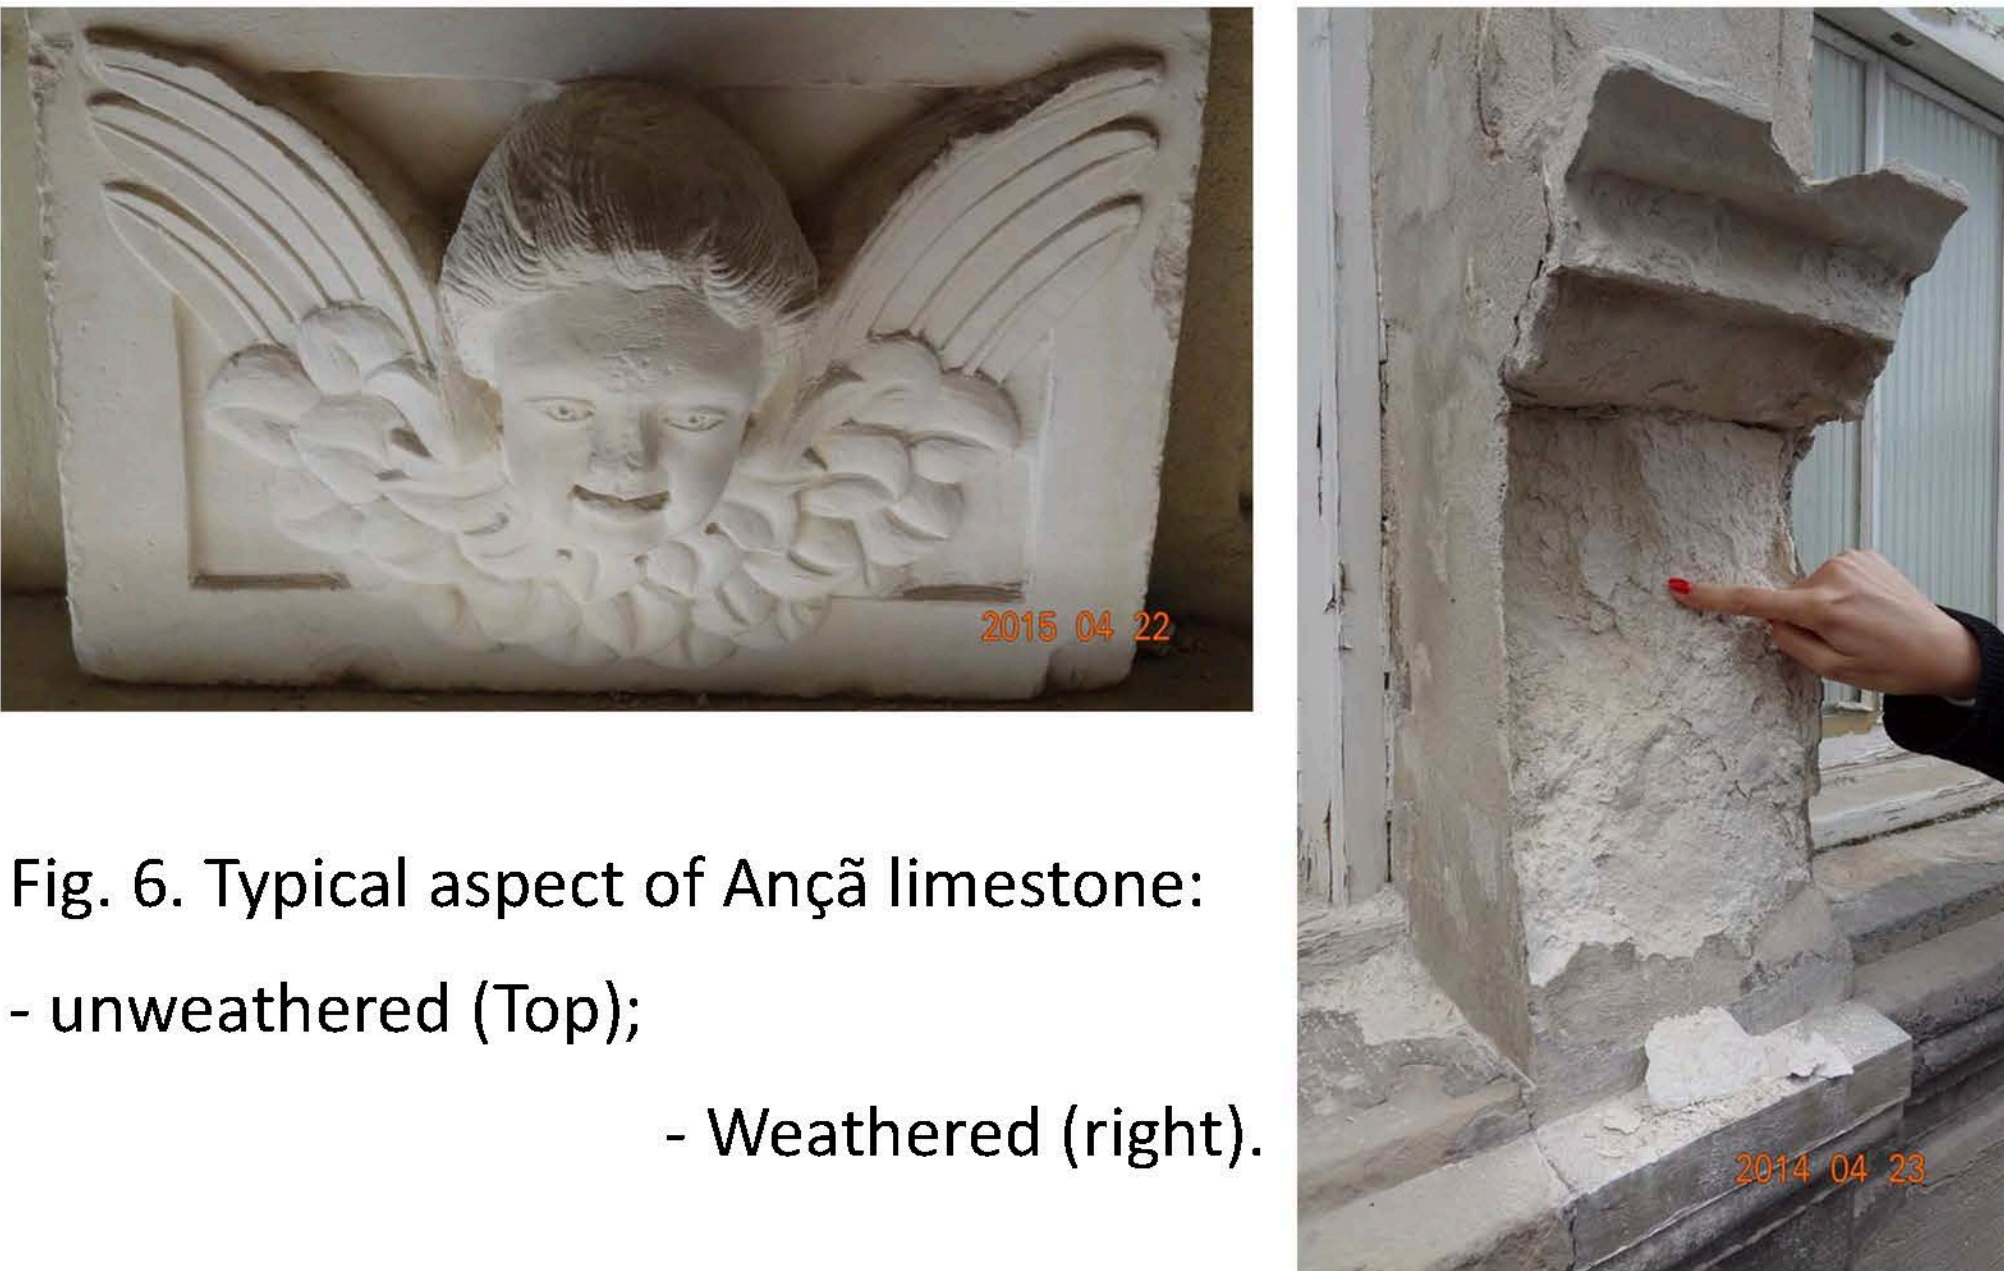
Fig. 6. Typical aspect of Ançã limestone:
- unweathered (Top);
- Weathered (right).

The white Ançã limestone is quite prone to deteriorate when exposed to atmospheric agents and to soluble salts (Fig. 6), mainly due to its high porosity. Deteriorated surfaces needing treatment constitute difficult conservation problems, especially when consolidation and protection treatments are required.
