# Morphological evaluation of watersheds and its relation with the debris flow magnitude

Vivian Cristina Dias<sup>1\*</sup>, Helen Cristina Dias<sup>1</sup>, Rebeca Durço Coelho<sup>1</sup>, Bianca Carvalho Vieira<sup>1</sup>, Tiago Damas Martins<sup>2</sup> e Marcelo Fischer Gramani<sup>3</sup>.

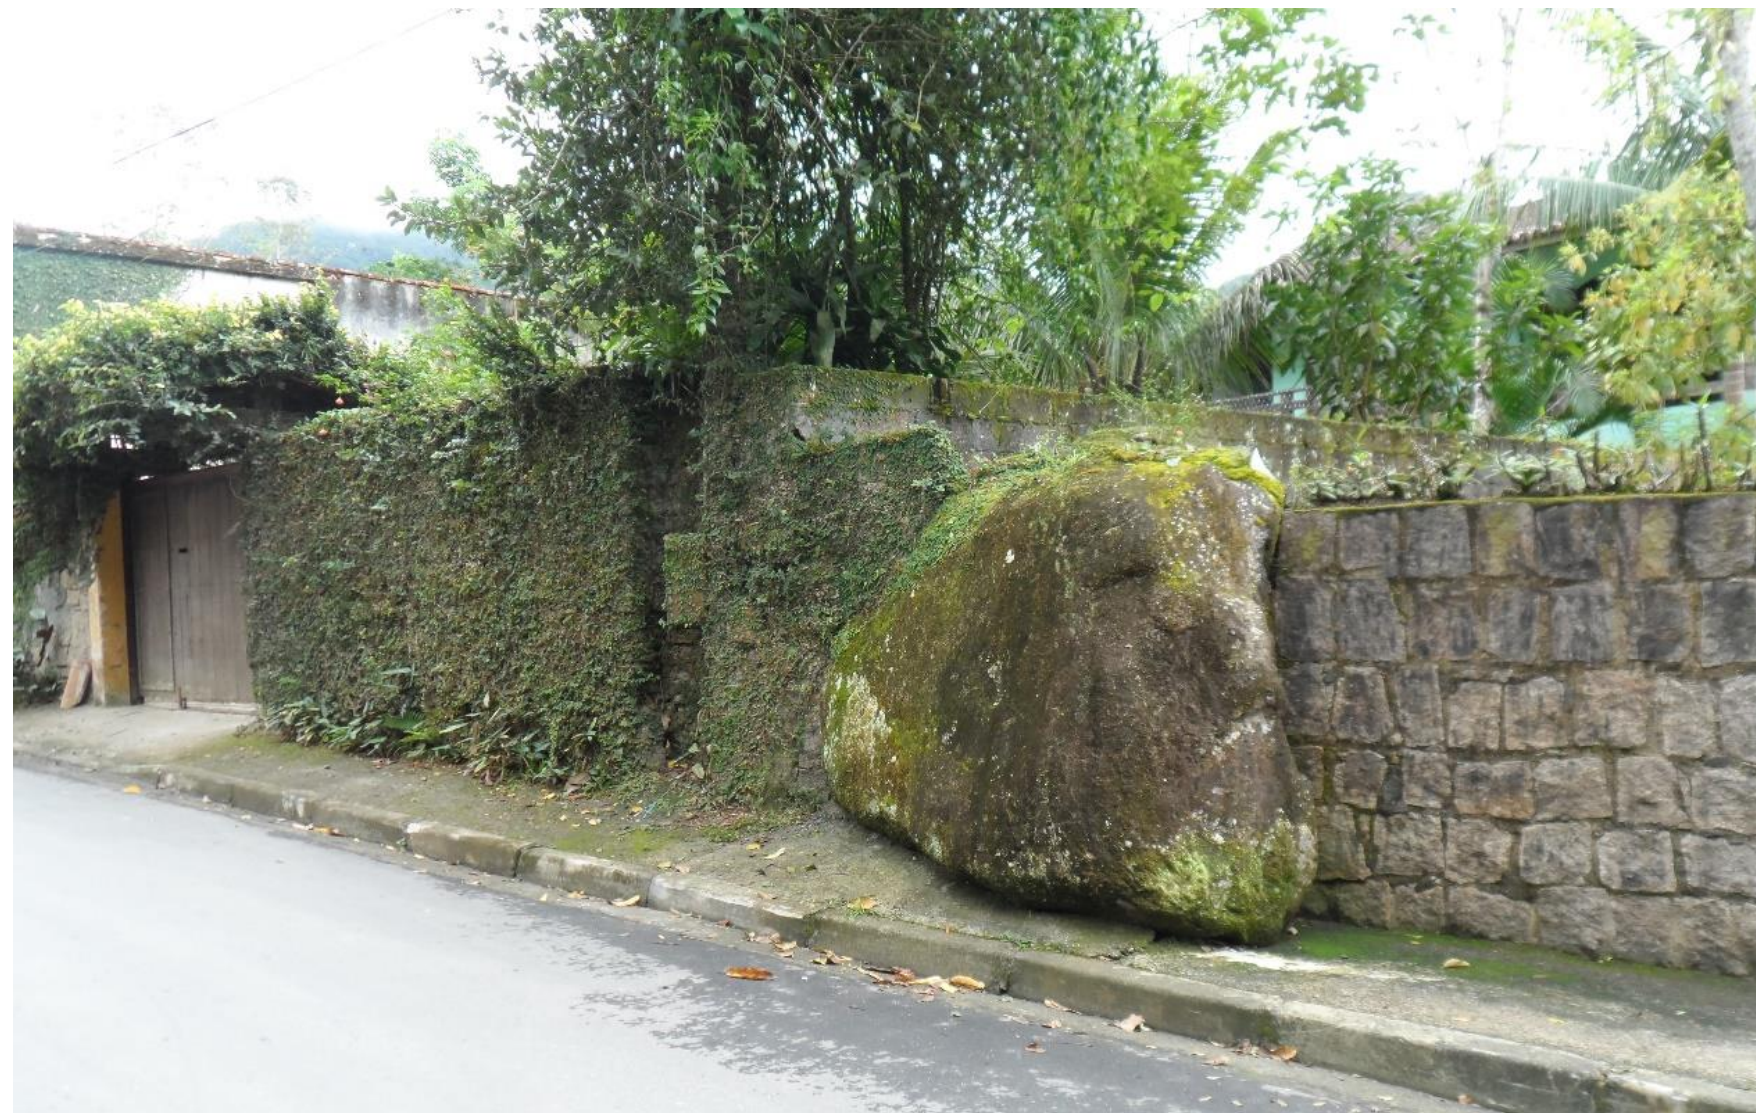
Fig. 1: Boulder used as part of the wall, in an area where occurred debris flow, in the city of Caraguatatuba, located in the Serra do Mar.

- In Brazil, debris flow occur due the contribution of sediments from landslides to the drainage.
- Many areas already hit by debris flows are still occupied by the population, that ignore the evidences of the process in the landscape (Fig. 1).
- The identification of susceptible areas through the morphological parameters and evaluation of the magnitude of past events helps in a better understandment of the process but also in the decision from the governments related to the occupation of those areas by the population.

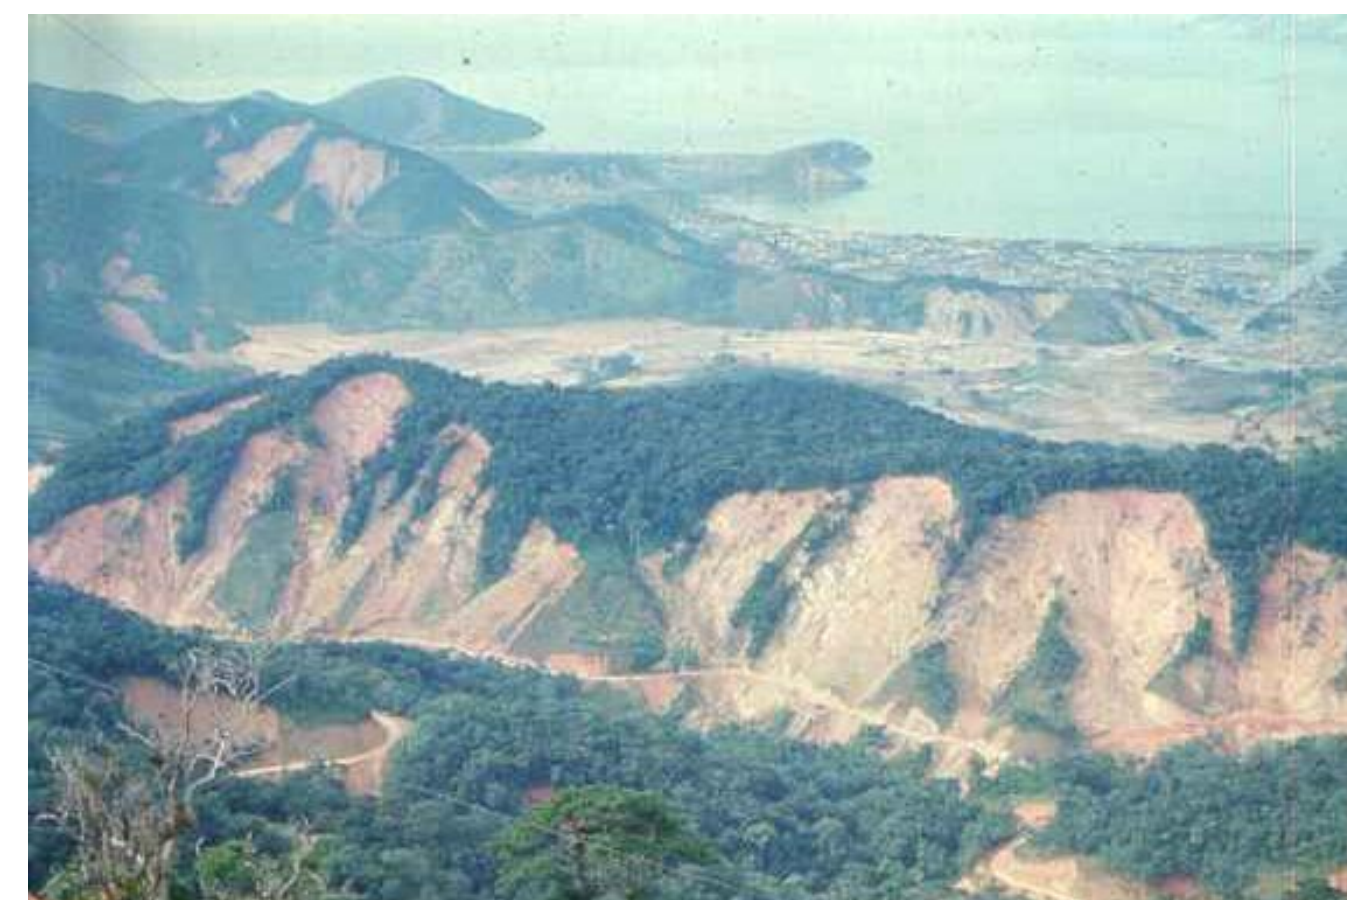
Fig. 3: Landslides and debris flows occurred in Caraguatatuba, in the 1967's disaster. Source: Nogami (1967).

- Serra do Mar is a mountain range located in the southeastern coast of Brazil. The city of Caraguatatuba (Fig. 2) is one of the many cities located along the mountain.
- In 1967, rained an average of **946 mm** in march with a critical values in the days 17 and 18, when rained **586 mm/48 hs**, triggering landslides and debris flows (Fig. 3);
- Materials mobilized hitted the urban area of the city, in the lowland (Fig. 4);
- 120 deaths, **400 houses destroyed** and damage to the highway to the city (Fig. 5 and 6);
- ~ **2 millions of tons** of sediments and boulders were mobilized (Fig. 7 and 8).

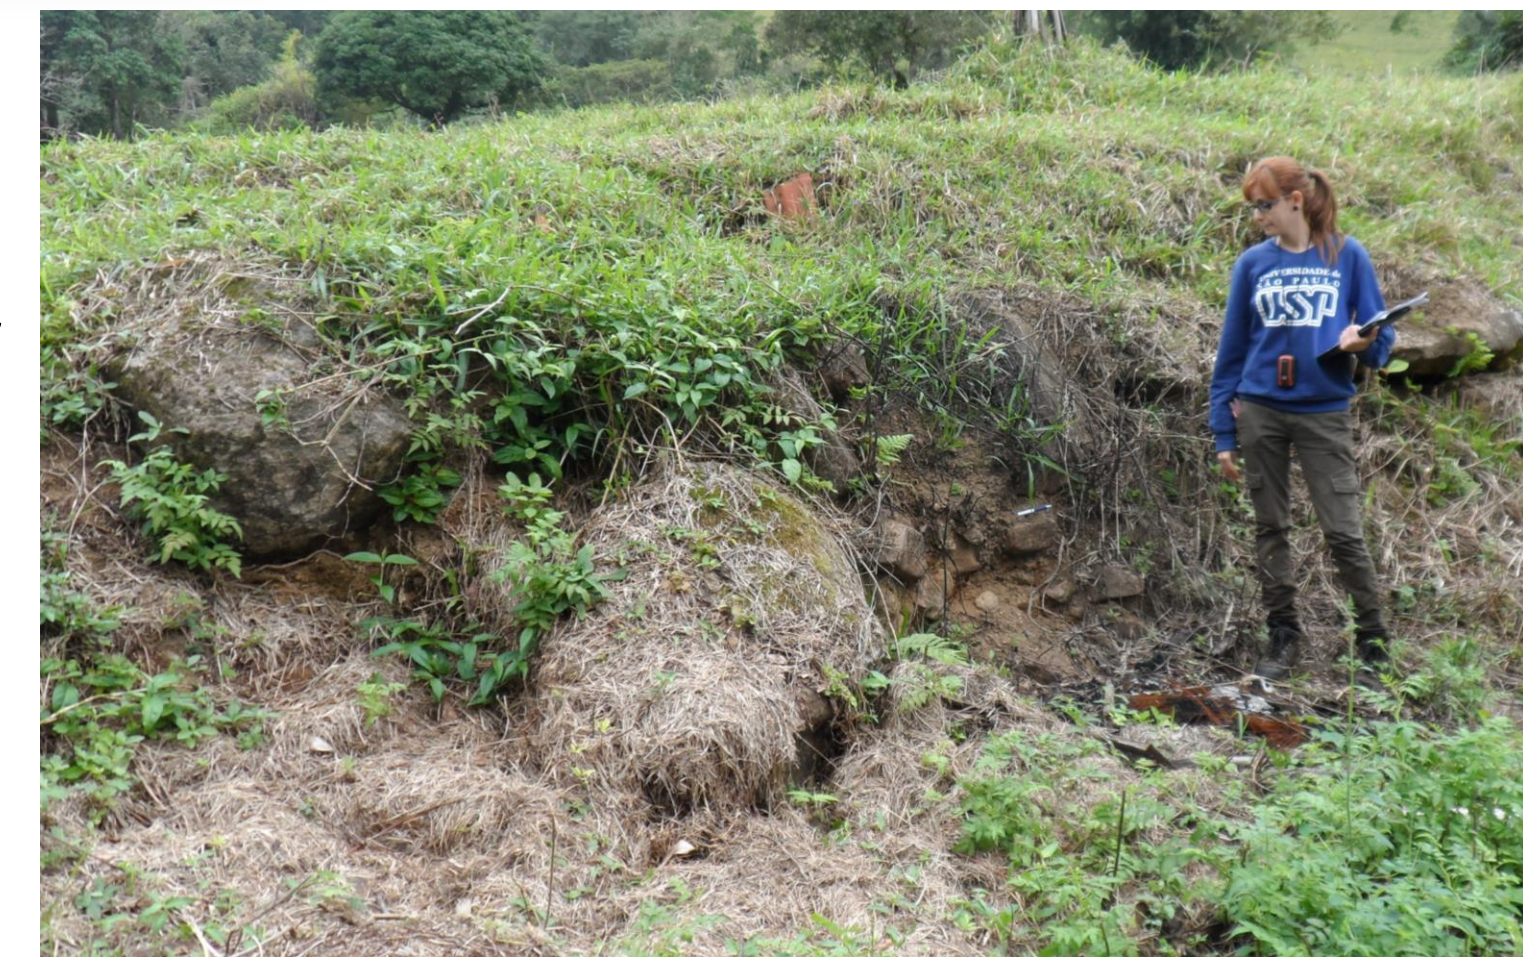
Fig. 9: Identification of debris flows's deposits in field.

- Selection of watersheds with occurrence of debris flow. It was made using the morphological mapping from De Ploey and Cruz (1979) and field works (Fig. 9).
- Determination of the characteristics of the deposits in field, using a morphology record (Fig. 10 and 11), and the delimitation of the magnitude using the methodology created by Jakob (2005), considering the inundation area (Table 1).
