## Flash-flood hazard hydro-geomorphic characterization and mapping: analysis of the 2019 and 1994 Francolí river flood effect

## OBJETIVE AND METHODOLOGY

The main objective of the study is to carry out a hydro-geomorphic analysis of the 2019 flood and to establish and map the Active Band and the Preferential Flow Zone (PFZ). We define the Active Band as the zone affected by the particular flood of 2019. The PFZ define by the Spanish legislation, is the envelope of the areas where the flow defined by concentrates during major floods, as well as the most frequently flooded areas in minor floods.

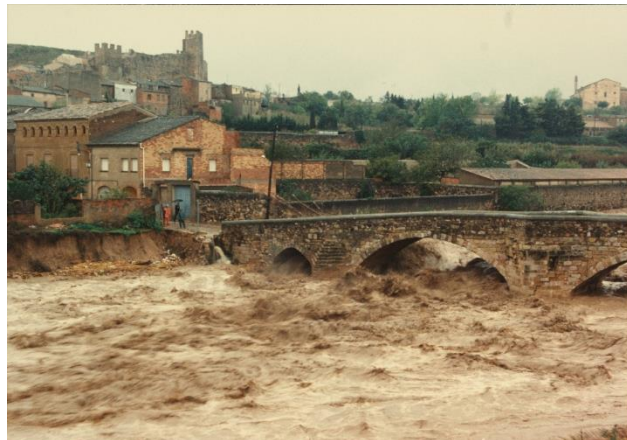
1994 Flood  
Arxiu Comarcal de la Conca de Barberà

Francolí is a typical Mediterranean river with frequent floods. There are records of major floods in 1874 (Santa Tecla), in 1930 (Sant Lluç) and, in 1994 the last one before 2019, when there were 10 fatalities and economic losses of 17.000 million euros.

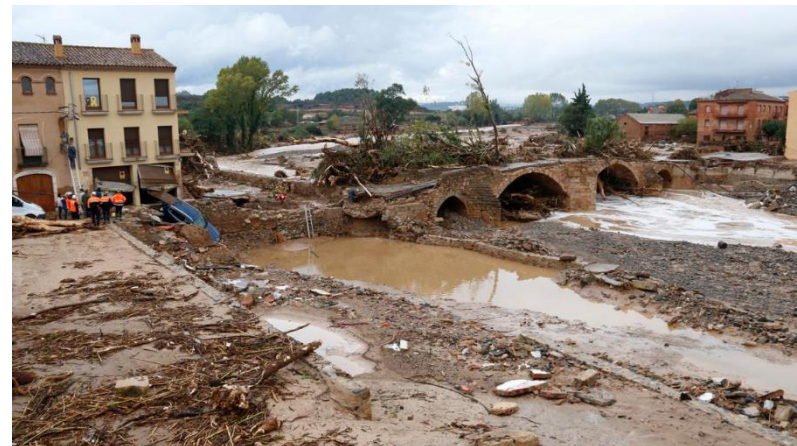
2019 Flood  
ACN - Núria Torres

On October 22, 2019, intense rains took place in Catalonia (292,6 mm in 24 hours at Prades). These rains caused a sudden discharge increase and a major flash flood in the Francolí river. Around 4 km upstream of the studied area, the peak flow was of  $1.330 \text{ m}^3 \cdot \text{s}^{-1}$  (Balasch et al., this session). As a result, the river swept along a large quantity of vegetation, crops and infrastructures. It caused a considerable economic damage (exceeding 100 million euros) and loss of six human lives.

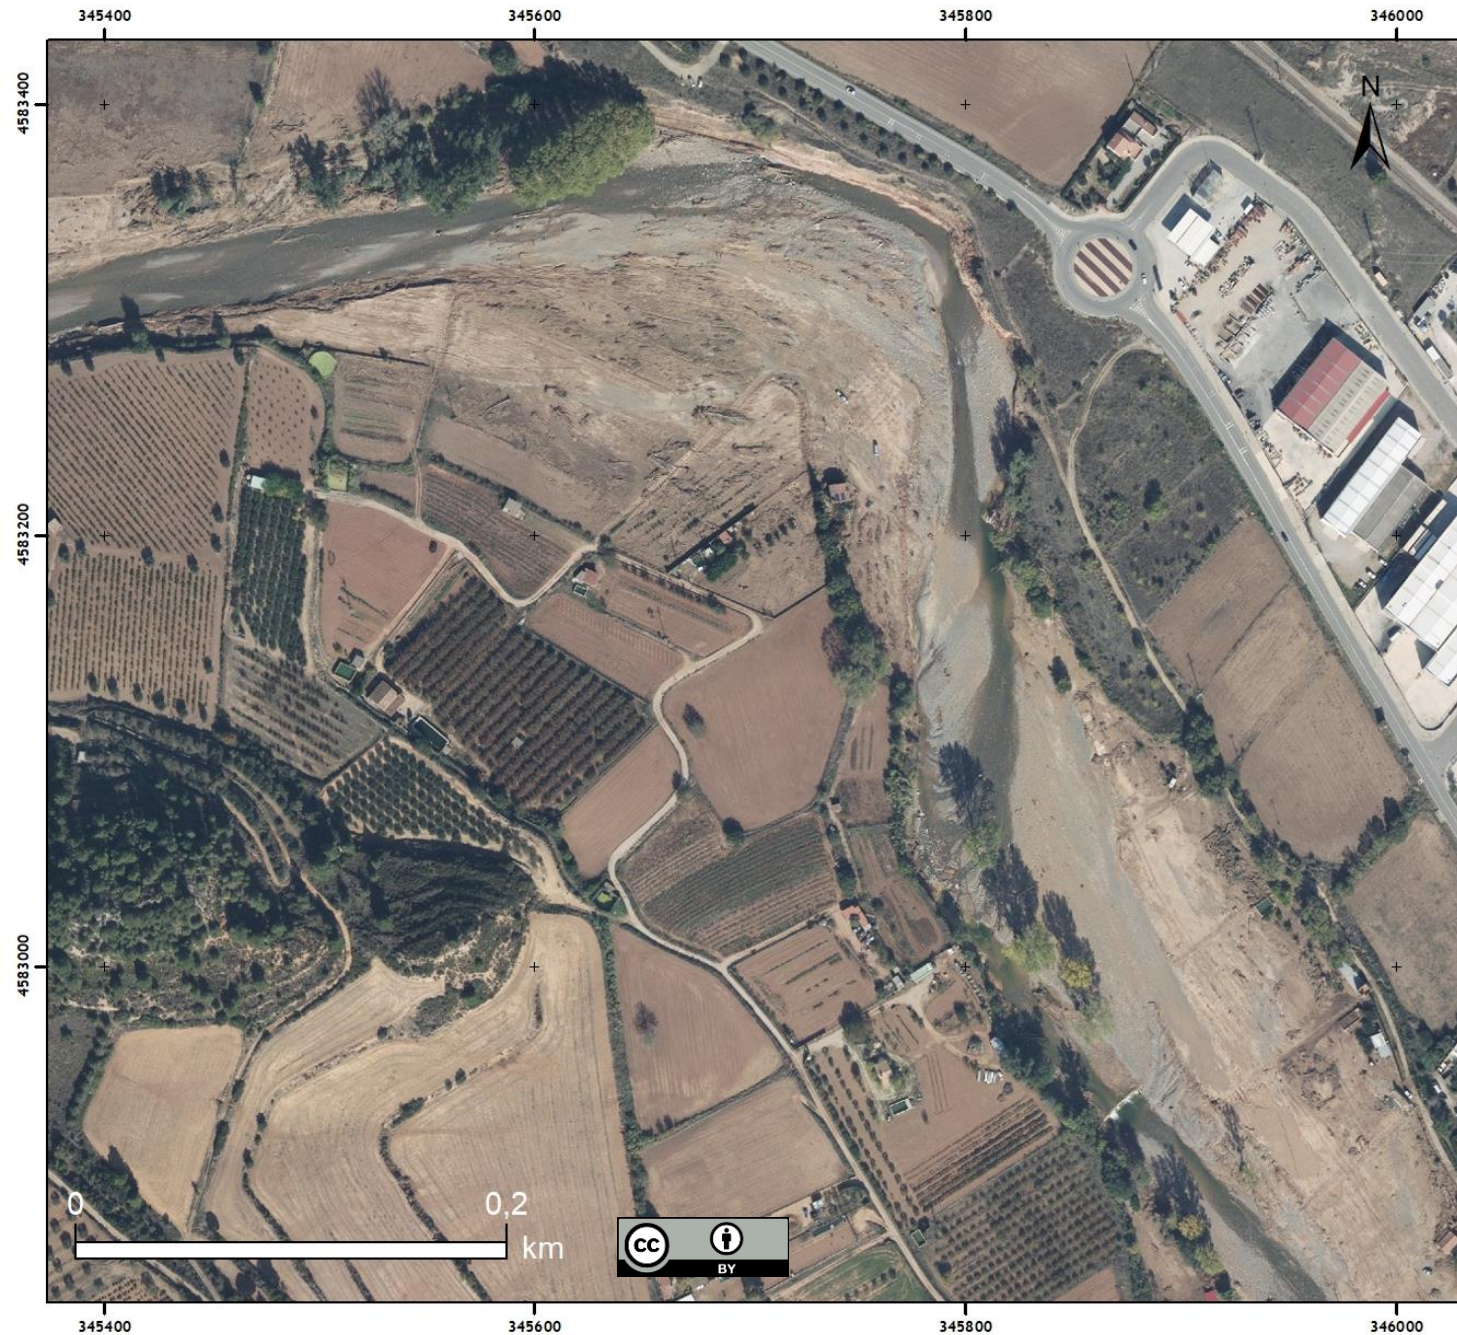
**2019**

**ORTHOPHOTO  
POST FLOOD**

Bank erosion

Large wood acumulation

Gravel bars

Water marks

Channel widening

Affected crops

Vegetal drifted  
ephemeral evidence

Affected riparian trees
