Image supplemental to abstract EGU2020-11869
Session NH3.1

Enhanced landslide mobility promoted by liquefaction of underlying sediments:
Evidence from detailed field, lab, and modelling investigations of the deadly Oso, USA landslide

Mark E. Reid
Brian D. Collins
U.S. Geological Survey

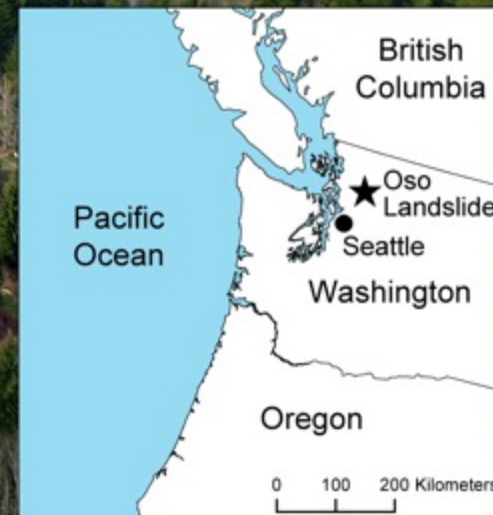
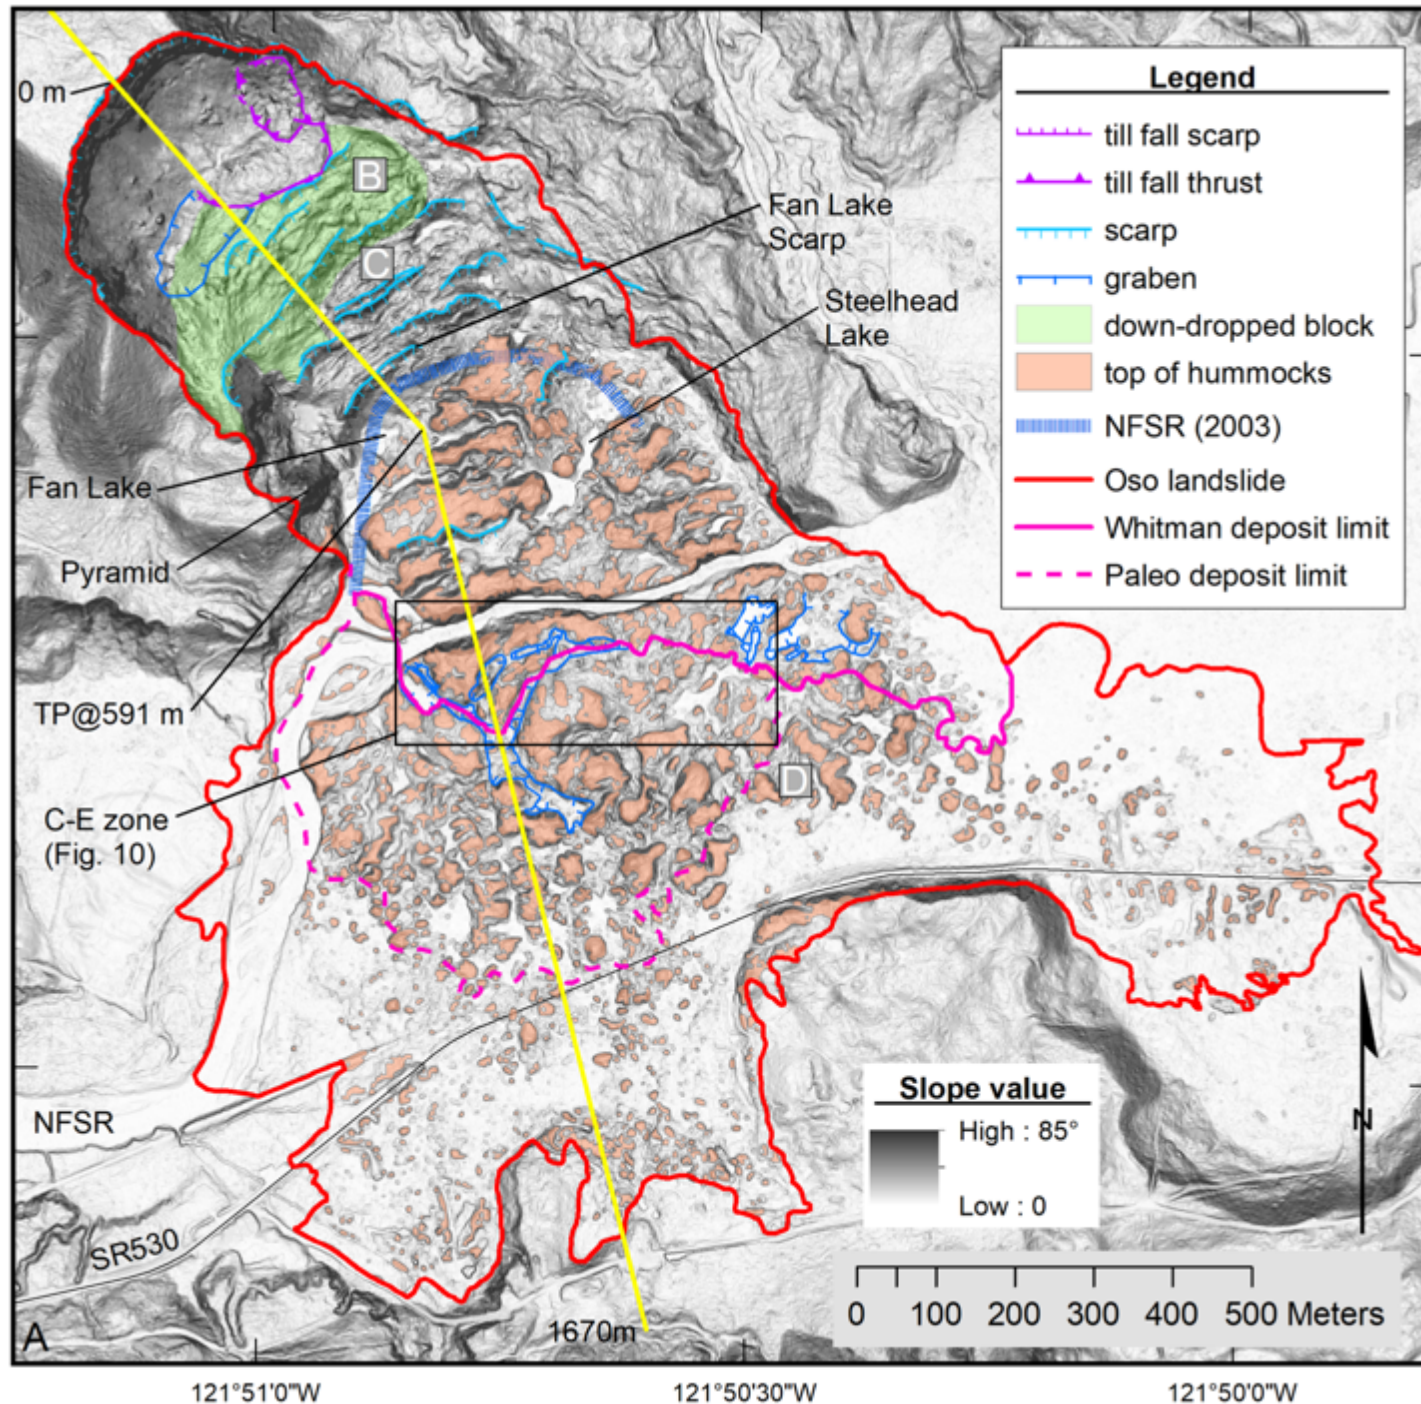
Overview of 22 March 2014 catastrophic Oso landslide, which swept more than 1 km across the river and valley flats, destroyed a neighborhood, and killed 43 people.

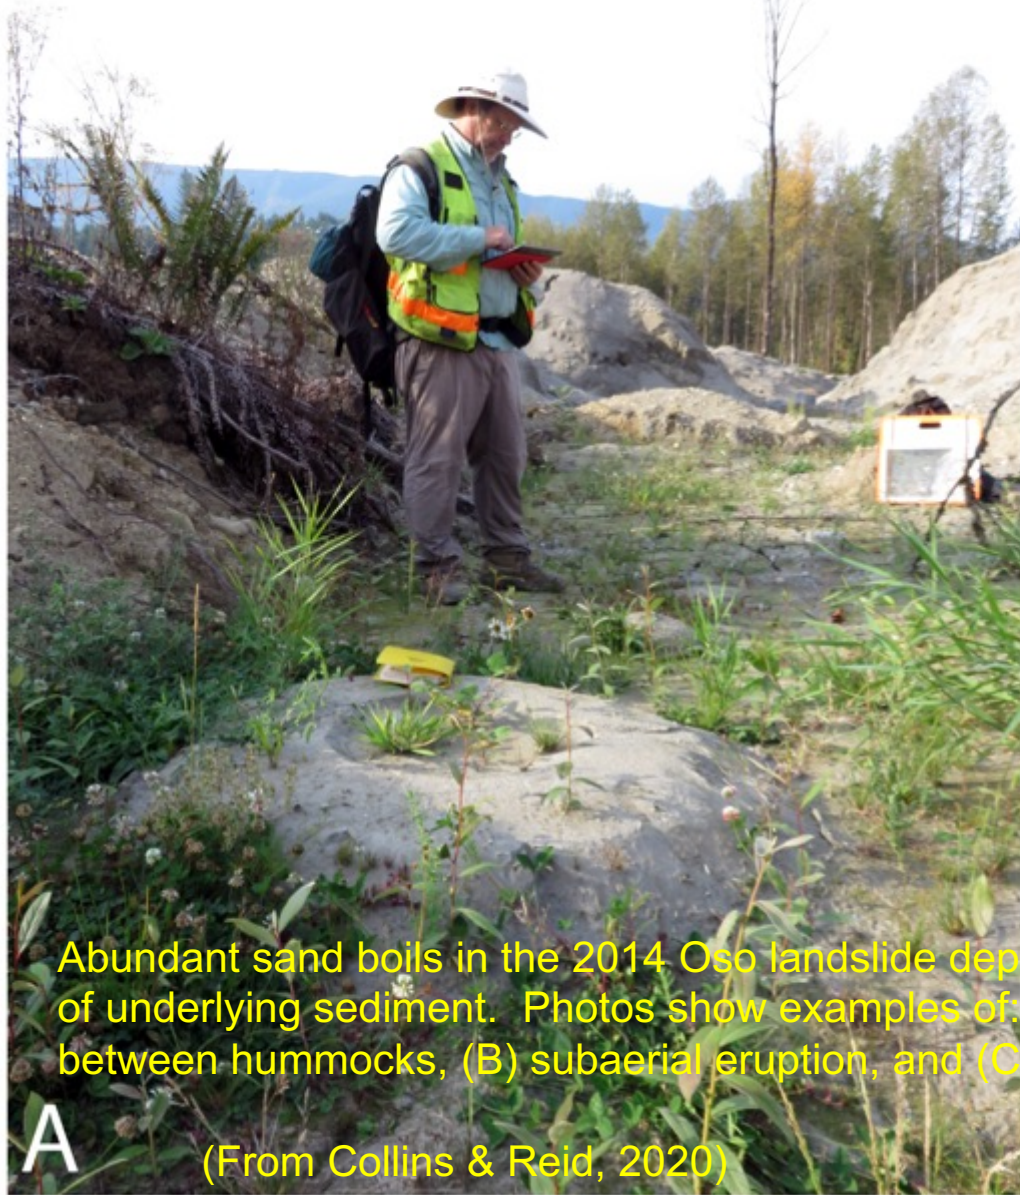
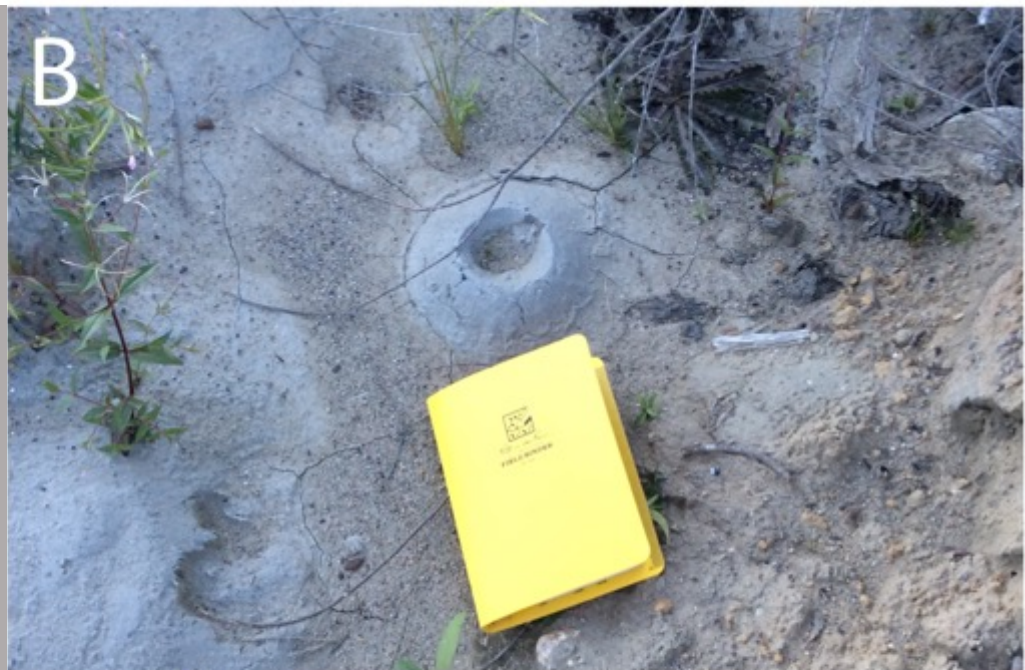
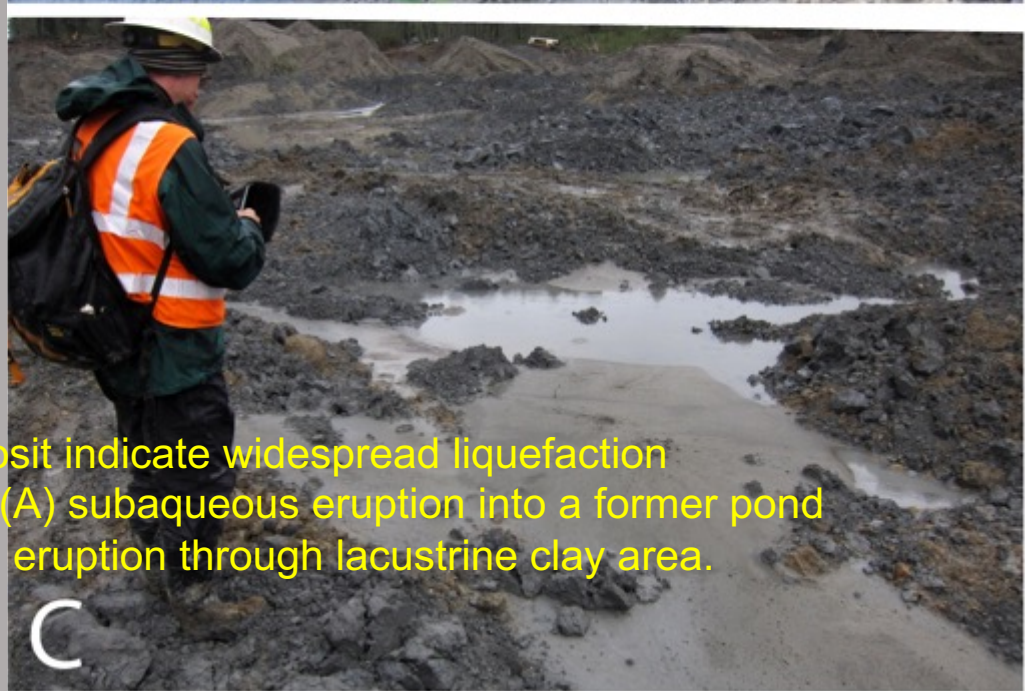
We mapped widespread sand boils, a classic liquefaction feature, throughout the hummock field of the 2014 Oso landslide. Hummocks (purple) range up to >20 m high and decrease in size to the south. We found abundant, but transient, sand boils (blue) between hummocks soon after the slide event. Some sand boils erupted through >5 m of slide deposit (light blue). The hummocks themselves did not liquefy.

Abundant sand boils in the 2014 Oso landslide deposit indicate widespread liquefaction of underlying sediment. Photos show examples of: (A) subaqueous eruption into a former pond between hummocks, (B) subaerial eruption, and (C) eruption through lacustrine clay area.

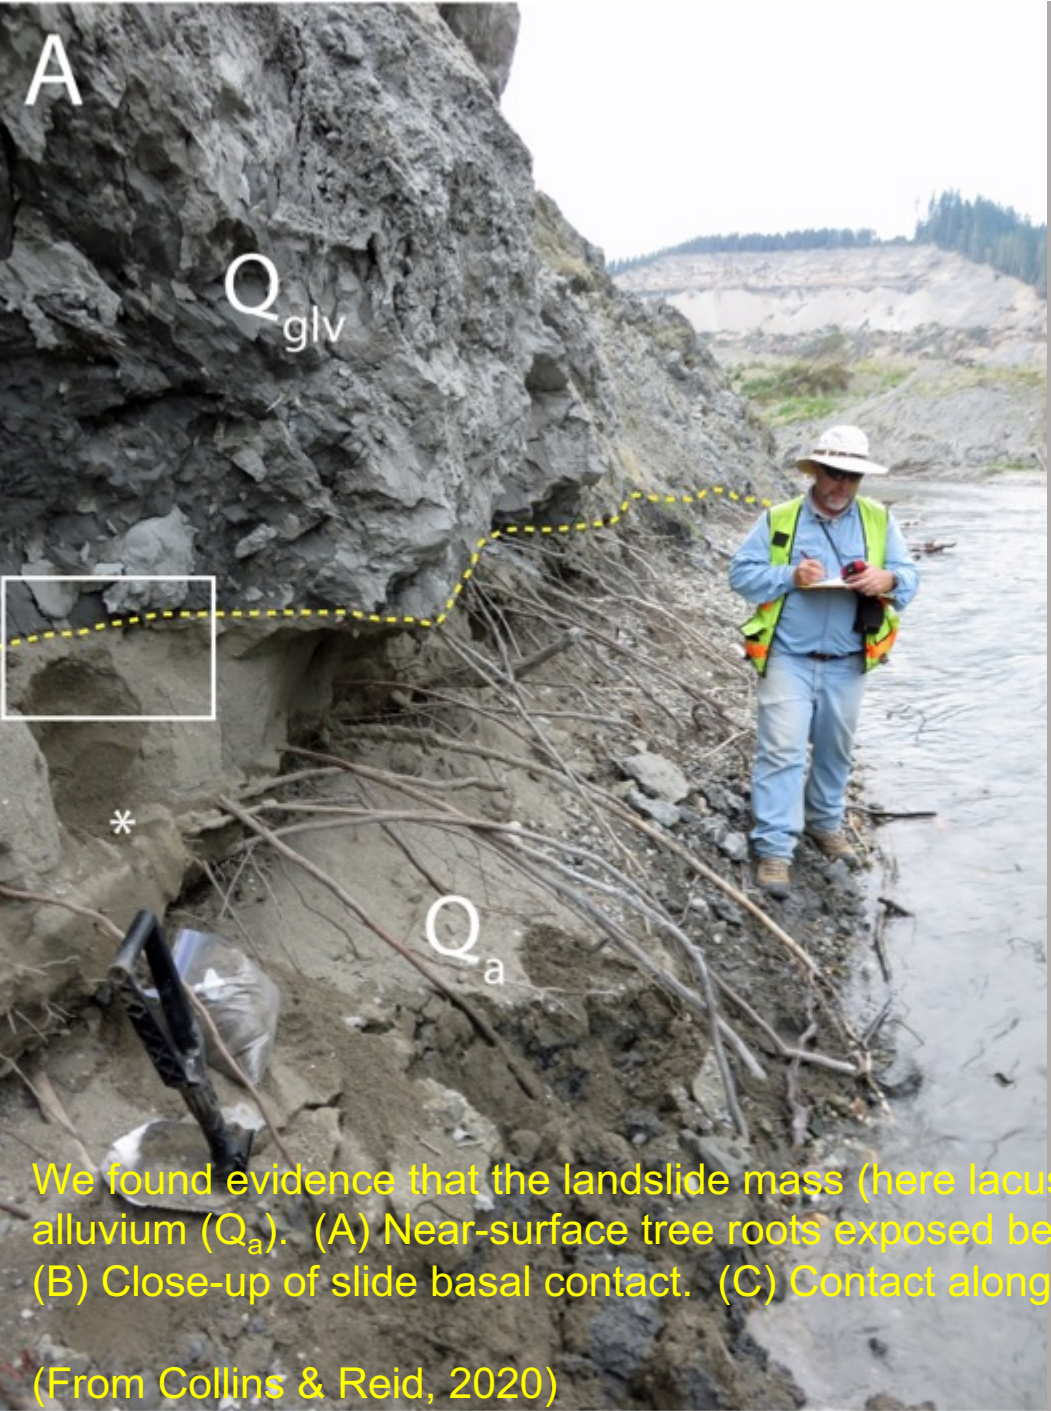
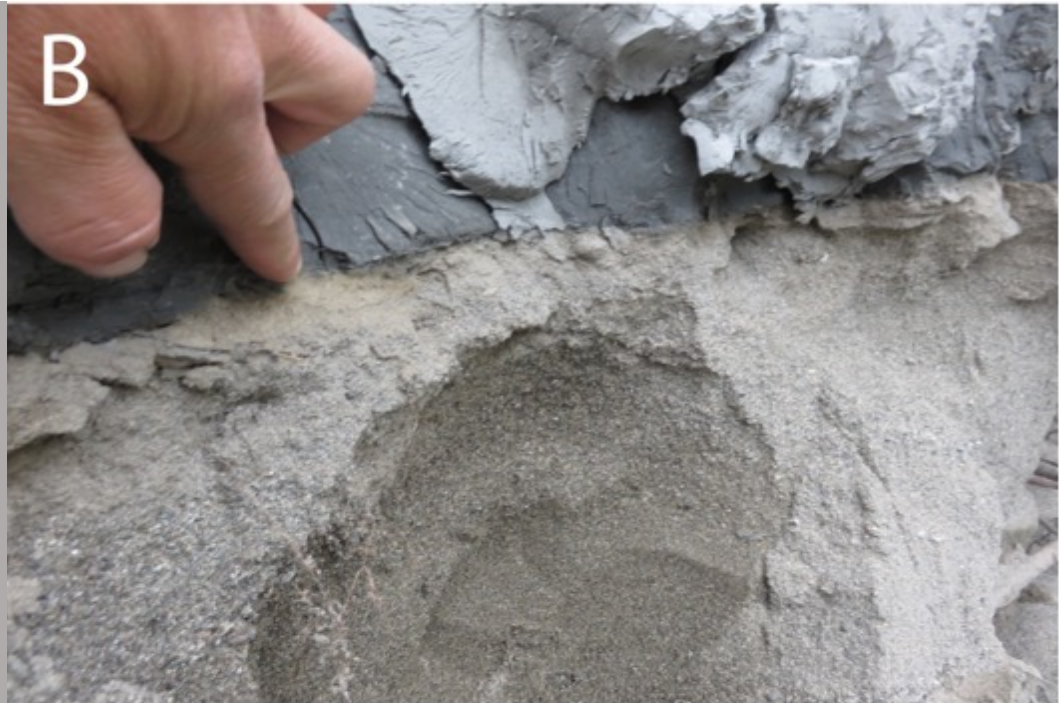
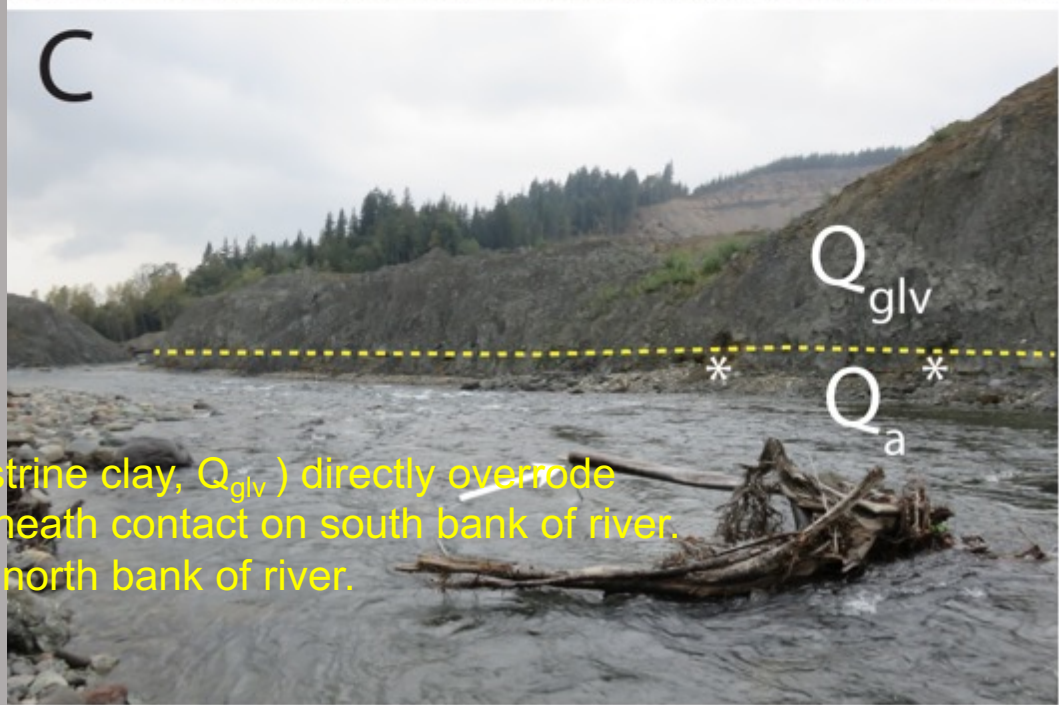
We found evidence that the landslide mass (here lacustrine clay, Q_{glv}) directly overrode alluvium (Q_a). (A) Near-surface tree roots exposed beneath contact on south bank of river. (B) Close-up of slide basal contact. (C) Contact along north bank of river.

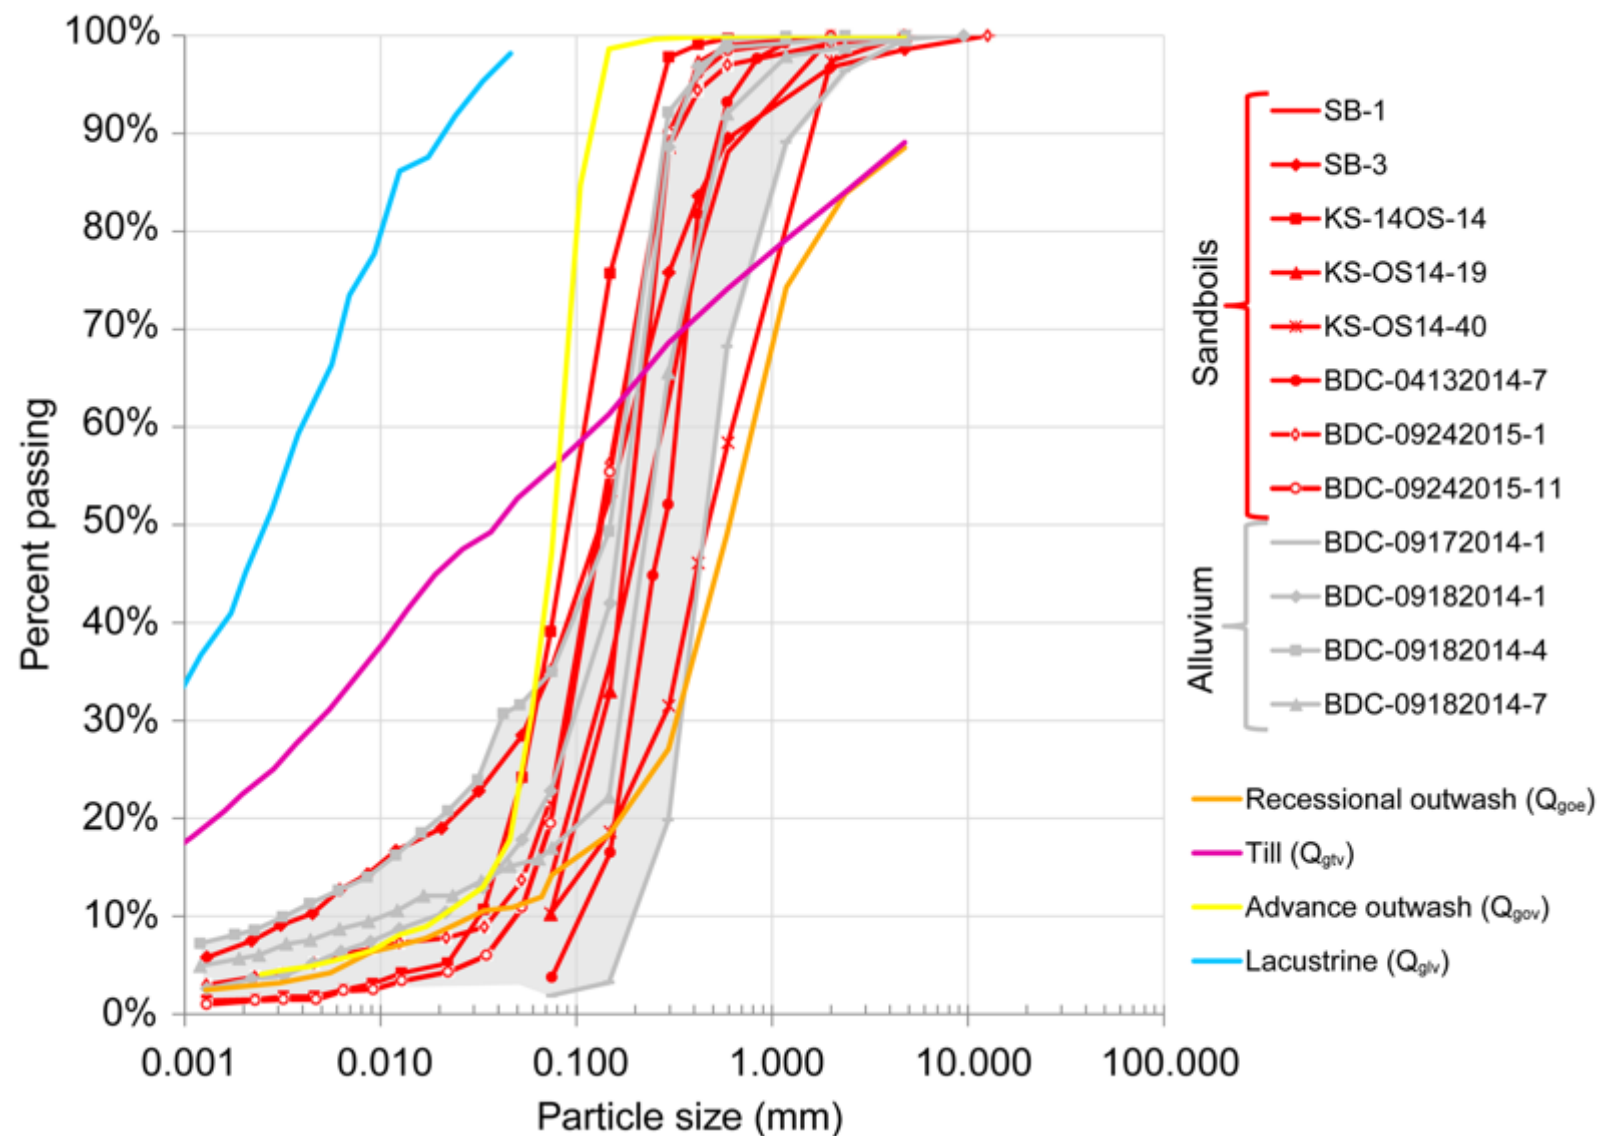
Grain-size distributions from sand boil samples that we collected (red lines) closely match the underlying alluvium (grey), and not the glacial materials composing the slide mass.

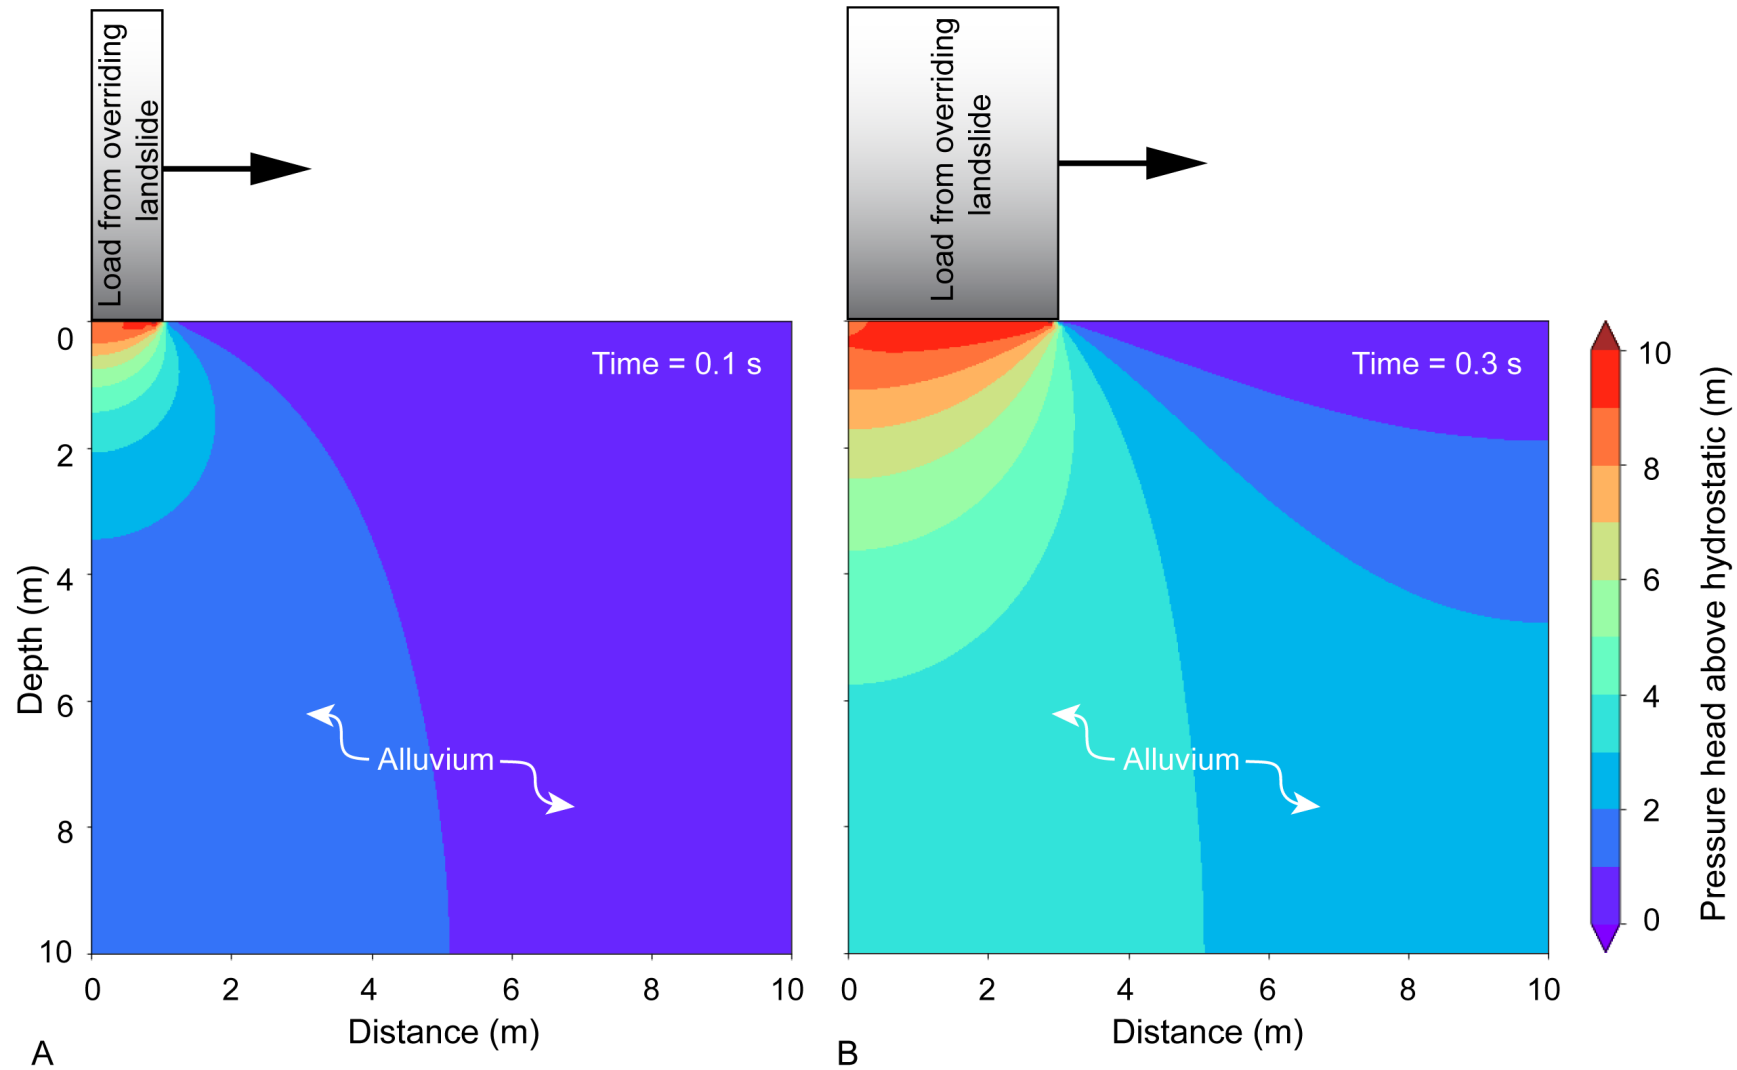
Our poroelastic model simulations show that rapid loading of alluvial sediment can increase underlying pore pressures to near liquefaction levels. The model simulates an overriding landslide moving across part of an alluvial domain from left to right at a speed of 10 m/s.

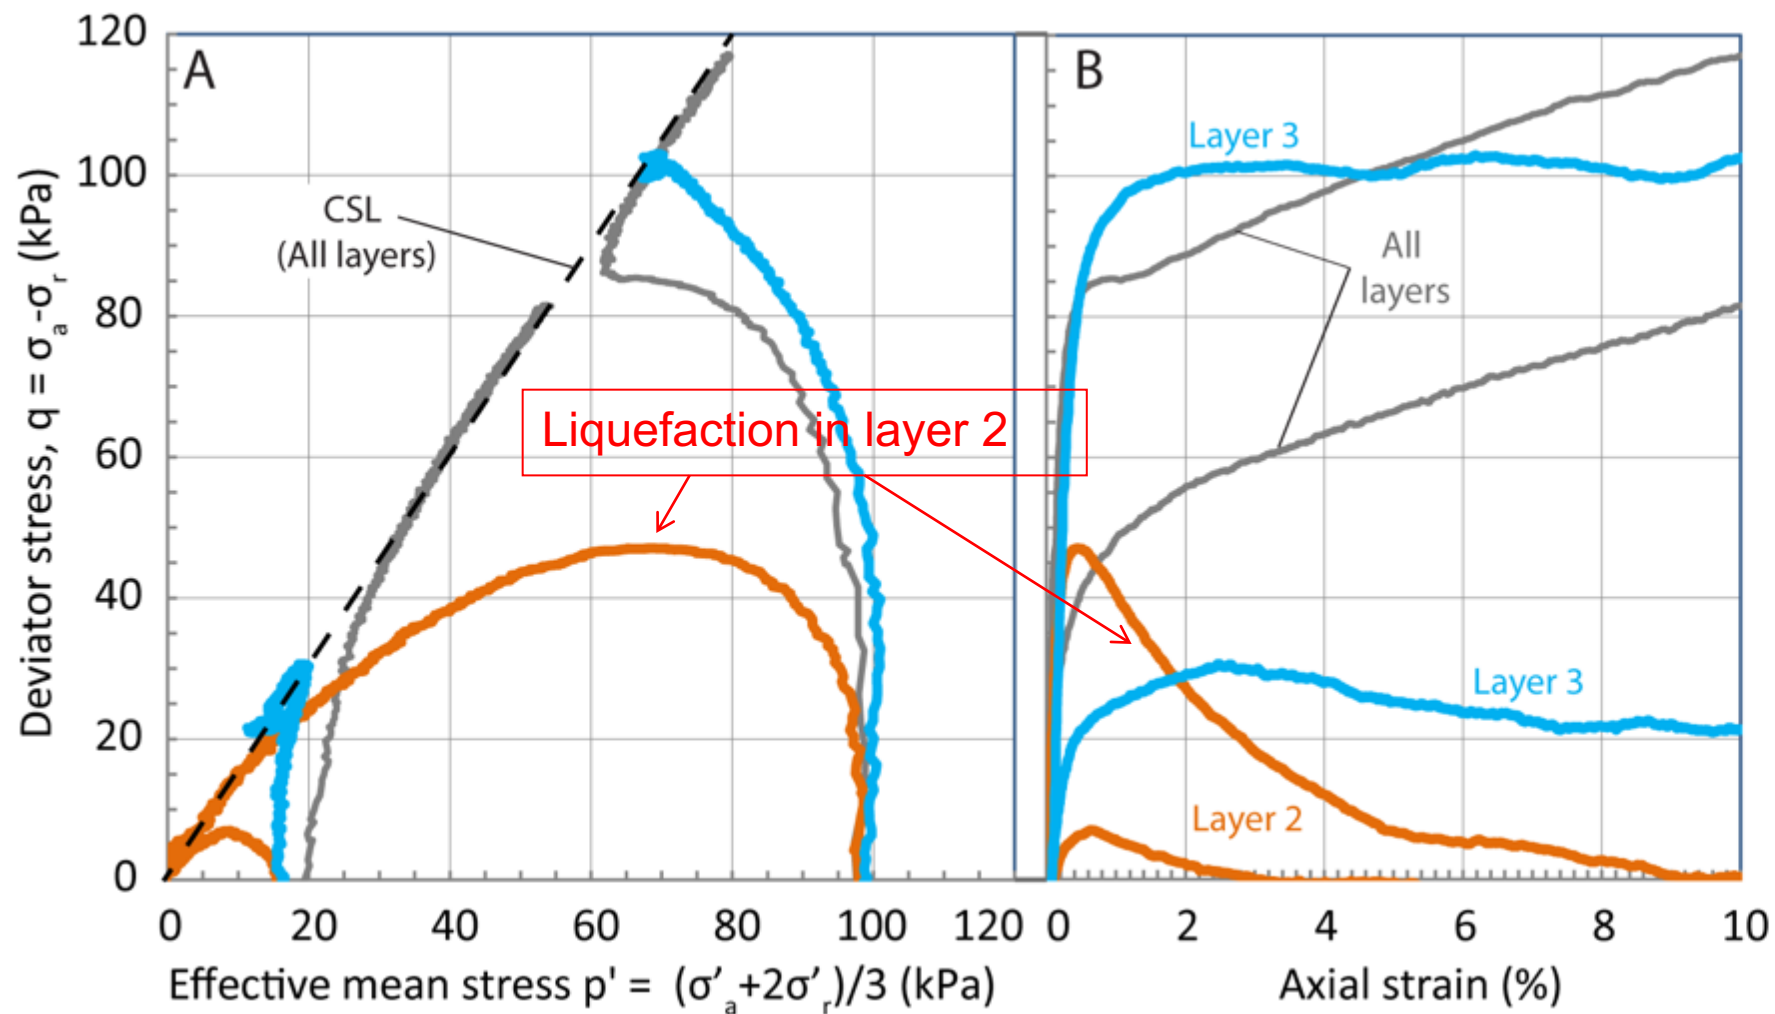
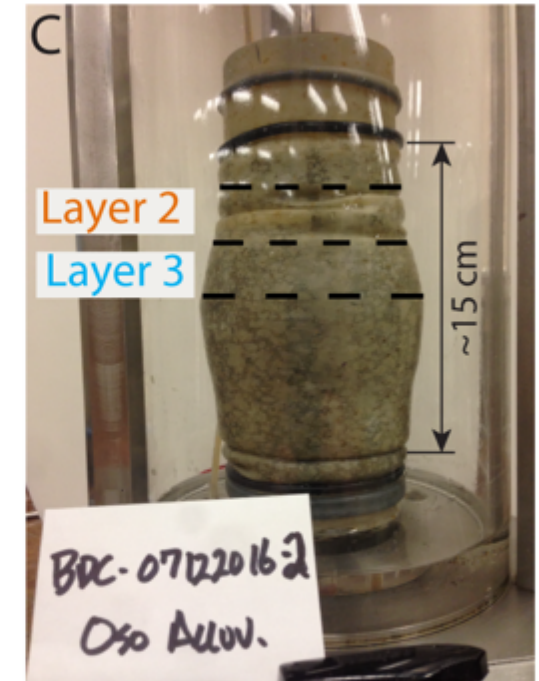
Triaxial tests show complete strength loss and liquefaction in select alluvial layers sampled from the slide site. Results from layer 2 (orange lines) and wrinkled membrane in photo indicate strength loss.

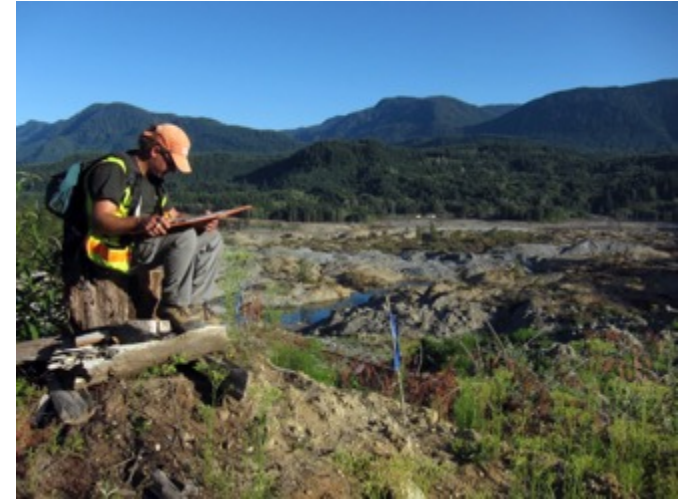
- The deadly Oso landslide was highly mobile and travelled far across valley flats
- We found widespread field evidence for liquefaction of alluvium beneath the overriding debris-avalanche hummocks of the slide
- Our poroelastic model analyses of Oso demonstrate that rapid failure onto saturated alluvial sediments promotes undrained loading and liquefaction
- In addition, triaxial lab tests show that Oso alluvial materials can liquefy and lose strength
- Liquefaction of the the underlying sediment differs from liquefaction of the slide mass itself – basal liquefaction may enhance the mobility of other slides
