# FIRST STEP OF THE DIAGNOSTIC ANALYSIS

# High Resolution 3D modelling of Cylinder shape bodies applied to ancient columns of the thirteenth century

ABSTRACT: A multi-technique high resolution 3D modelling is described here aimed at the investigation of the state of conservation of the ancient church of Buoncammino (thirteenth century) located in the homonymous district of the town of Cagliari (Italy). The integrated application of different Non-Destructive Testing (NDT) diagnostic methods is of paramount importance to locate damaged parts of the building material of artefacts of historical buildings and to plan their restoration.

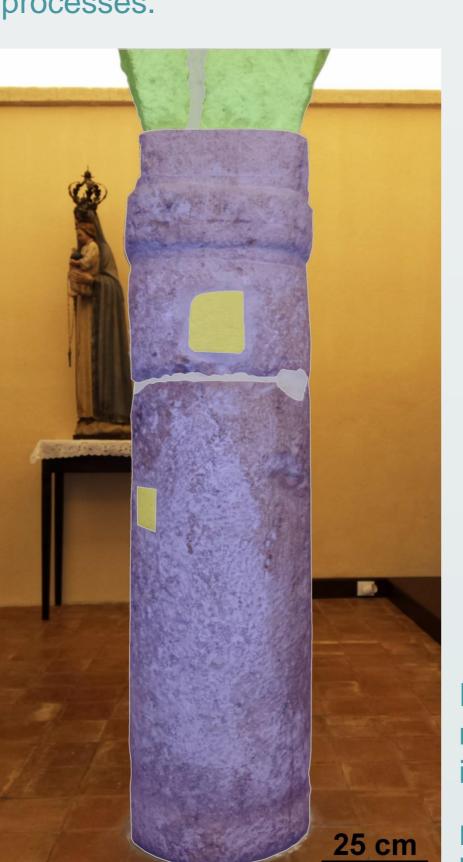
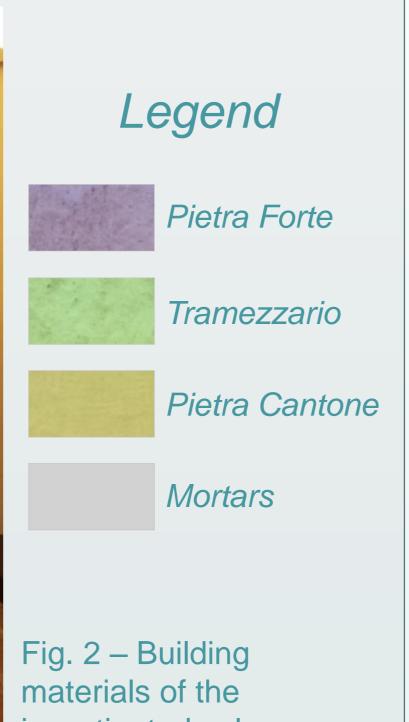
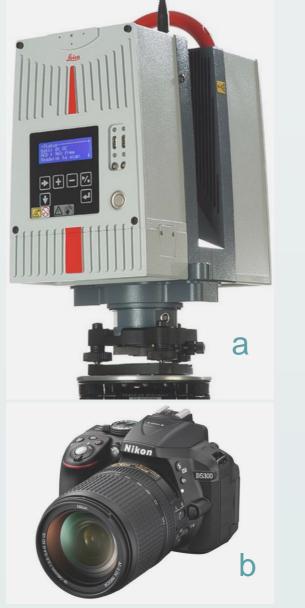
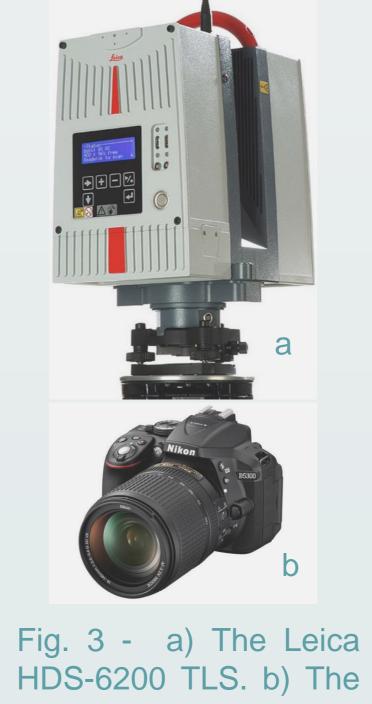
investigated coloumns. mage elaborated by

etigo Map Software.

We applied INSPECTION module of release 3 of software JRC 3D Reconstructor<sup>®</sup> suitably implemented to compute the geometrical anomalies of the aggregated point cloud as residuals with respect to a best fitted cylindrical geometrical model adopted as reference (Fig.10). The resulting highlighted surface anomalies are useful for the comparison with other diagnostic techniques able to investigate the internal structure of the Calcari di Cagliari columns. In Fig.10 the color scale anomalies are expressed in m.
