Linking erosion-deposition to geomorphic units changes in a high-gradient stream in the Central Chilean Andes: Estero Morales

Ricardo Carrillo and Luca Mao
Pupuya, Chile. May 2020

Work overview

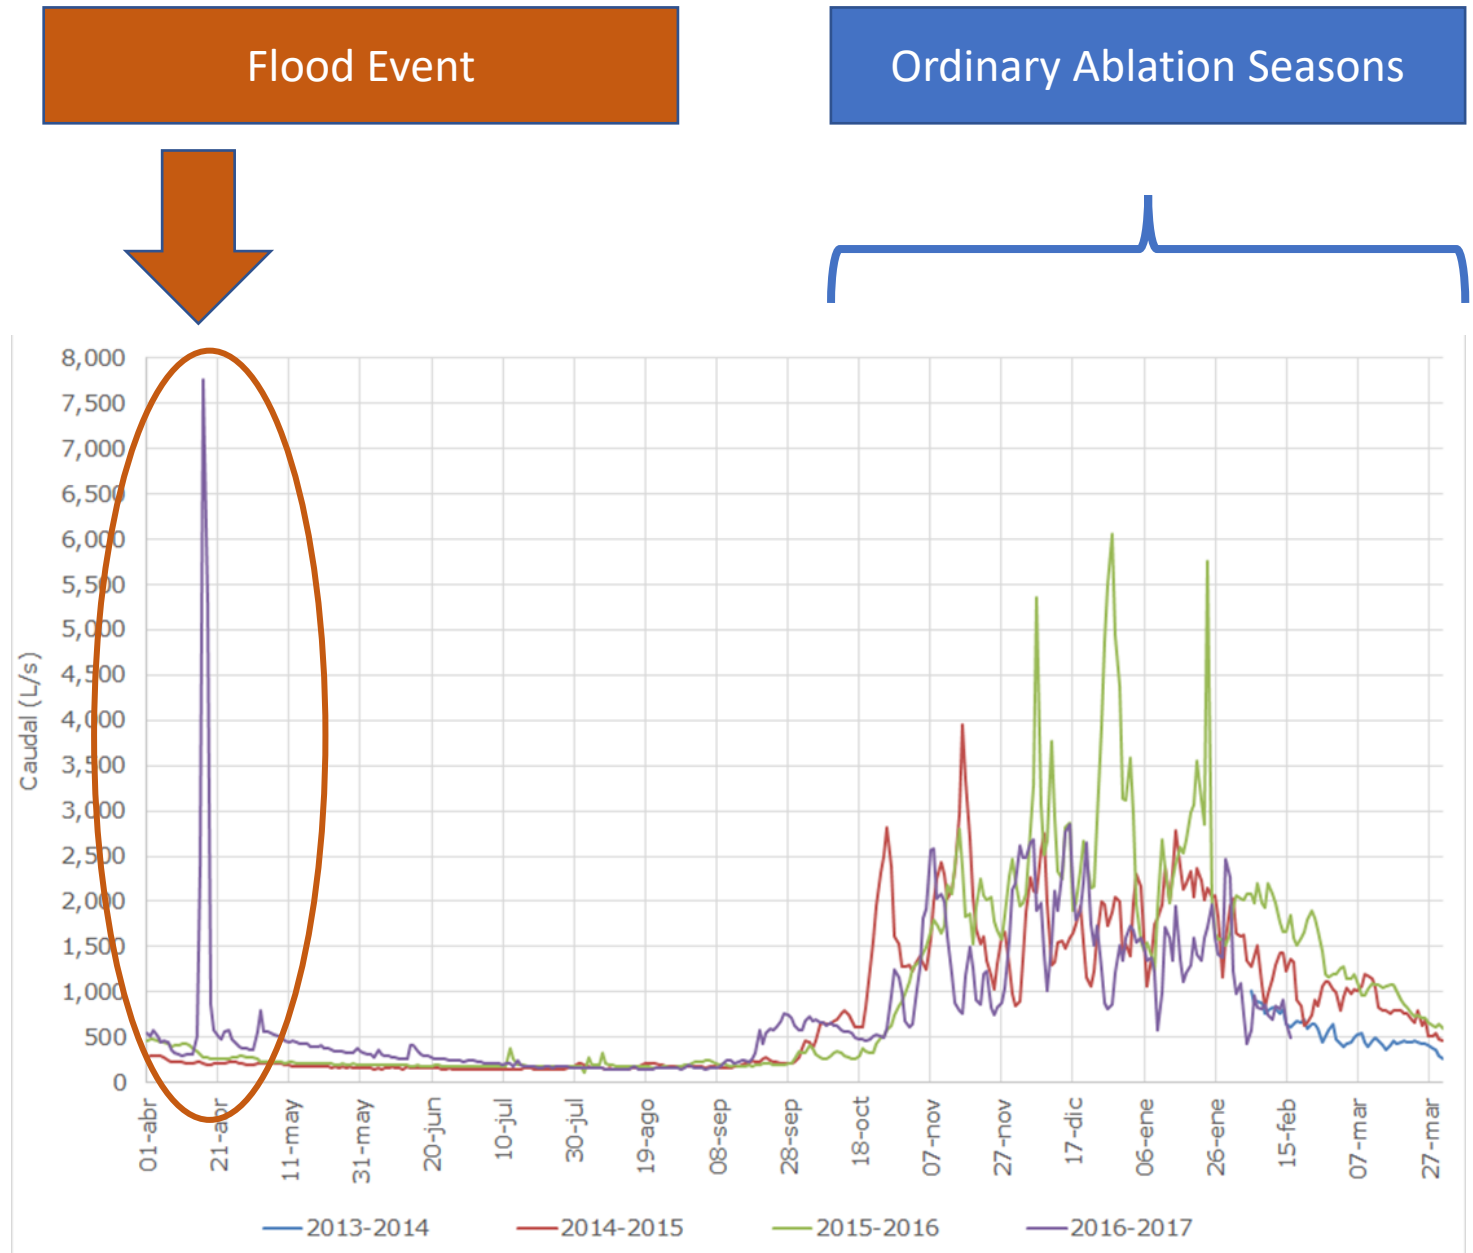
Flood Event

- April 13, 2016
- **ENSO** Event (El Niño South Oscillation)
- High zero **Isotherms**
- From **$0.5 \text{ m}^3\text{s}^{-1}$** to **$7.5 \text{ m}^3\text{s}^{-1}$**

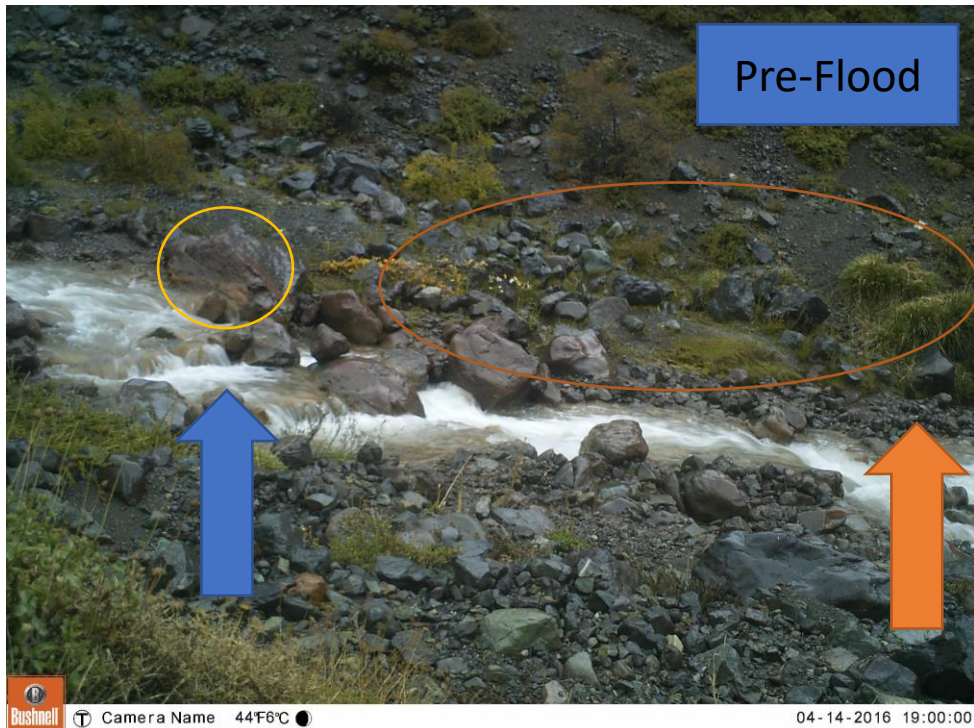
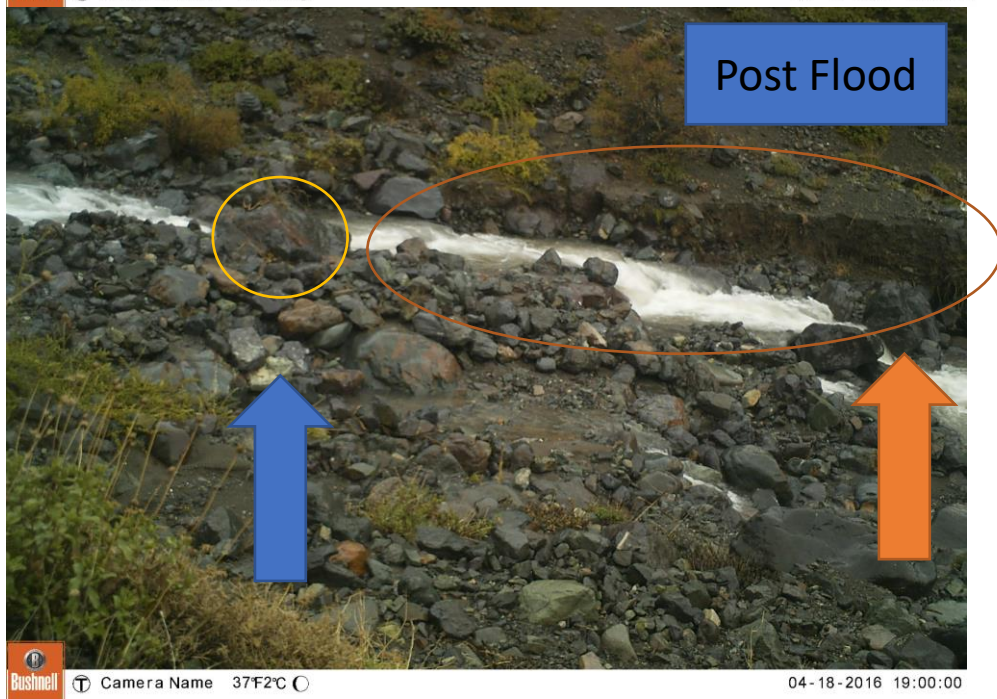
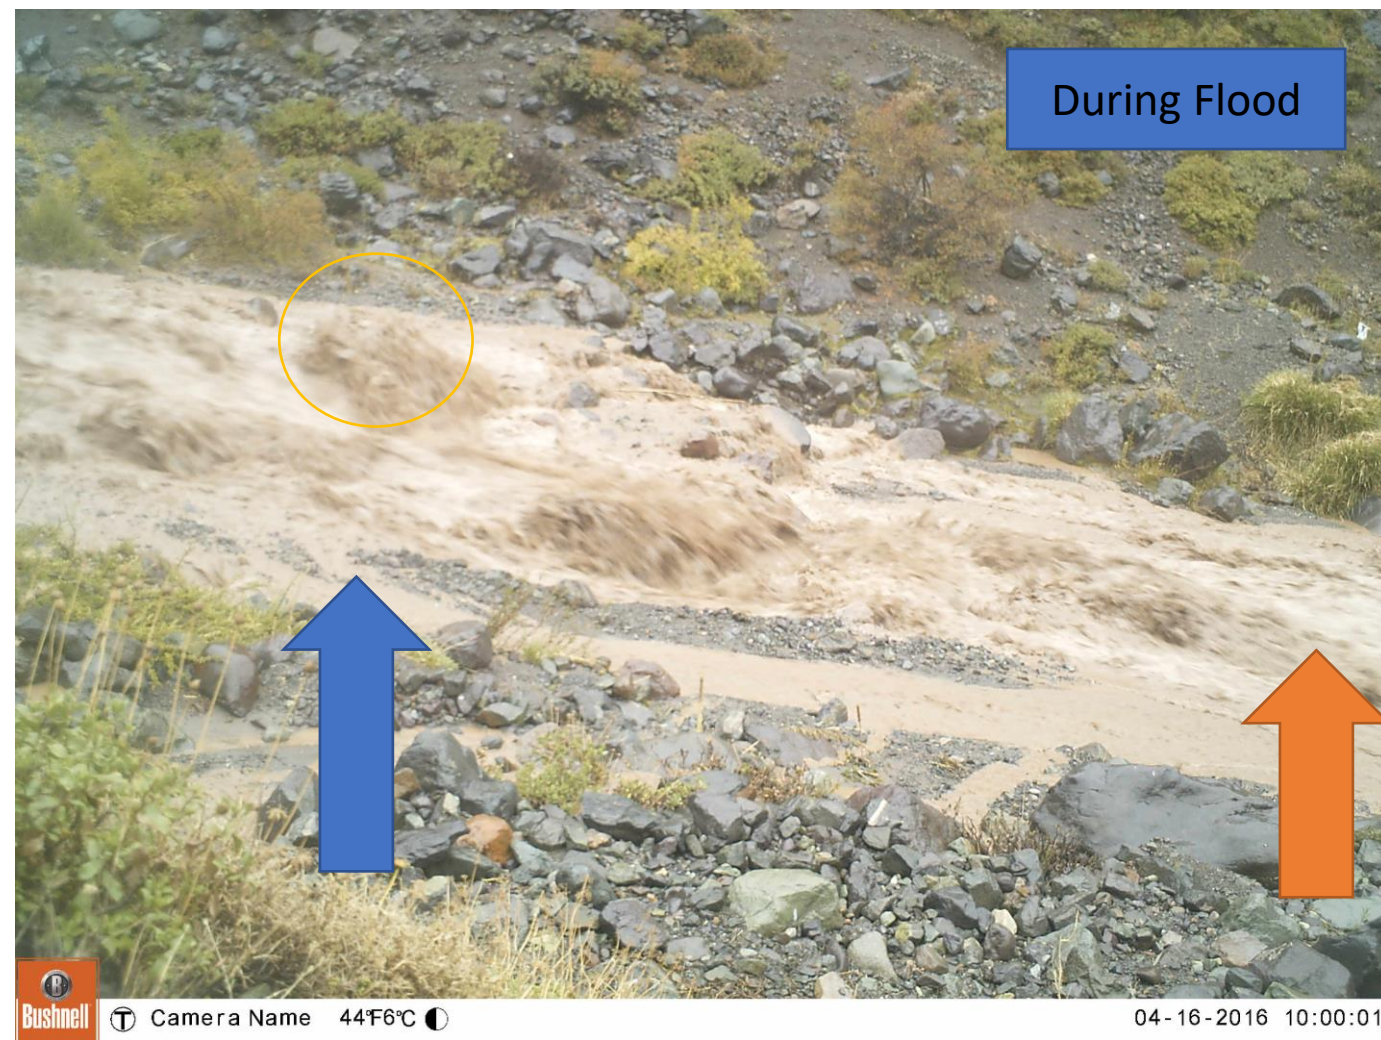
Methodology: Study Area and Surveys

- 150 m long
- 1878 to 1894 m a.s.l.
- 0.108 m m^{-1}
- 3893 m^2
- Water level monitoring
- Ground Control Points

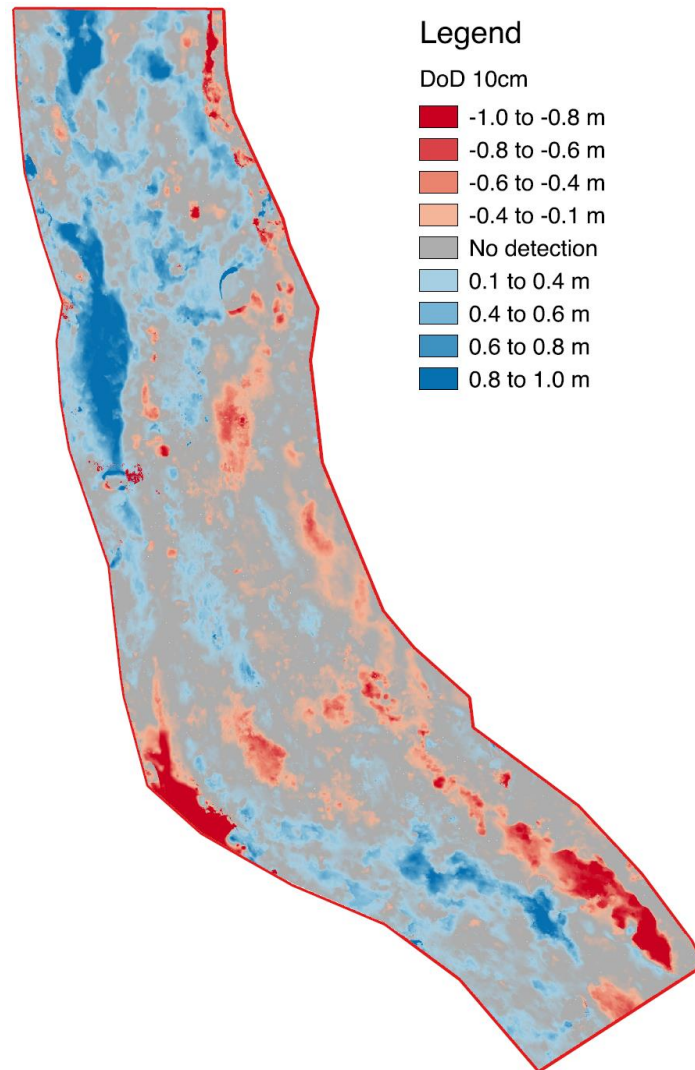
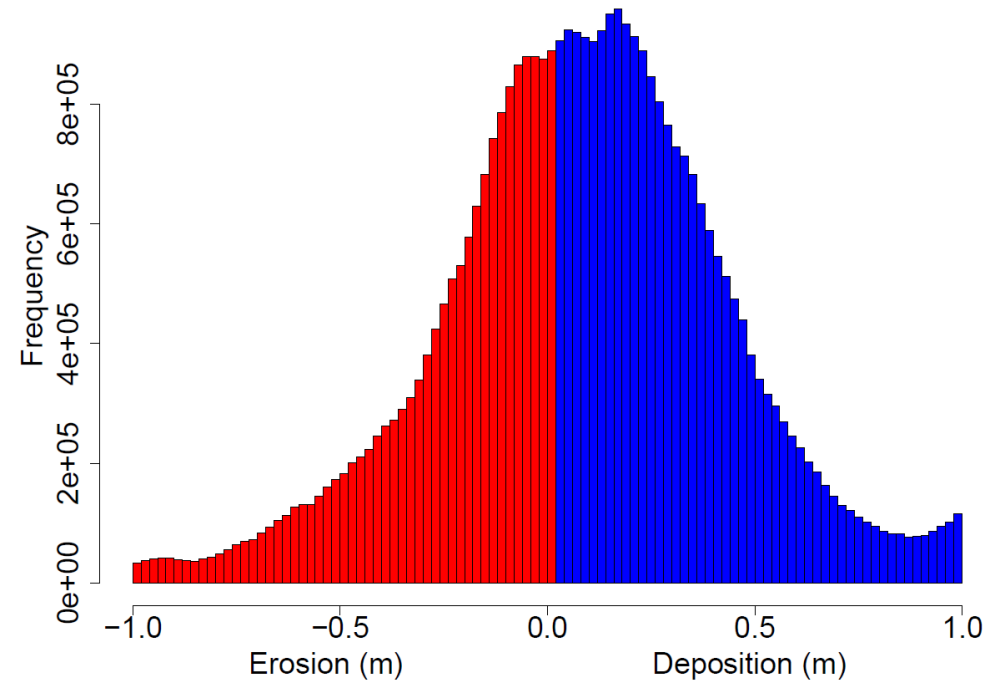
Erosion: 359 m³

Deposition: 680 m³

Net Volumetric
Change:

+321 m³

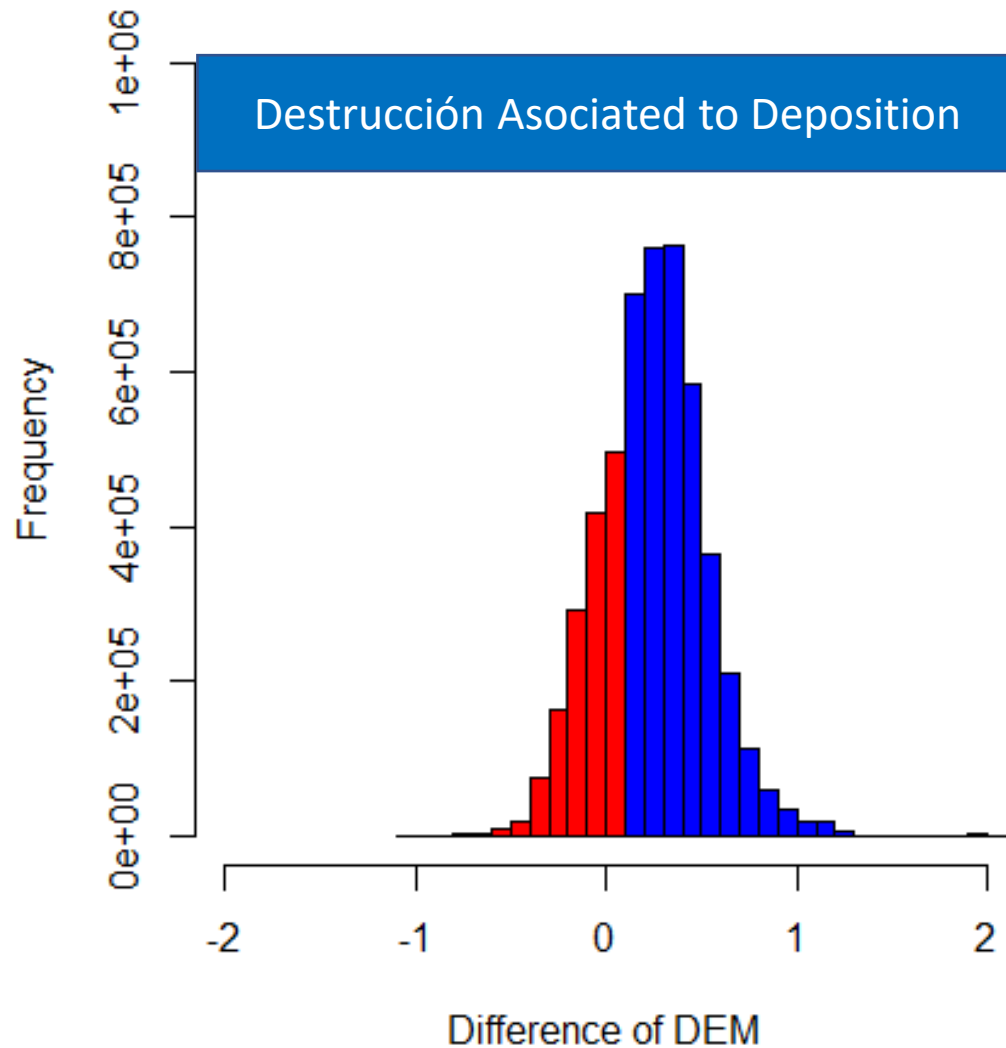
Step-pool destruction

Link between Step-pool Dynamic with erosión and deposition
