# Analysis on situation of water environment in Wujiang District of the Taihu Lake

Kanami Kogure<sup>1</sup>, Siqi Shi<sup>2</sup>, Changtao Yang<sup>2</sup>, and Jianhua Li<sup>2</sup>

<sup>1</sup>FUSO Corporation, Department of Technology Management, Tokyo, Japan (kanamikogure@gmail.com)

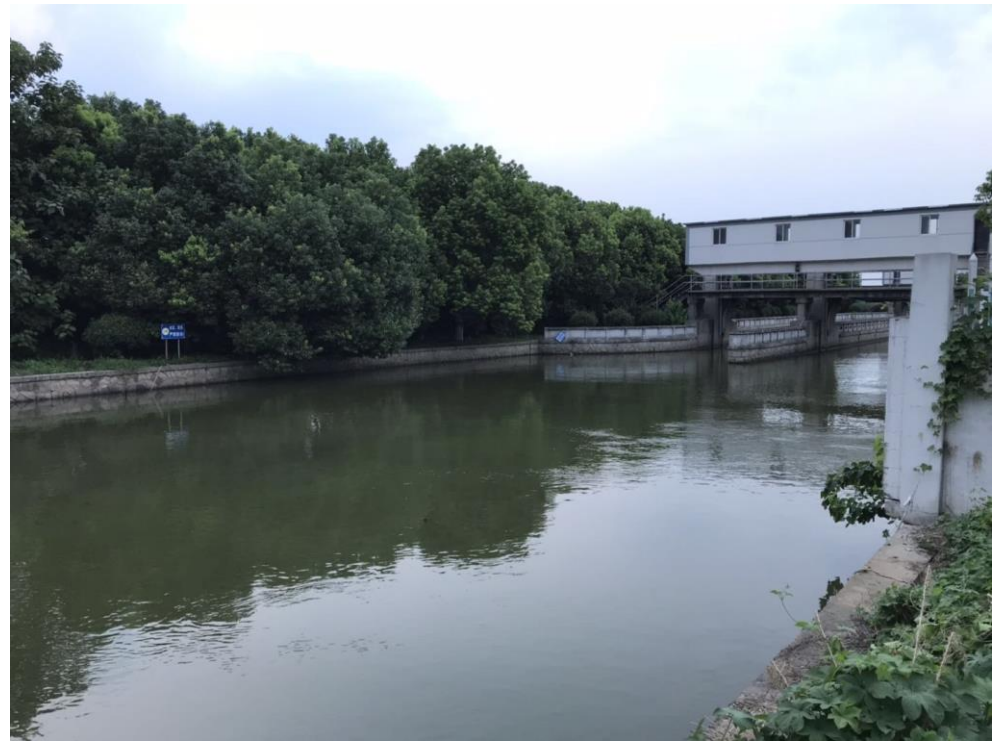
Slice gate at connection point

As the Taipu River is utilized as water resources for drinking water, water level is kept higher than connecting rivers and channels to avoid contamination from tributaries by controlling slice gates.

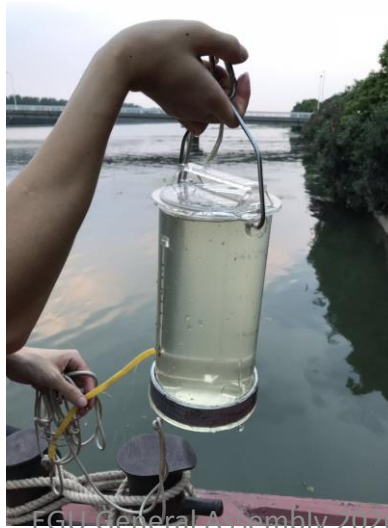
Water sampling
