Regenarating ECOsystems with Nature-based solutions for hydro-meteorological risk rEduCTion

Hydro-meteorological monitoring activities in Portofino Natural Park (Italy) as a demonstrator of the H2020 RECONNECT project: preliminary results.

Demonstrator A

Portofino Park, Italy

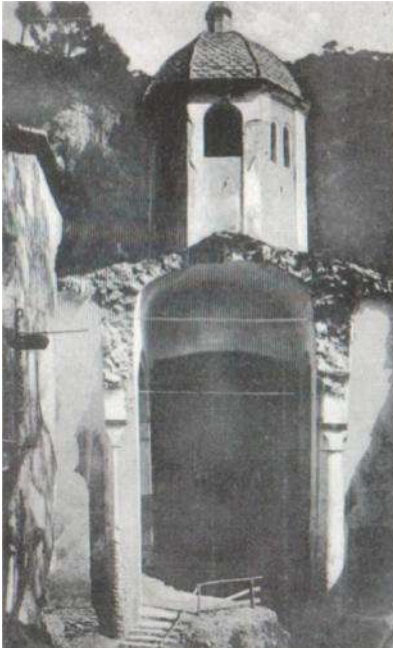
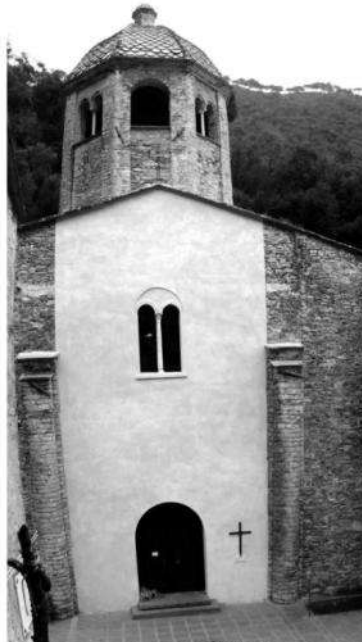
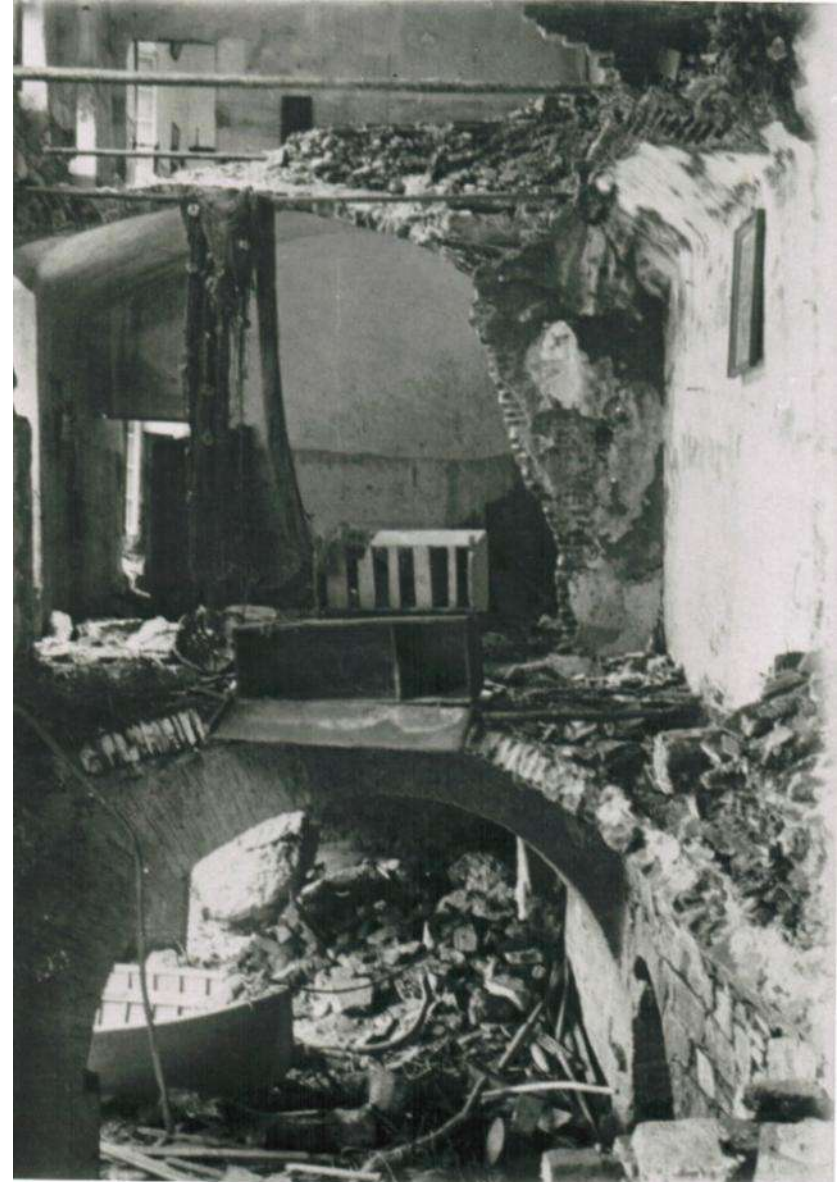
September 1915 – M. Portofino

Heavy rainfalls on 25th September 1915 caused the partial collapse of San Fruttuoso Abbey, due to debris descending from the slopes.

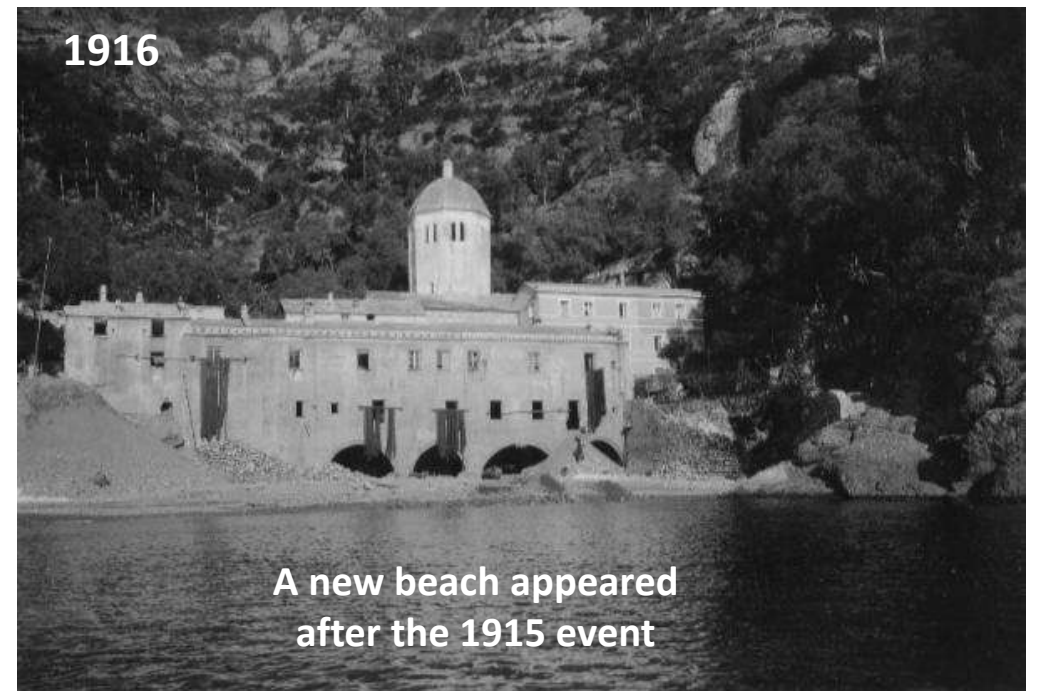
1916

A new beach appeared
after the 1915 event

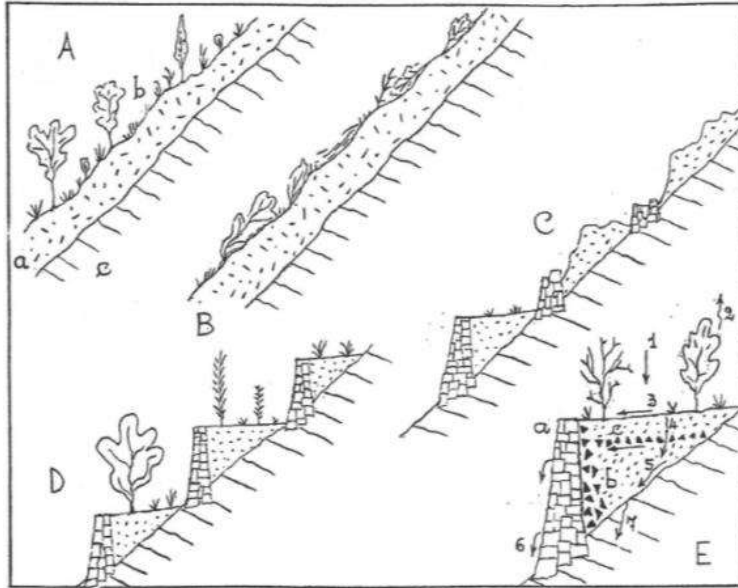
A = debris cover (natural) on the slope
 B = deforestation and slope preparation
 C = dry stone-wall construction and soil fills
 D = terraced slope, with orchards
 E = some details

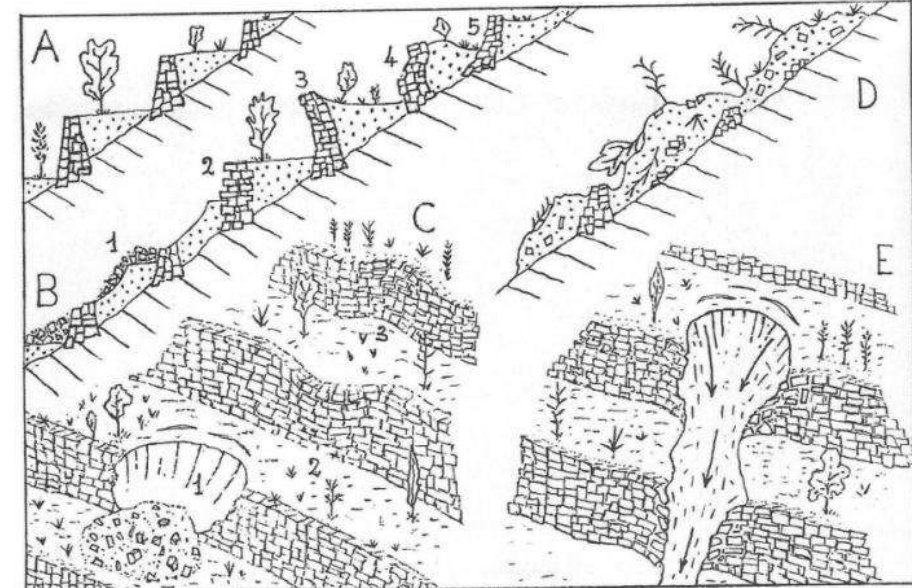
A = cultivated and integrated terraces
 B, C = dry stone walls collapse along shear surfaces
 D = complete collapsed slope with terraces
 E = landslide for "domino effect" along slope with terraces

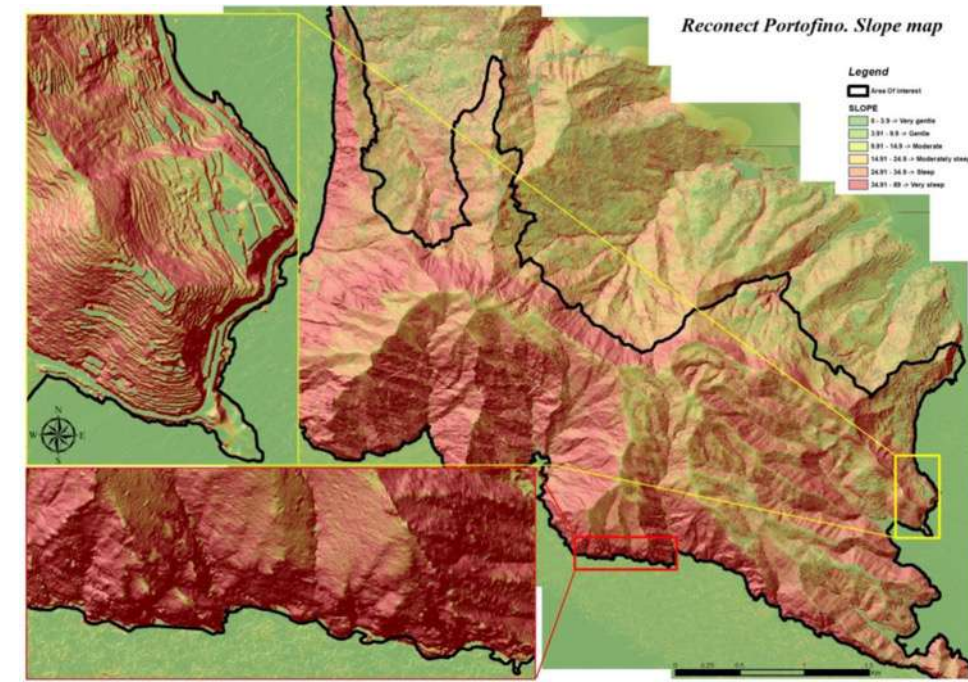
The high point density and top sensors quality will allow to obtain a **0.5 m** and **0.25 m DTM** after *points classification* in: ground, non-ground (includes vegetation, stone walls, buildings...), water and bridges.

LiDAR system Riegl VQ 1560-II, with two 2 MHz sensors

Point density= up to 20 m⁻²

Data will allow a precise detection of terraces and a detail geomorphometric analysis.

From the aerial images RGB- and CIR- orthophotomosaic will be obtained.
