Application of precision technologies in geomorphology: analysis of the flash flood occurred in Sant Llorenç des Cardassar, Mallorca, October 2018

EGU General Assembly 2020

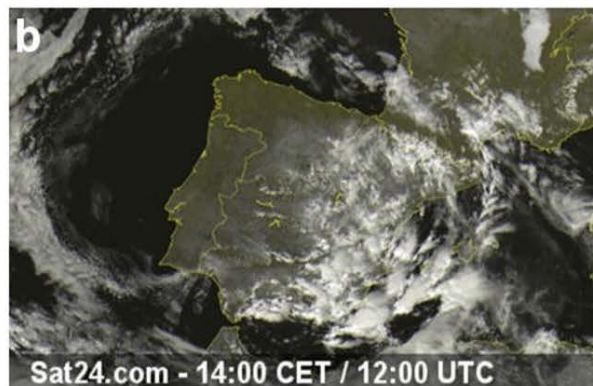
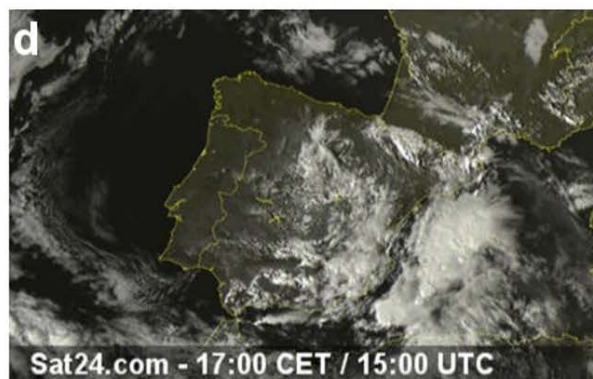
Synoptic situation

(a) Surface pressure and 500-hPa height analyses at 1200 UTC 9th October 2018
 Source: <http://wetter3.de>; i.e. , at the beginning of the precipitation event.
 Satellite image at (b) 12.00UTC and (d) 15.00UTC Source: <http://www.sat24.com>.
 EUMETSAT and radar images at the same hours (c and e) Source: <http://www.aemet.es>.

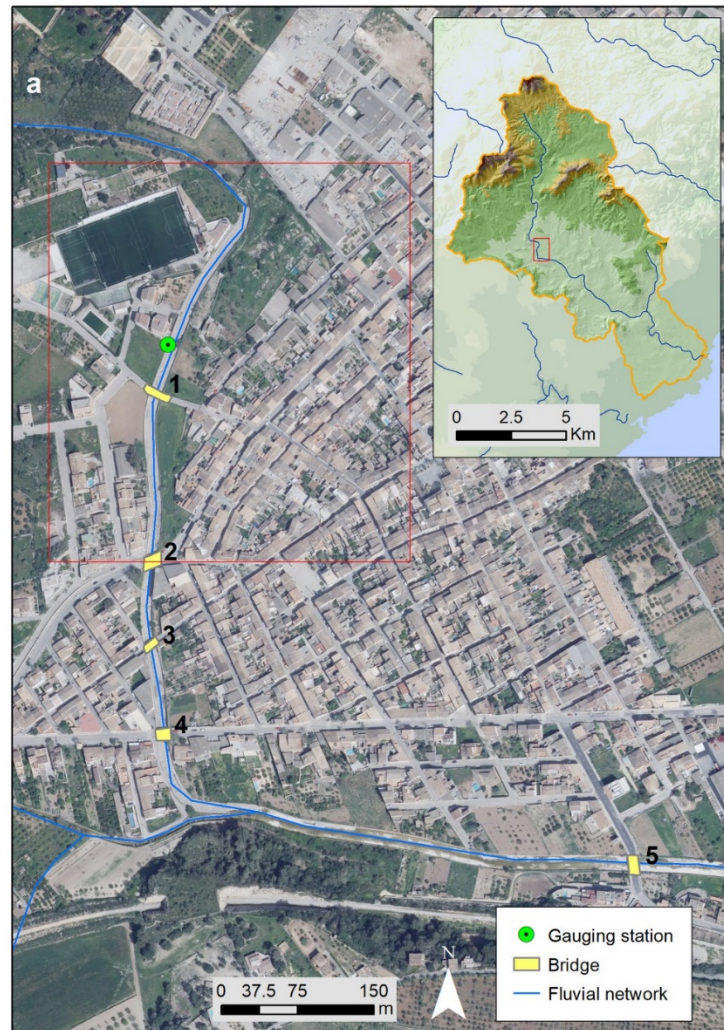
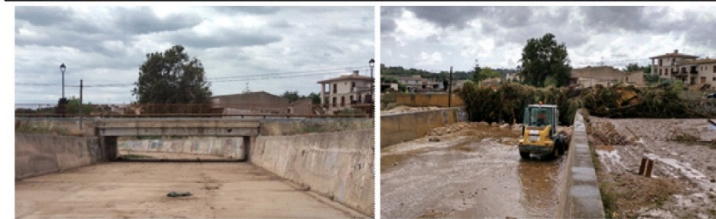
Discharge data

(a) Aerial view of the Begura de Saumà River of concrete channelization that crosses Sant Llorenç des Cardassar village and the location of bridges. (b) Detailed aerial view of the very beginning of this concrete channelization where the hydrometric station is located. The photographs show a view of the Bridge 1 from the hydrometric station when (the right picture) was installed the digital equipment, 10th June 2015 and (the left one) few hours after the flash flood, the 10th October 2018. Background: aerial photography and DEM data (PNOA, 2015).

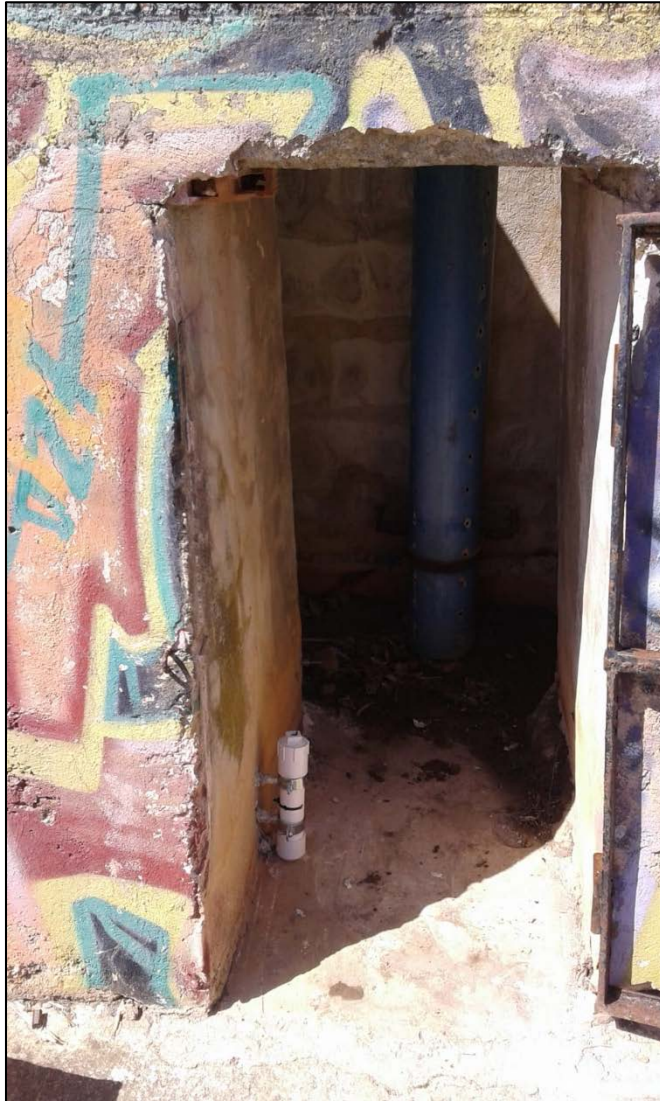
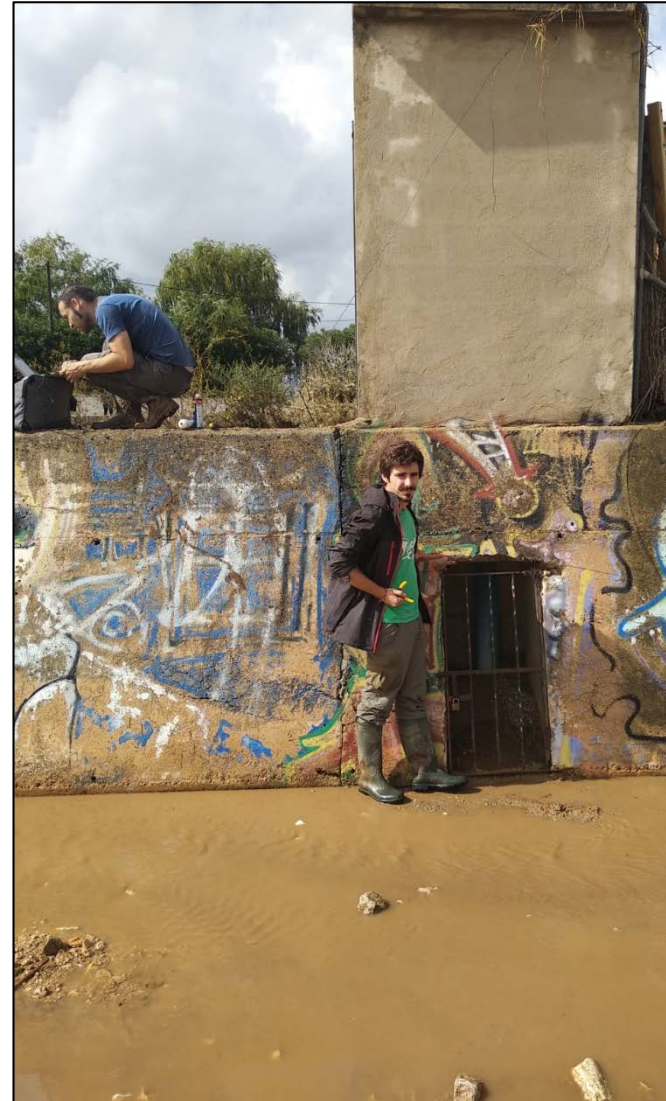
Methods Discharge data

Hydrometric station of the Begura de Saumà River. (Left) Installation of the digital equipment, 10th June 2015. (Right) Data downloading the day after the flash-flood -10th October 2018-.

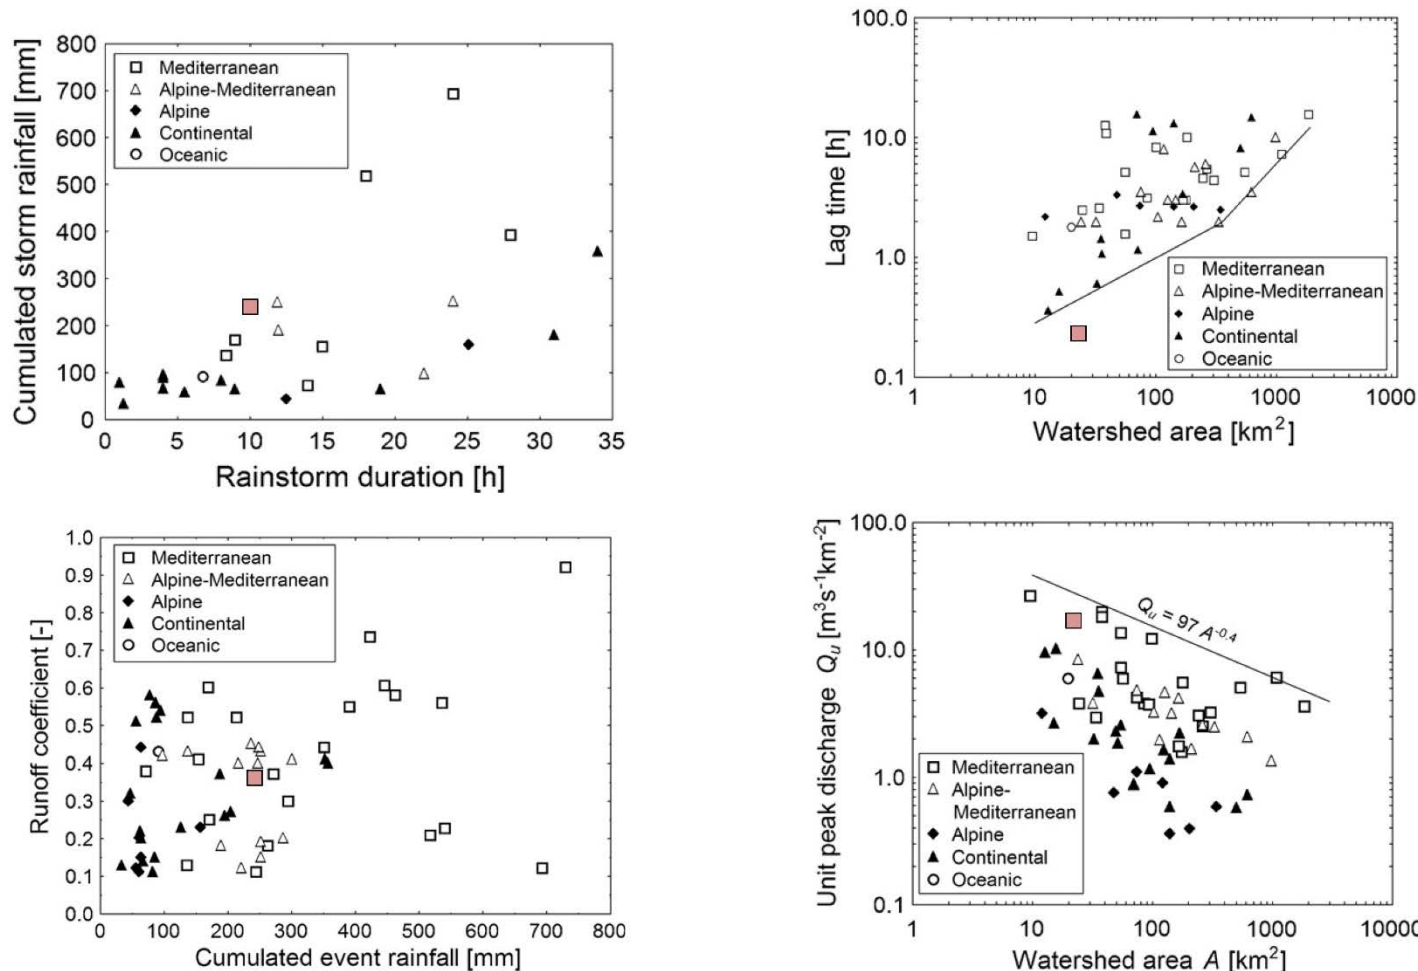
Results Hydrological response and flash flood modelling in small Mediterranean karstic catchments

Pink square: Sant Llorenç des Cardassar flash-flood
