Ten years of civil protection support activities in landslide areas of Basilicata (southern Italy)

Angela Perrone

Institute of Methodologies for Environmental Analysis (IMAA)
Italian National Research Council (CNR)

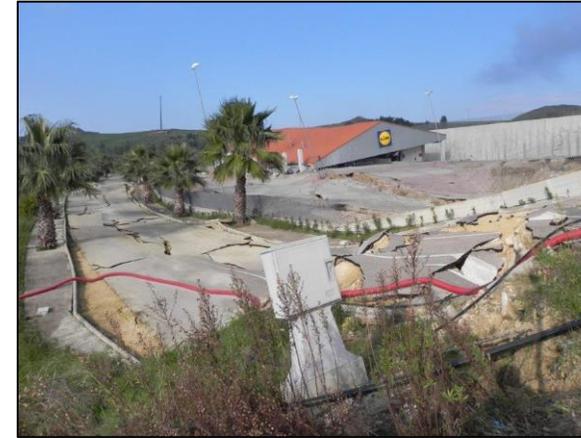
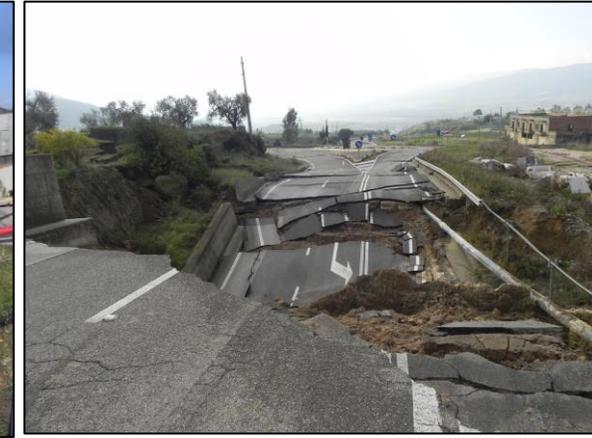
Montescaglioso landslide: December 2013

Trigger factor: rainfall (rain gauge station of Ginosa 8 km east)

Cumulative rain (mm)	Starting date and local time	Ending date and local time
246.4	6 th of October 2013 at 00:00	9 th of October 2013 at 11:00
157.6	30 th of November 2013 at 13:00	3 rd of December 2013 at 2:00

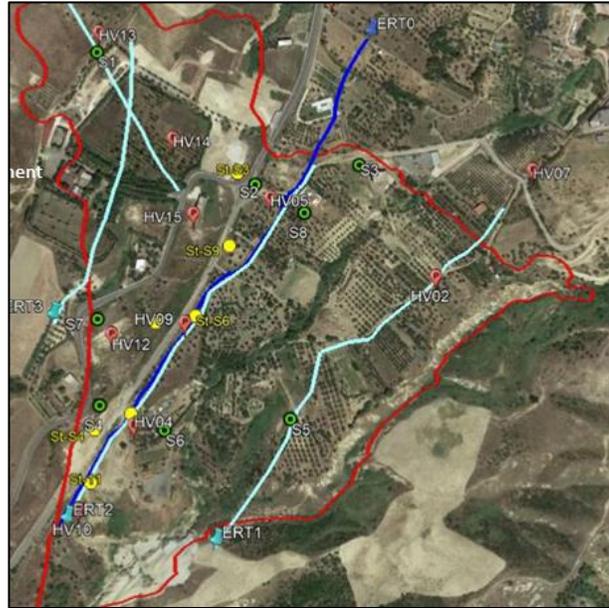
Montescaglioso landslide: comparison between ERT, HVSR and stratigraphical data

Geophysical measurements
 n. 5 Electrical resistivity tomographies (ERT)
 n. 15 Ambient seismic noise measurements (HVSR)

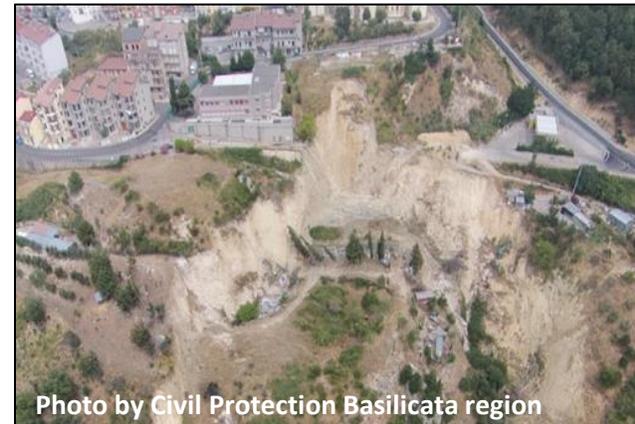
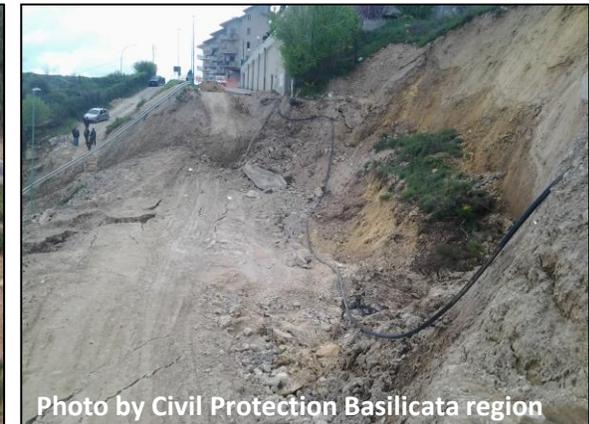
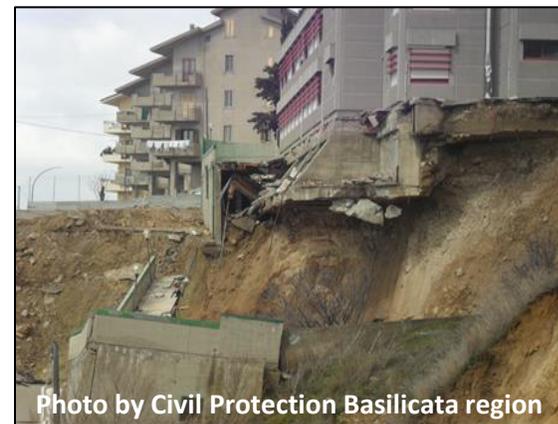
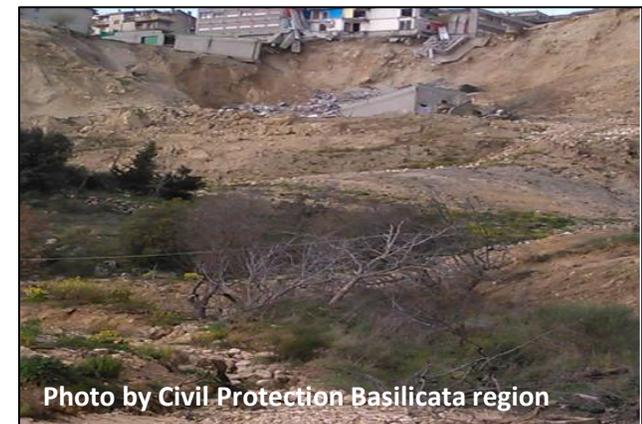
Trigger factor: rainfall

Date	Rain gauge station	Cumulative rain (mm)	Time (h)
5 th – 7 th October 2013	Gorgoglione	50.60	72
5 th – 7 th October 2013	San Mauro Forte	26.60	72
11 th – 13 th November 2013	Gorgoglione	98.40	72
11 th – 13 th November 2013	San Mauro Forte	107.60	72
30 th November – 2 nd December 2013	Gorgoglione	164.40	72
30 th November – 2 nd December 2013	San Mauro Forte	191.20	72
1 st – 3 rd February 2014	Gorgoglione	124.40	72
1 st – 3 rd February 2014	San Mauro Forte	97.20	72

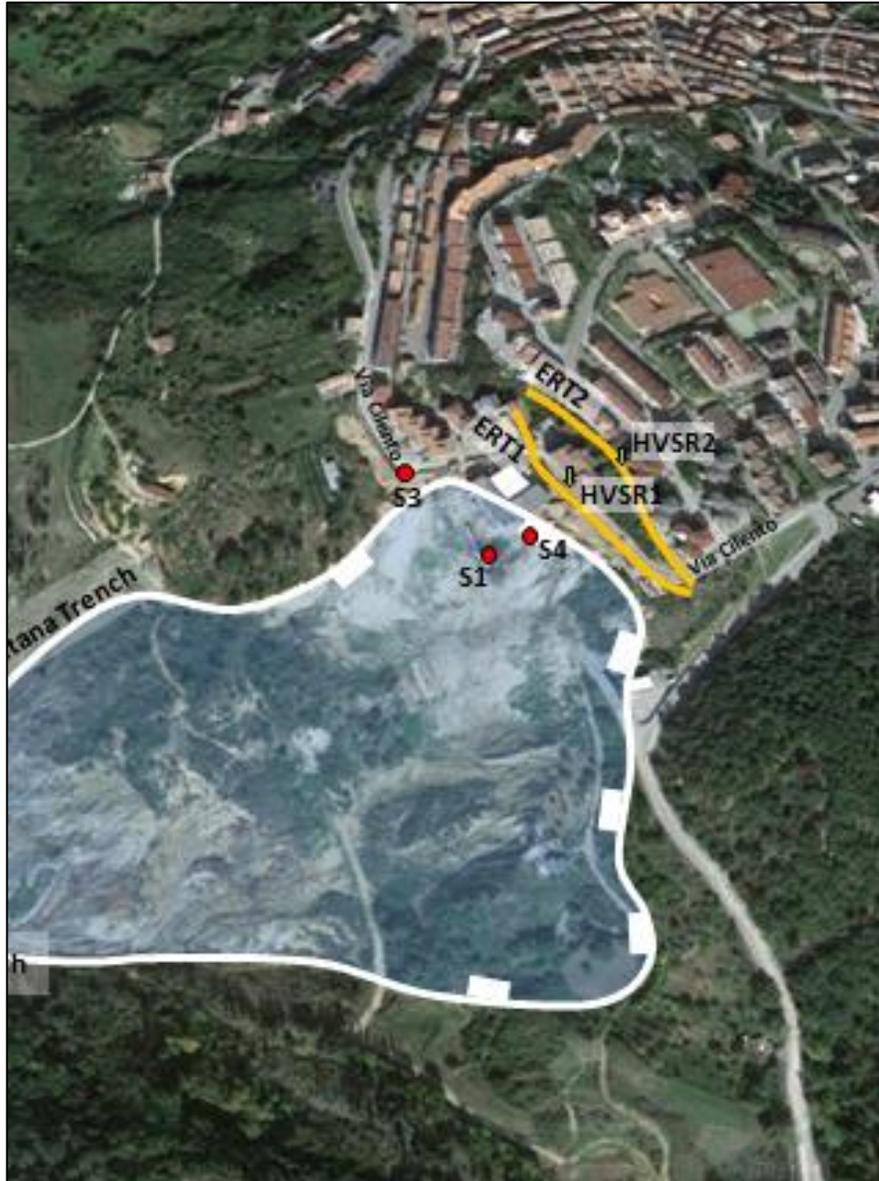
Stigliano landslide: comparison between ERT and HVSR

Geophysical measurements

n. 2 Electrical resistivity tomographies (ERT)

n. 2 Ambient seismic noise measurements (HVSR)

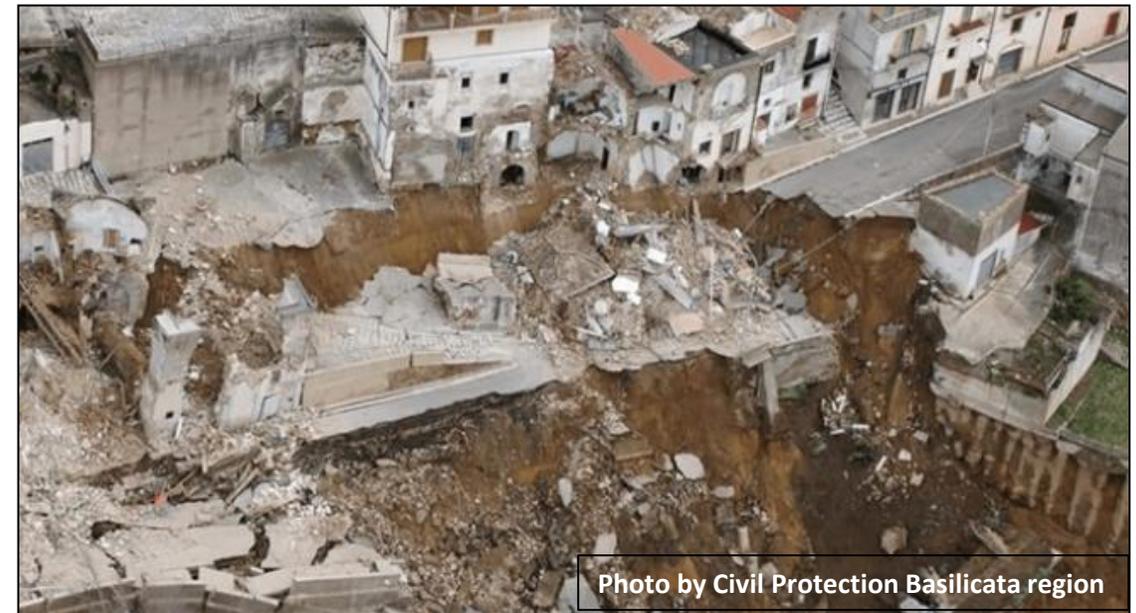
Trigger factor: rainfall

Date	Rain gauge station	Cumulative rain (mm)	Time
24 th – 26 th January 2019	Matera	42 mm	48 hours
24 th – 26 th January 2019	Torre Accio – Bernalda	55 mm	48 hours

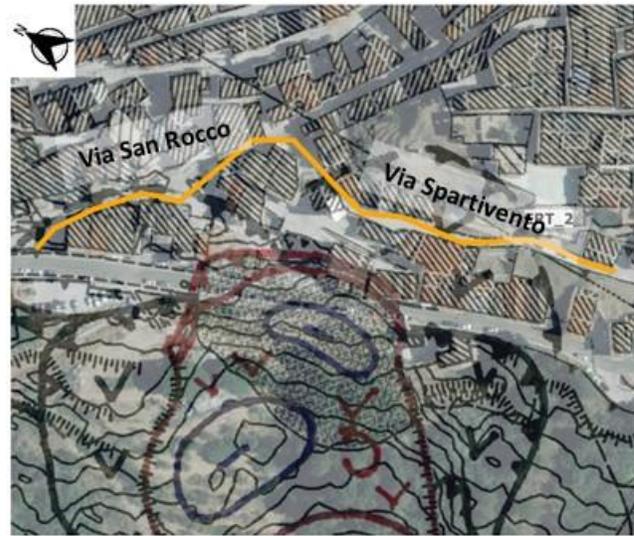
Pomarico landslide: comparison between ERT, MASW and stratigraphy

Geophysical measurements

n. 3 Electrical resistivity tomographies (ERT); n. 4 Multichannel Analysis of Surface Waves (MASW)

n. 1 Seismic refraction tomography (SRT); n. 20 Ambient seismic noise measurements (HVSr); 810 m georadar profiles (GPR)
