Applying InfraRed Thermography (IRT) for the protection and conservation of rupestrian CH sites affected by slope instabilities

Frodella W., Spizzichino D., Gigli G., Elashvili M., Margottini C., Casagli N.

Vardzia rock cut city (IX-XII sec.)

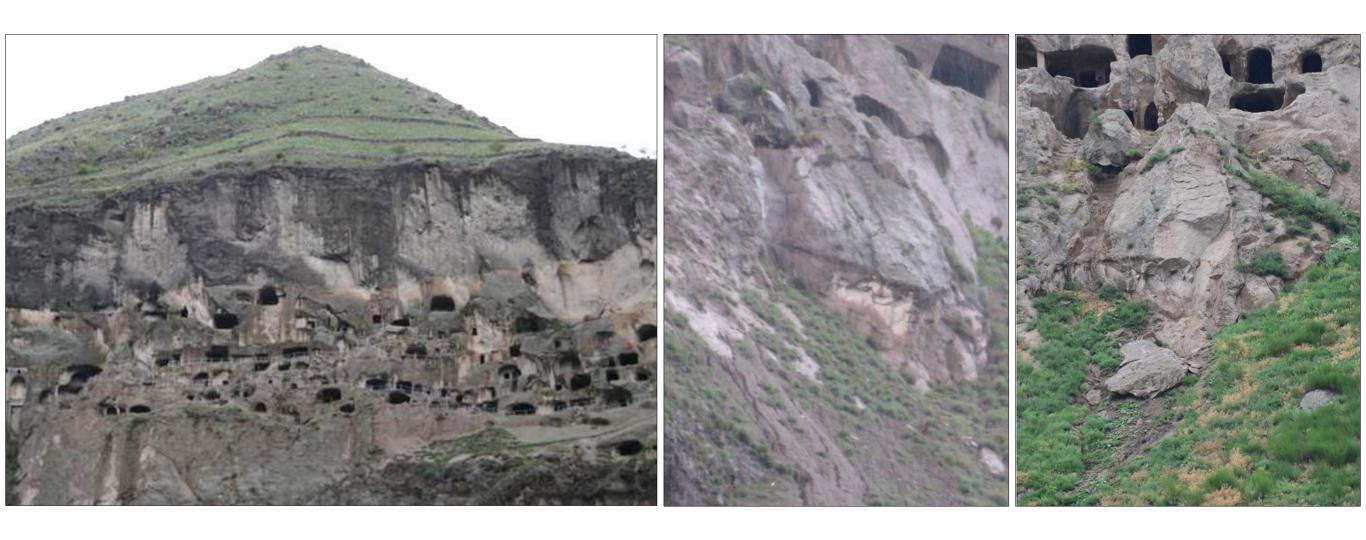
Conservation problems

- Moisture causes weathering and degradation of the tuff slope, reducing wall strength, causing the widening of the joints and loosening of the rock mass
- Moisture is therefore recognized as one of the most important factors contributing both to the degradation and instability processes acting in the site of Vardzia

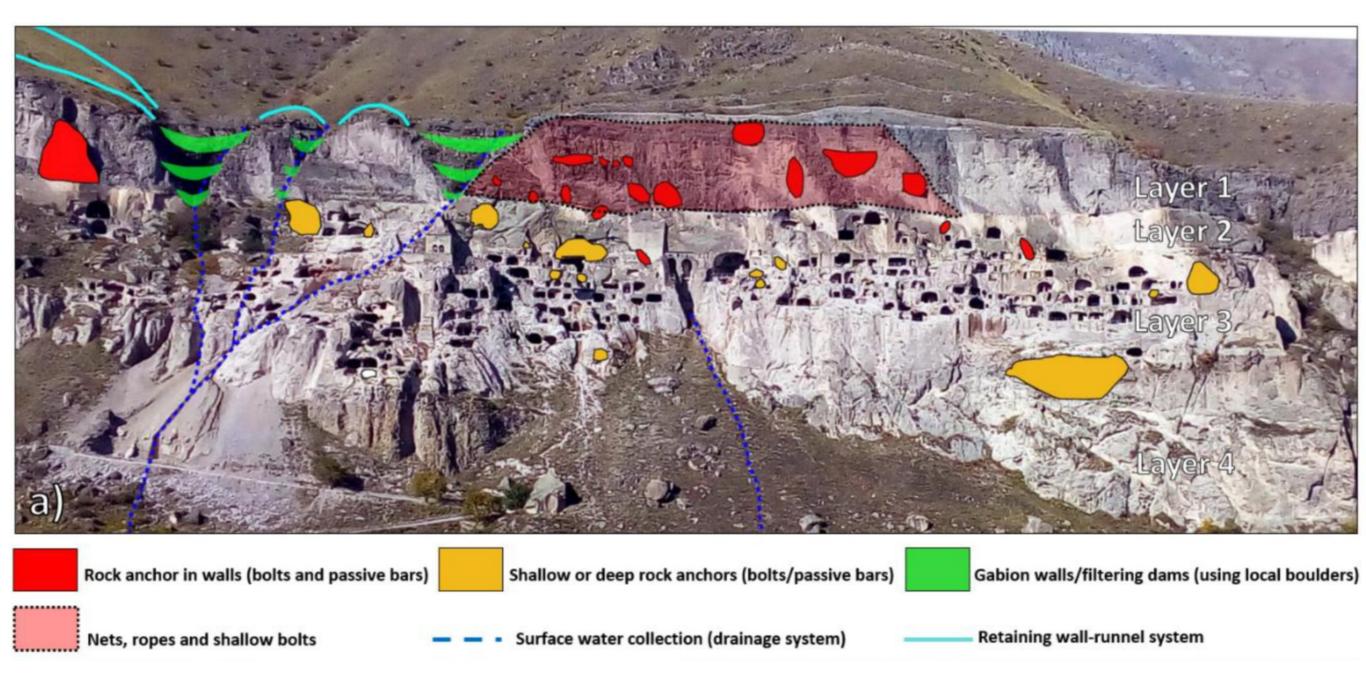
IRT contribution for sustainable mitigation measures

(a) Contribution to the General Master Plan of the proposed mitigation measures for the whole Vardzia Monastery: system of surface water collection and runnel-retaining walls built along the monastery slope rock wall upper sector, sectors characterized by instability on the rock cliff with related anchor type,
