Laboratory experiments for analysing the impact of herbaceous vegetation on riverbank erosion

NBS analysed: Installation of herbaceous perennial deep rooting plants as coverage of earth embankments.

OPEn-air laboRAtories for Nature baseD solUtions to Manage hydro-meteo risks

Real world case study (Open Air Lab): reach of the bank of the Panaro River tributary of Po River (Northern Italy)

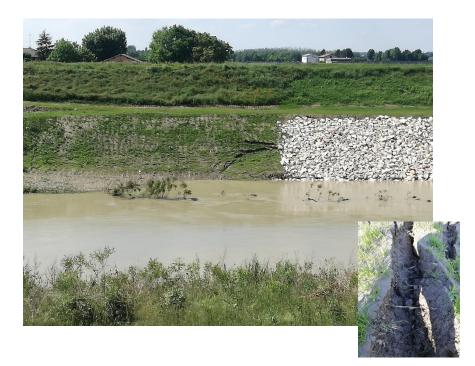
Panaro River

In this section, remediation works (piles and riprap) on the Panaro riverbank have been recently (spring 2019) concluded by the Po river authority (AIPO) to improve bank stability. On the adjacent bank, cracks have already appeared.

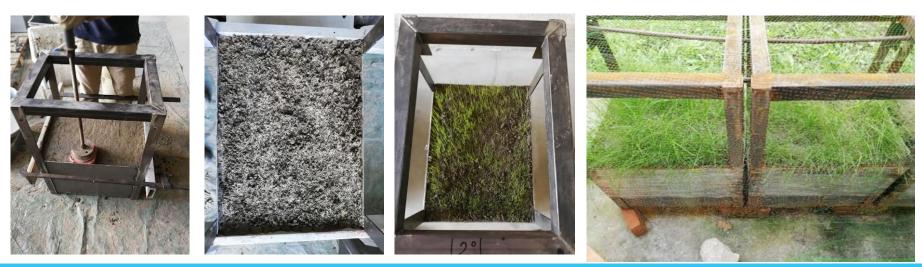
Experiment setup: Planting and growing of the vegetation

Laboratory flume tests was performed in different soil surface conditions, i.e.:

- Smooth, compacted and **non-vegetated soil**;
- Soil vegetated with standard herbaceous plants typically used by the river authority (when any vegetation is planted, since generally there is no artificial seeding along the banks)
- Soil vegetated with deep-rooted herbaceous plants

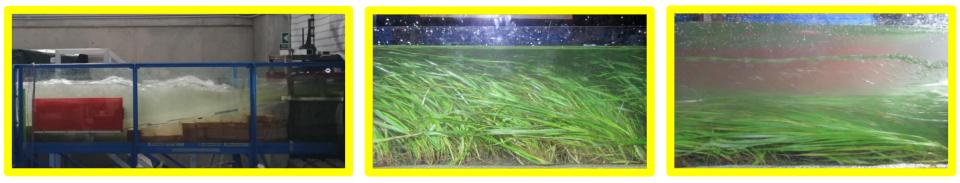
Vegetated soil experiments

For each vegetation type (standard and deep-rooted herbaceous plants), two channel slopes were tested (0.3% and 8.5%), each with three different discharges.

The main challenge resulted to be the estimation of the volumes of soil eroded during the experiments, due to the very limited quantities that are eroded and to the particularly fine-grained texture of the soil.

Partial and local states of failure were obtained during the erosion test at the higher bed slope for the bare soil and, to a lesser extent, for the deep-rooted plants, while erosion processes were negligible for the "standard grass".
