**Gaume, E.¹,
Charpentier--Noyer, M.¹,
Payraastre, O.¹**

The October 1940 extraordinary flood in the Pyrenees revisited: validation of some hypotheses based on hydraulic simulations

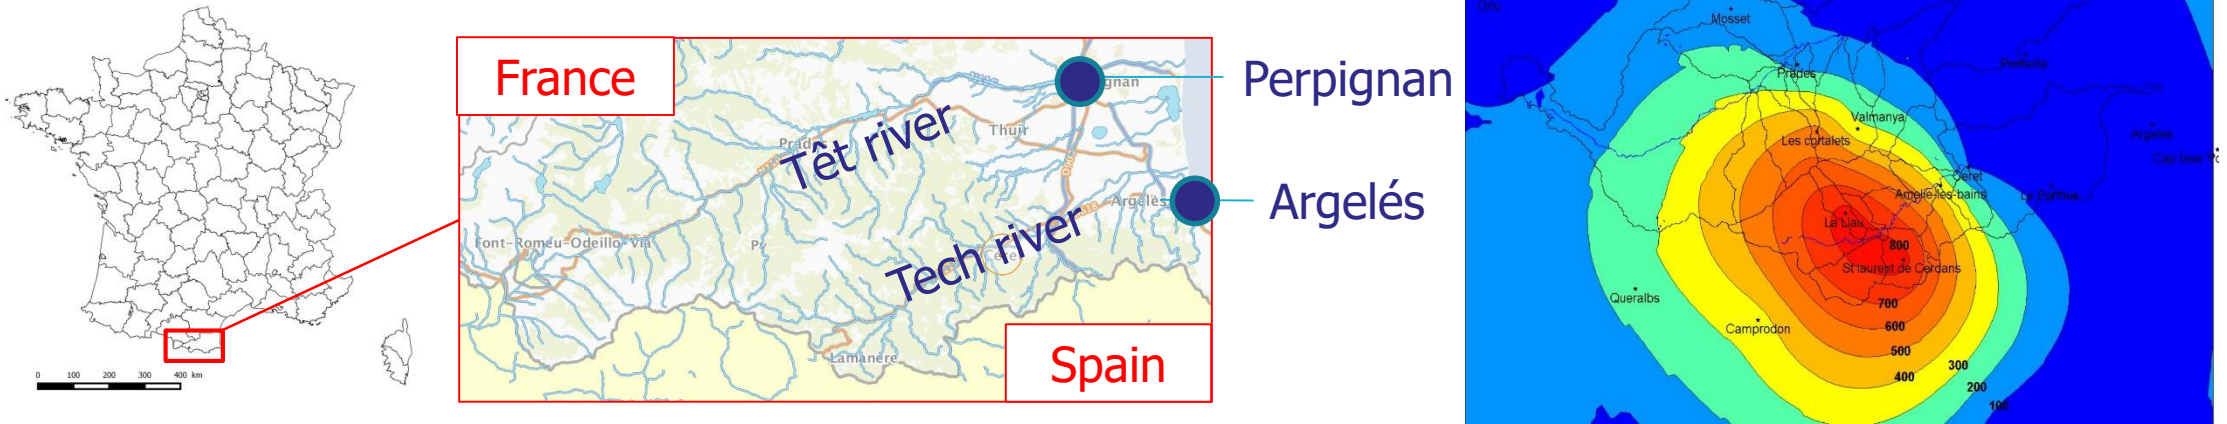
*Figure 1: Location of the event and estimated rainfall (obtained by kriging)
E. Gaume, O. Payrastre, G. Degoutte, 2015*

- One of the most impressive flash floods of the 20th century
- Eastern part of the Pyrenees: France and Spain
- Large floods on the Tech and Têt rivers
- Maximum observed 24-hour rainfall close to 1m (fig.1)
- Major erosion/sediment transport effects
- Casualties: 47 deaths in France, more than 100 deaths in Catalonia
- Large damages to buildings and infrastructures, destruction of town centers as Vernet-Les-Bains (fig.2)

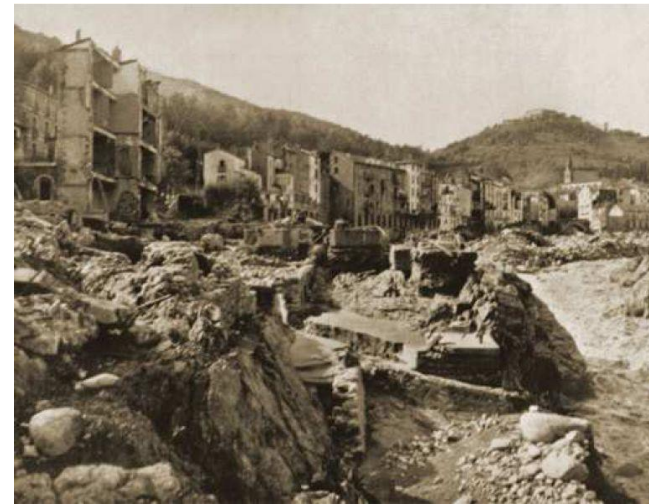
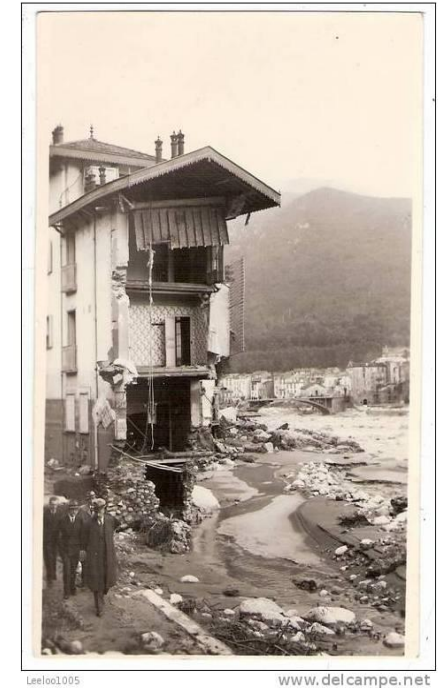
Figure 2: Damages in Vernet-Les-Bains

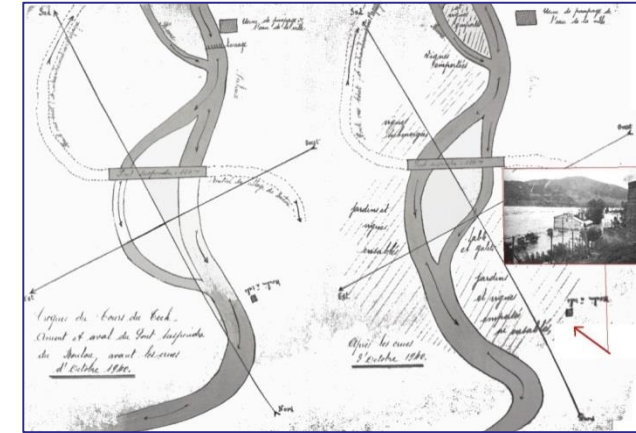
Figure 3: Extracts of teachers testimonies

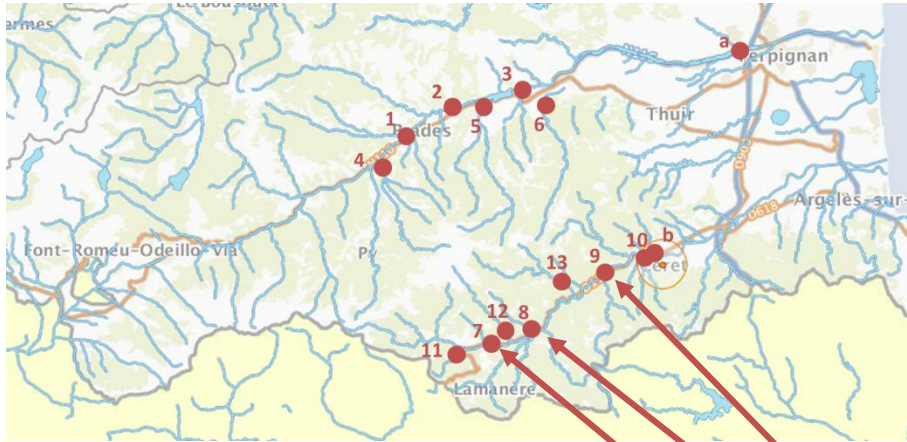
River	K	V m/s	Q m ³ /s	S _{hy} km ²	Q _{unit} m ³ /s/km ²	Fr
Tech	30	8.3	5200	382	13.5	1.1
Tech	30	7.5	2200	186	11.9	0.9
Tech	40	15.3	2000	109	18	2.7

Figure 4: Examples of cross-sections and initial peak discharges estimations (from E. Gaume, O. Payrastre, G. Degoutte, 2015)

➤ With the initial peak discharge estimations (fig.4):

- Roughness values (i.e. 30 to 40 for Strickler's K coefficient) are in the highest range observed for natural streams and artificial channels
- Velocities exceeding 10 m.s⁻¹ for some cross-sections

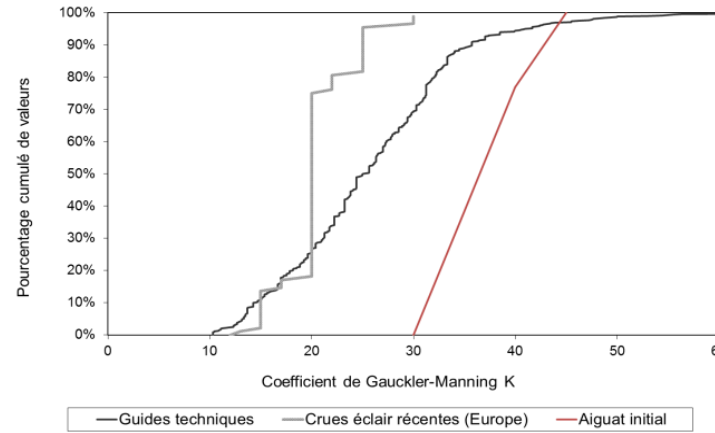
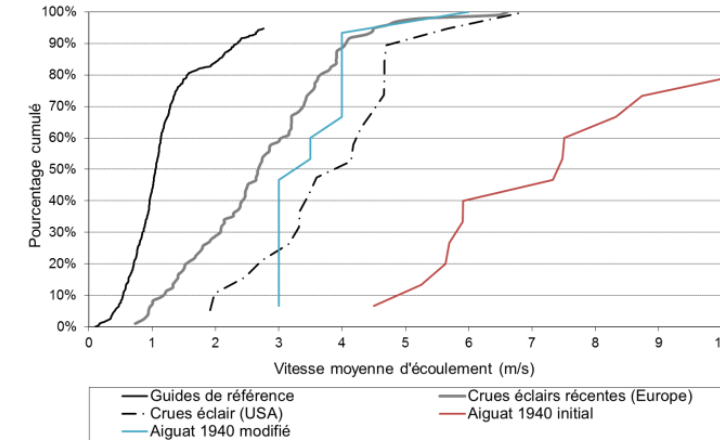
Figure 5: Distributions of roughness coefficients and mean flow velocities measured or estimated (various flash floods), compared to the values of velocities and roughness coefficients used by B. Quesnel for the 1940 Aiguat flow estimates (from E. Gaume, O. Payrastre, G. Degoutte, 2015)

- Supercritical flows (Froude number over 1) rarely observed in natural rivers and streams
- Large differences between the distribution of roughness coefficients and mean flow velocities of recent flash floods and the values used in 1940 (fig.5)

- Initial roughness coefficients are not realistic must be reduced to obtain reasonable flow velocities
- Initial peak discharges of the 1940 flood seem to have been largely overestimated

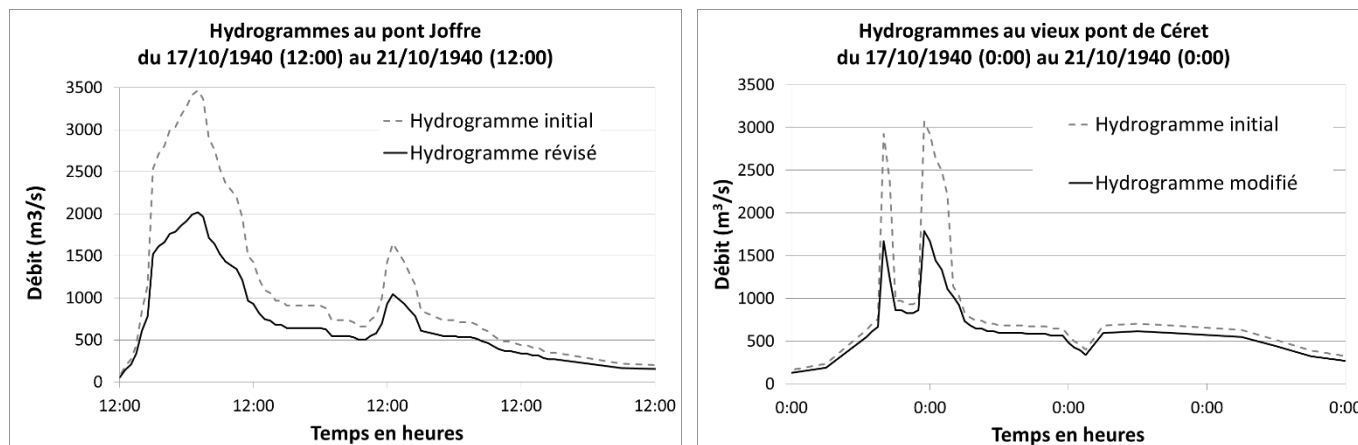
Figure 6: Reconstructed hydrographs of the October 1940 flood at Pont Joffre (Têt) and Pont de Céret (Tech), from E. Gaume, O. Payrastre, G. Degoutte, 2015

- Revisited hydrographs with new estimations of peak discharges (fig.6)
 - Lower roughness coefficient than historical estimates ($K \sim 20$ rather than $K \sim 35$)
 - Smaller peak discharges
 - A complex inundation dynamic in the downstream floodplains of the Tech river according to the teacher's testimonies (fig.7)
 - Flood chronology described in Ortaffa consistent (fig.7) with the chronology of upstream hydrograph at Céret (with a 3 hours time shift)
 - Reported max. of inundation in Elne apparently not consistent with the same hydrograph.
- Is the new hydrograph consistent with the inundation observed in the downstream floodplain?
 - How to explain the maximum of inundation in Elne ?
Assumption to be validated:
Railway dike breach upstream the city?

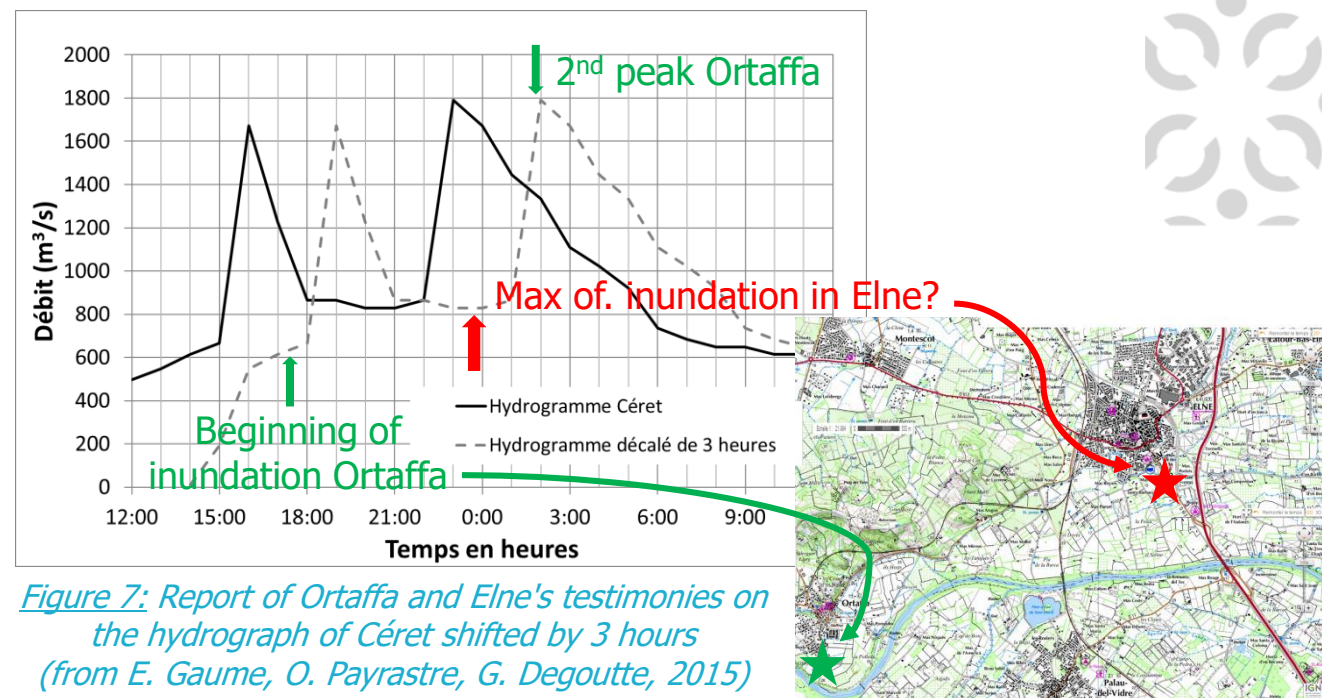
Figure 7: Report of Ortaffa and Elne's testimonies on the hydrograph of Céret shifted by 3 hours (from E. Gaume, O. Payrastre, G. Degoutte, 2015)

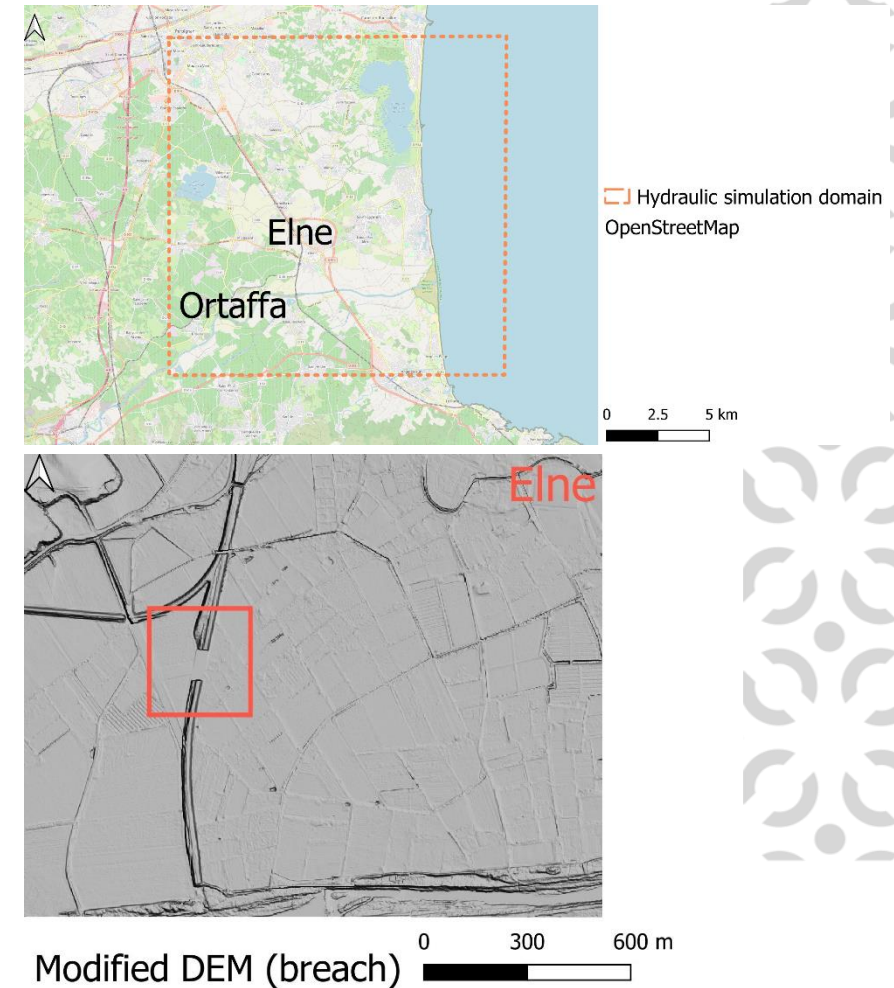
Figure 8: Simulation area (A) and railway breach in the DEM (B)

- Hydraulic model chosen for the simulation, Basilisk – 2D:
 - Shallow-Water finite volume numerical scheme
 - Order 2 in space and time
 - Quadtree-adaptive grid refinement:
 - Cohabitation of several mesh sizes at the same time
 - Reflecting the characteristics of the flow: precise calculation in areas of interest and broader calculation in areas of less interest
- Simulation area: from Ortaffa to the Mediterranean Sea (fig.8 A)
- Creation of a breach of the railway embankment in the DEM (fig.8 B):
 - Location based on original testimonies and historical aerial views (Geoportail website)
 - Opening of about 130m length
- Realization of two hydraulic simulations (historical and new hydrograph) and comparison of the results with the available validation data (flood marks and original testimonies):

Simulation with the new hydrograph	Simulation with the historical hydrograph
Roughness coefficients	Riverbed $K=20$ ($n=0.05$) Floodplain $K=10$ ($n=0.1$)	Riverbed $K=35$ ($n=0.029$) Floodplain $K=10$ ($n=0.1$)
Hydrograph	New estimates E. Gaume, O. Payrastre, G. Degoutte, 2015	Historical estimates Quesnel and Pardé, 1941-42
DEM	RGE ALTI 1m with a breach in the railway embankment from 11PM on October, 17

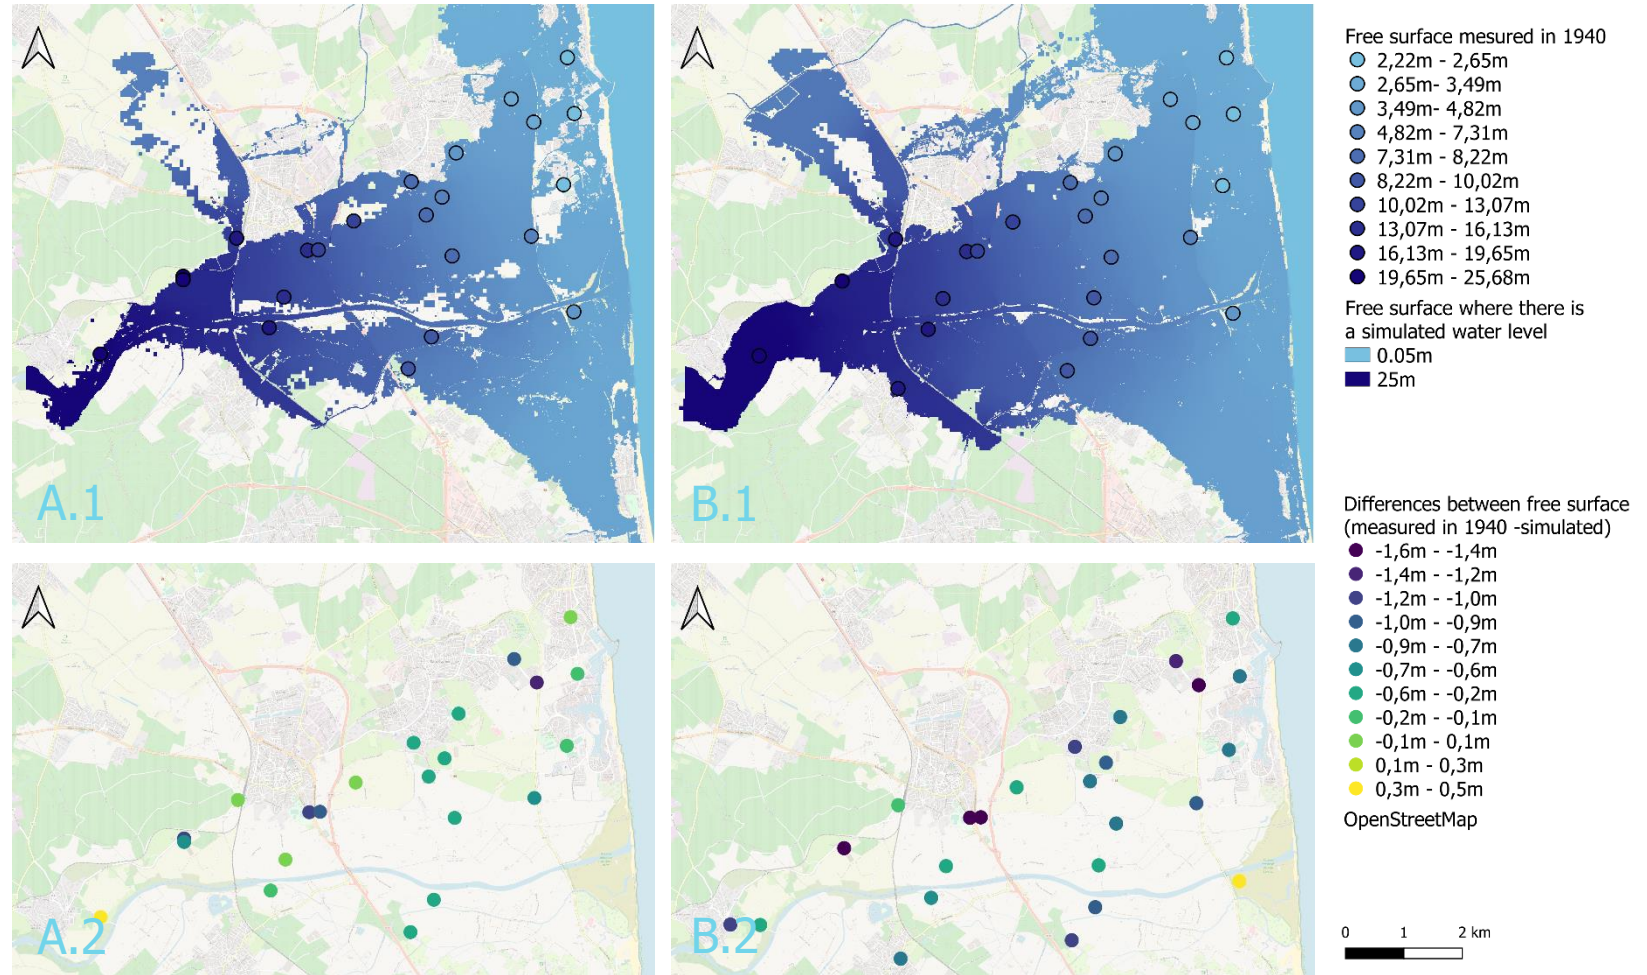
Figure 9: Difference between the water surfaces measured in 1940 and calculated by Basilisk
A - New hydrograph and Manning coefficients
B- Historical hydrograph and Manning coefficients

- Across the entire simulation area, numerous flood marks were recorded after the flood:
 - Way to check the simulation results with a comparison between the reported and simulated water surfaces
- The flooded area (fig.9 B.1) is significantly larger with historical flow values than with new values (fig.9 A.1):
 - Logical since the flow rate is 50% higher in the case of historical values
- The differences between the measured in 1940 and simulated free water surfaces are mostly negative (fig.9 A.2 & fig.9 B.2):
 - Regardless of the hydrographs used, overestimation of the free water surface

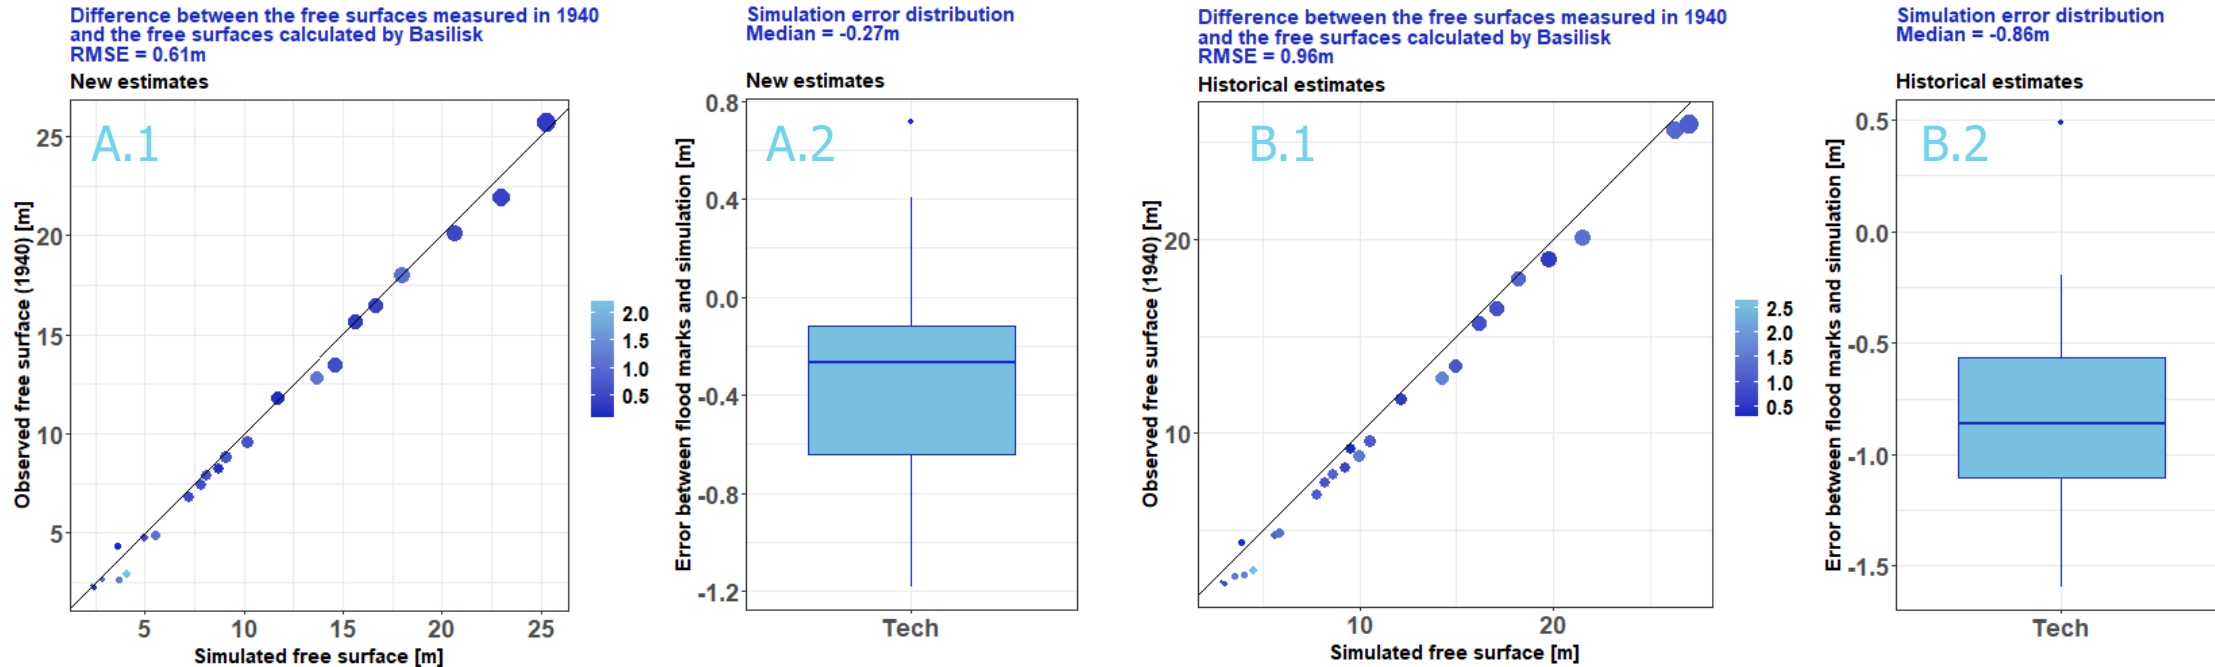
*Figure 10: Difference between the water surfaces measured in 1940 and calculated by Basilisk and distribution of simulation errors
New estimate of flows and Manning coefficients - A
Historical estimate of flows and Manning coefficients - B*

- The scatter plots (fig.10 B.1 and fig.10 A.1) confirm the clear overestimation of the free water surface, which is more important with the historical hydrograph than with the new one.
- Best approximation with the new hydrograph: smaller RMSE, Error distribution closer to 0

- Better results with the new hydrograph and roughness estimates,
- However it is not really possible to invalidate historical hydrograph (results not significantly different)

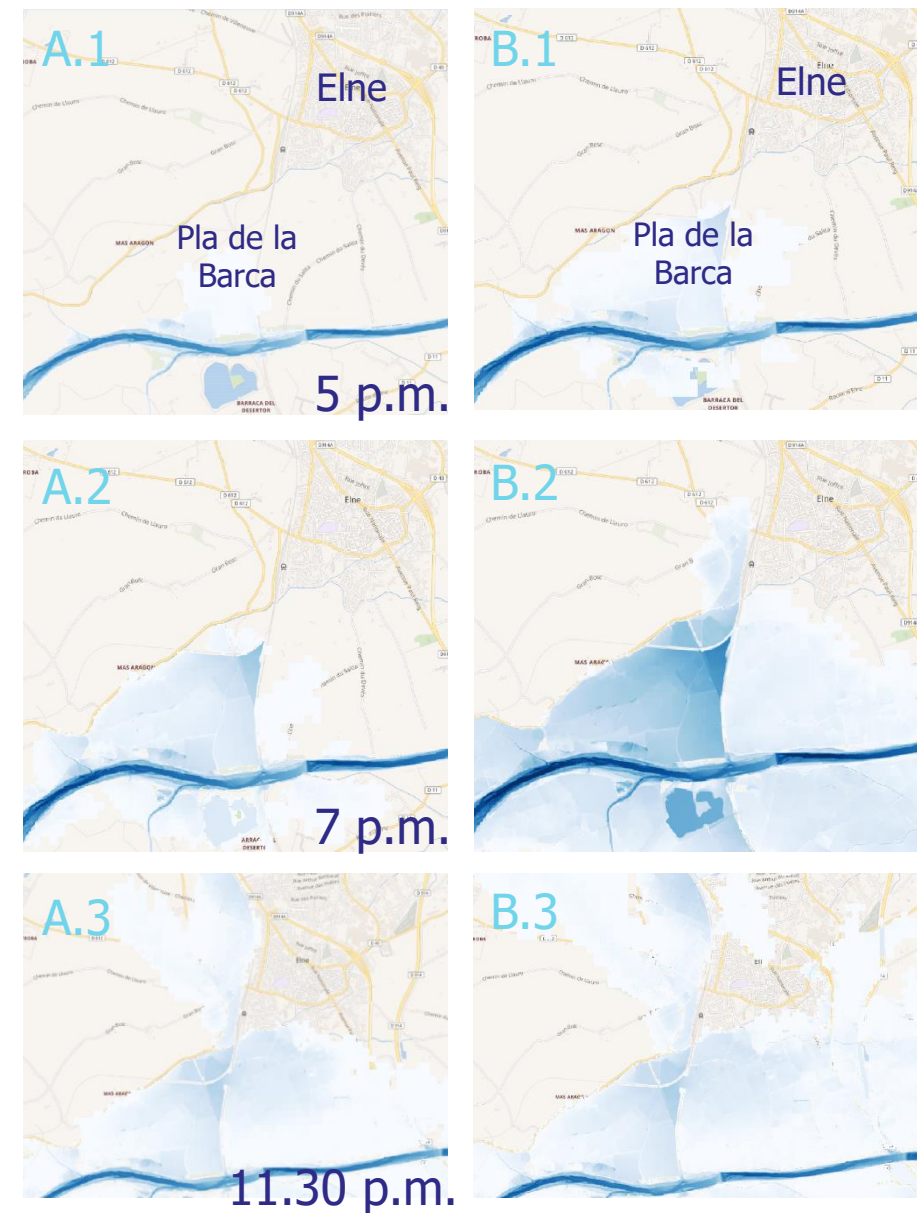
Figure 11: Comparison of the water level for the two simulations

*New estimates of flows and Manning coefficients - A
Historical estimates of flows and Manning coefficients - B*

- At 7 p.m., the water already passes over the railway line and reaches the lower districts of Elne (fig.11 B.2, contradiction with the testimonies).
- With the re-estimated hydrographs, results seem in better agreement with the testimonies:

- The Pla de la Barca is only filled from 7 p.m.
 - Beginning of the flooding in the lower districts of Elne around 11.30 p.m. (fig.11 A.3).
