Constraining Source Properties of the 1894 Istanbul Earthquake

Nesrin Yenihayat¹, Eser Çaktı², and Karin Şeşetyan³

07.05.2020

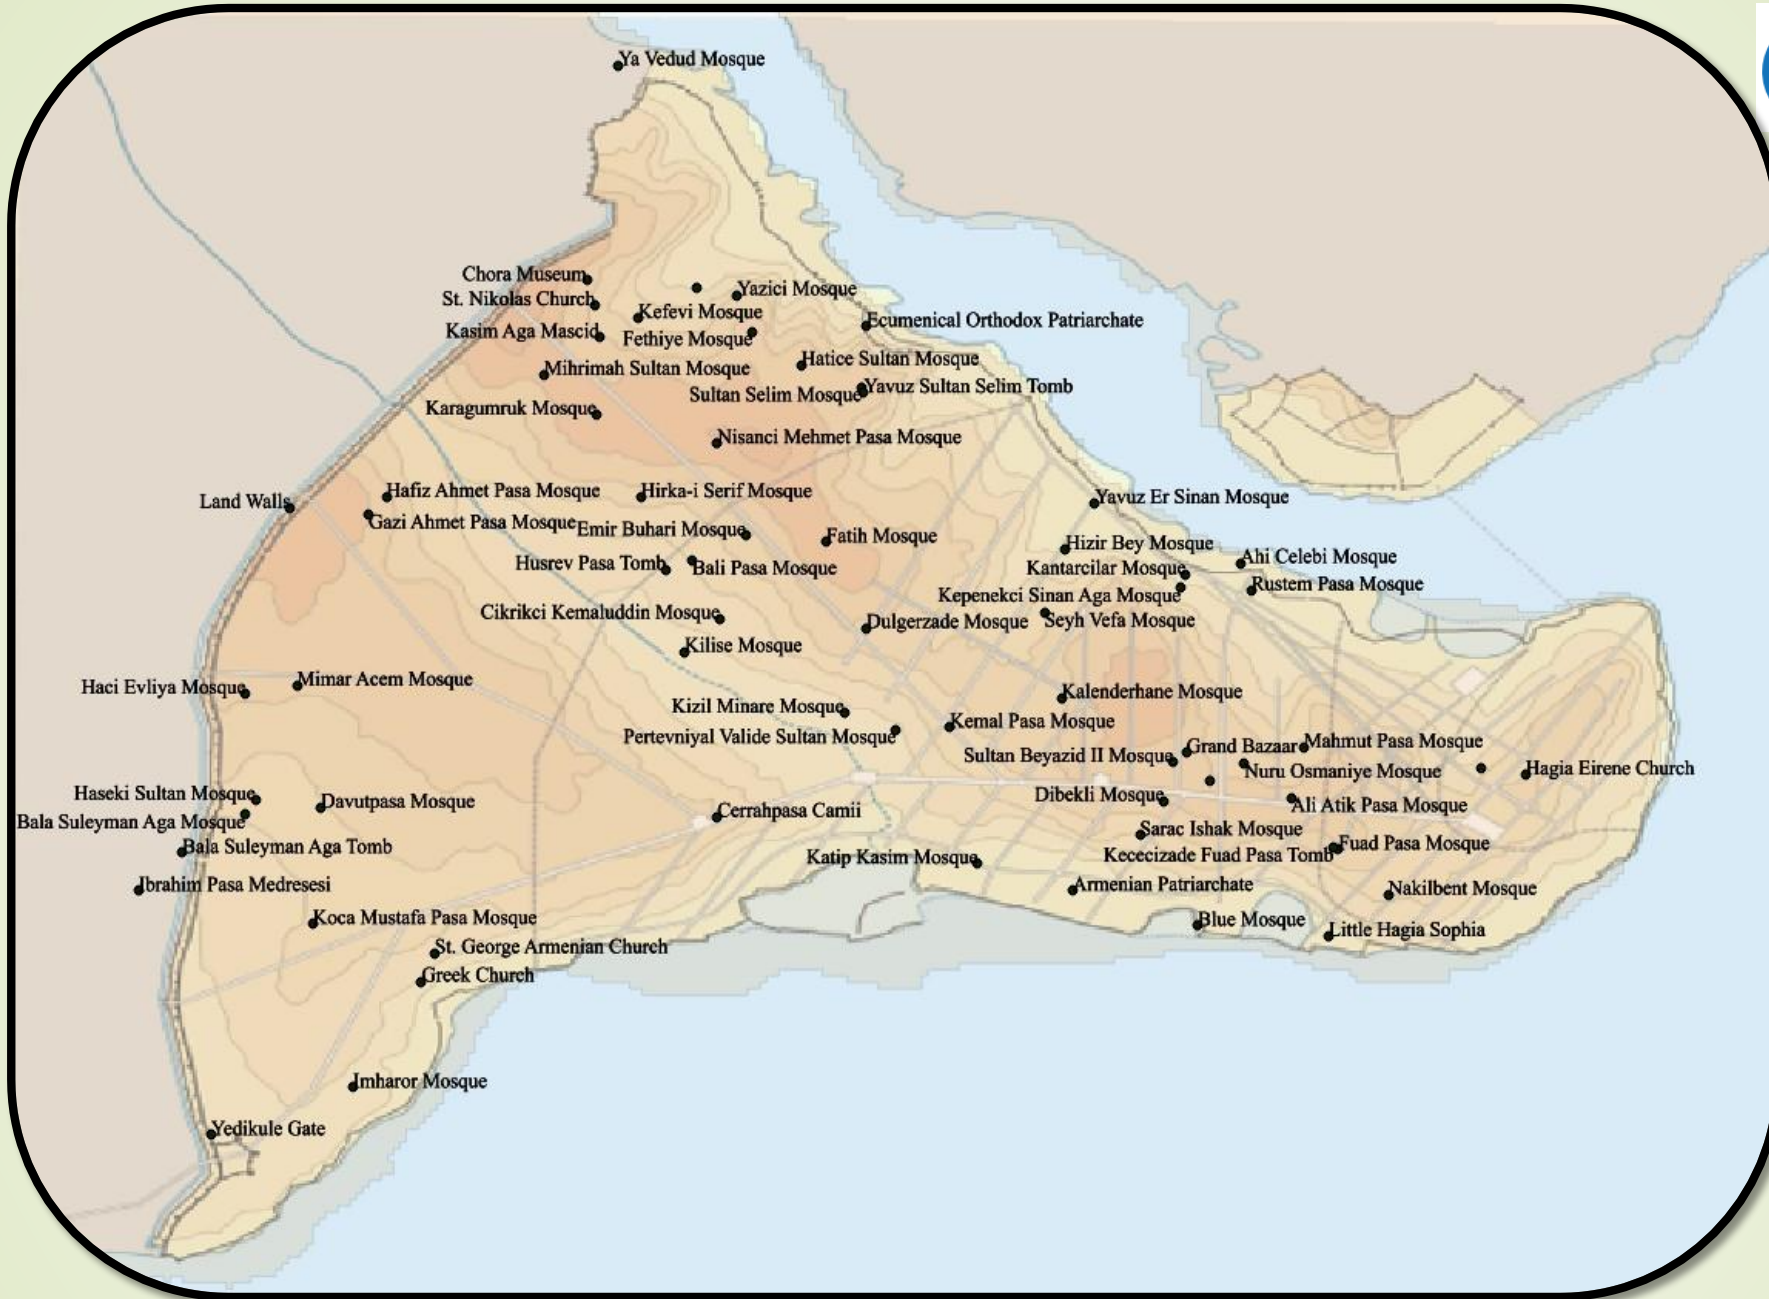
Figure 2: Damaged structures in Suriçi district after the 1894 earthquake, using the inventory given by Oztin, 1994.

The damaged structures in Suriçi district using the inventory shared by Oztin, 1994 are illustrated in Figure 2. Having the old and poorly maintained structures increased the devastation of the earthquake in Suriçi. Many monumental structures damaged. Fatih, Edirnekapı, Balat, Eminönü, Gedikpaşa, Samatya, Kumkapı, Kadırga had the worst damage. Many houses, mosques, churches collapsed. Chimneys, water gauges, minarets fell down.

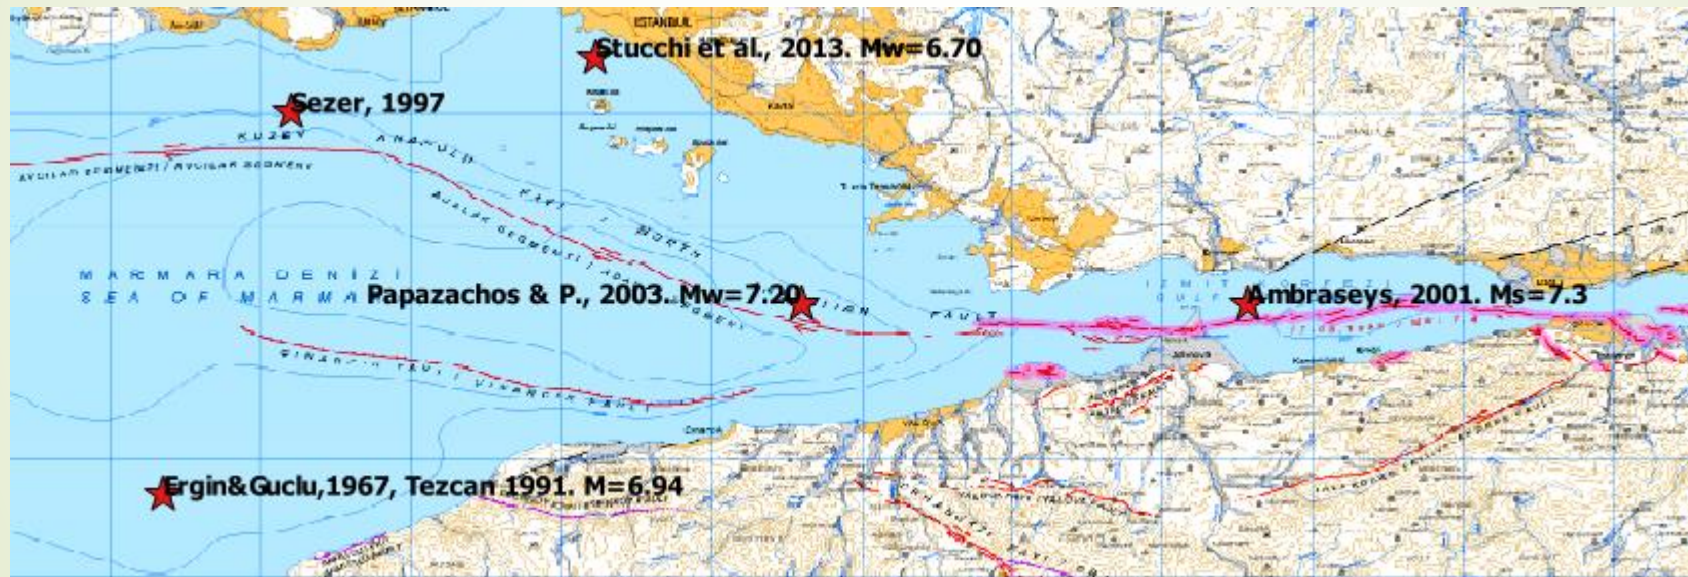
Figure 3: Red stars correspond to the epicenters of the 1894 event by different researchers.

Figure 3 illustrates epicenters assigned by different researchers to the 1894 event.

There are also discrepancies between researchers about the intensity, epicenter, magnitude, rupture length and associated fault segment of the event . Even though we have respectively more knowledge about the 1894 event, researchers have split in opinion as it can be seen in the table below and Figures 3 and 4.

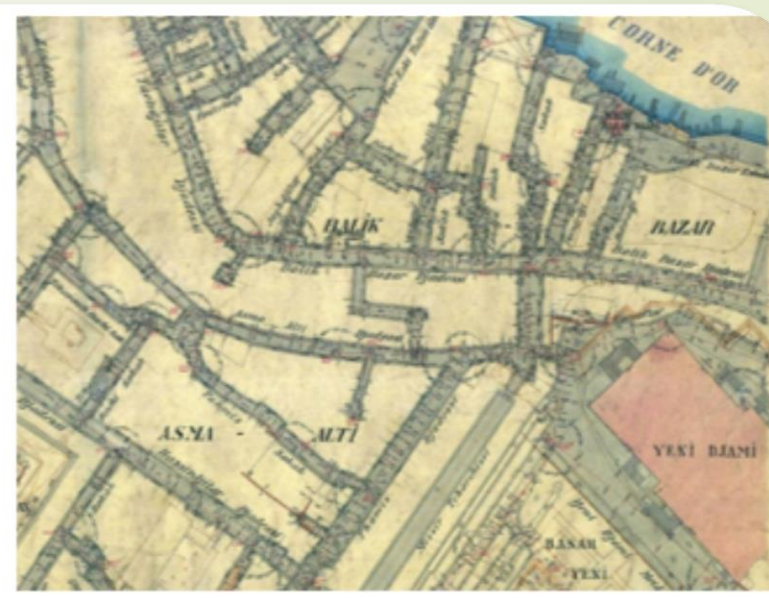
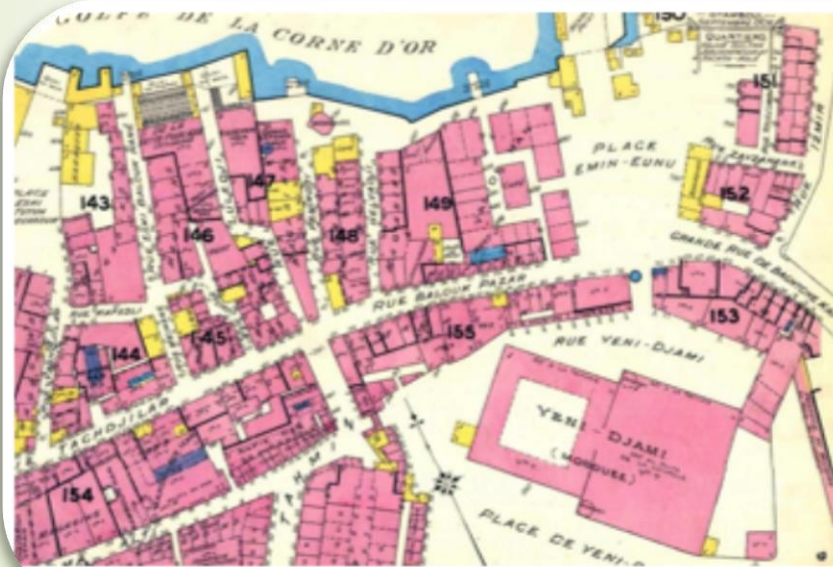
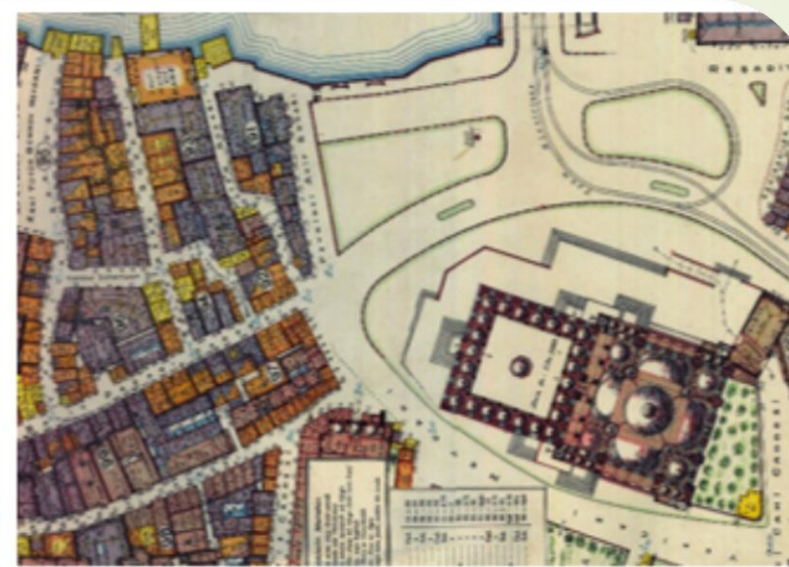
Figure 5: Examples of maps a) Ayverdi Maps, b) German Blue, c) Goad Maps, d) Pervititch Maps.

Locations of damaged buildings due to the 1894 earthquake were found using old city maps. Brief information about the maps can be found below:

Positions of the damaged buildings were mostly obtained using Map of İstanbul in 19th Century by Ekrem Hakkı Ayverdi. Ayverdi Maps in black and white represent settlements in Istanbul between 1875 and 1882 (Ayverdi, 1958).

As the first fire insurance map for the city of Istanbul, Goad maps clearly show footprints, heights, usages and locations for each building with their roof and construction materials between 1904 and 1906. Construction materials were presented using different colors as red for brick or stone buildings and yellow for wooden buildings.

The German Blues were prepared for the purpose of city planning between 1913 and 1914. German Blues mostly focused on the public and monumental structures of Istanbul, dwelling houses were excluded.

As another precious fire insurance map in extended time period between 1922-1945, Pervititch Maps include name, street number, material type of the construction and its roof, height, number of floors, and some other detailed information about the buildings. In Pervititch Maps, construction material types of buildings were represented using different colors as pink for masonry and yellow for wooden. By looking the sheets, it is clearly seen that pink colors are concentrated in city center, and yellow marked buildings are getting denser in exurban areas.

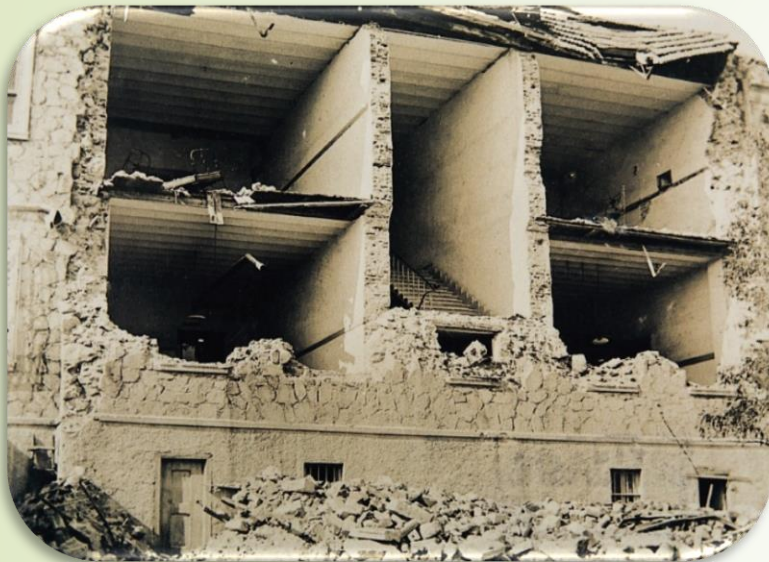
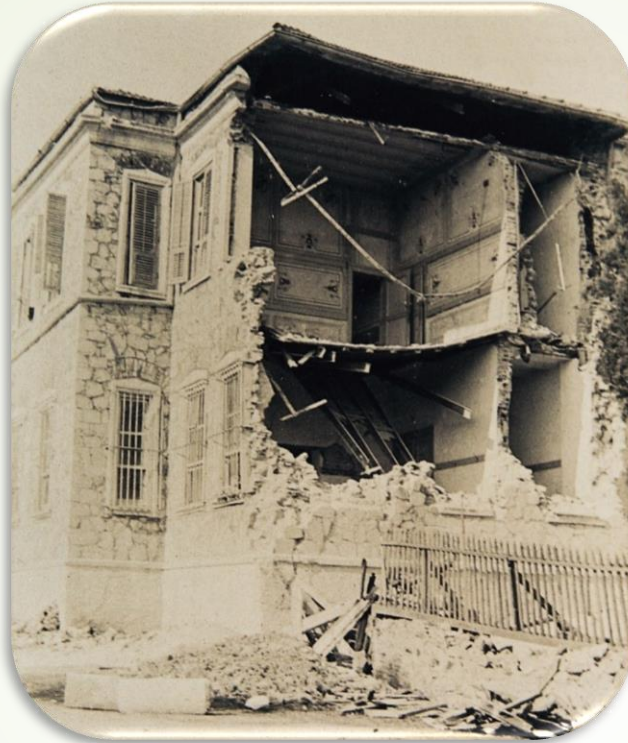
Figure 6: Damage Level of Ecole de Theologie, Heybeliada, different views.

Heybeliada, Ecole de Theologie

Damage Definition: dislodged and uninhabitable

Damage Level: **D4**

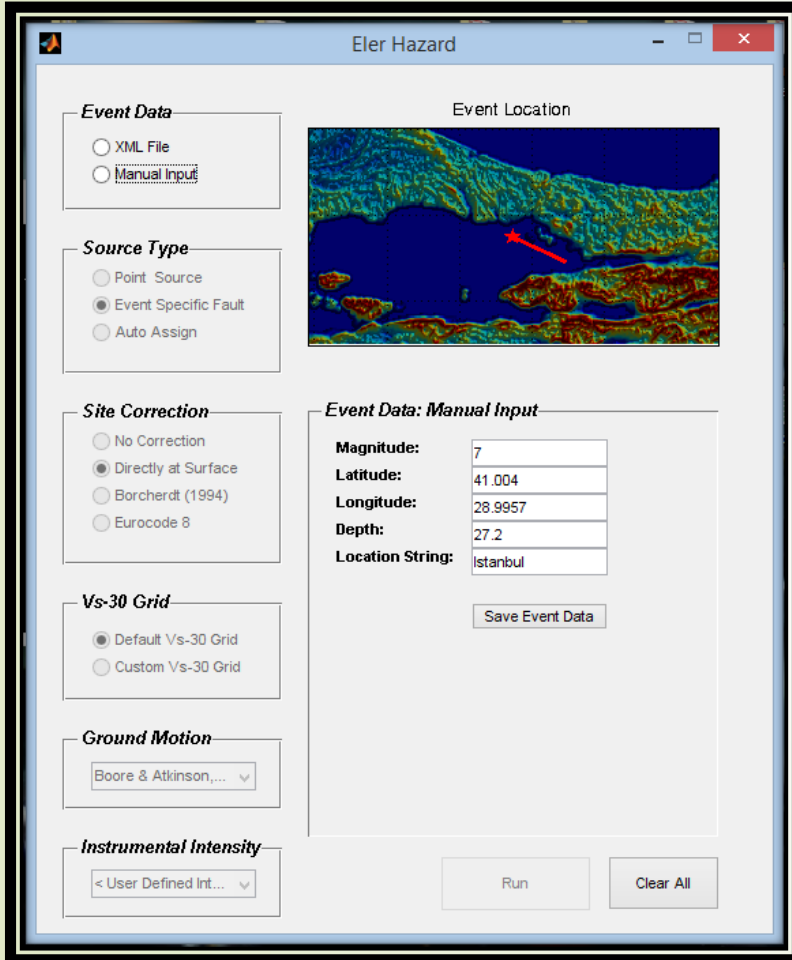
Figure 15: Earthquake modelling in ELER (Earthquake Loss Assessment Routine)

The screenshot shows the 'Eler Hazard' software interface. It features several input sections on the left and a central map area labeled 'Event Location'. The map displays a coastal region with a red star indicating the event location. The input sections include:

- Event Data:** Radio buttons for 'XML File' and 'Manual Input'.
- Source Type:** Radio buttons for 'Point Source', 'Event Specific Fault' (selected), and 'Auto Assign'.
- Site Correction:** Radio buttons for 'No Correction', 'Directly at Surface' (selected), 'Borcherdt (1994)', and 'Eurocode 8'.
- Vs-30 Grid:** Radio buttons for 'Default Vs-30 Grid' (selected) and 'Custom Vs-30 Grid'.
- Ground Motion:** A dropdown menu showing 'Boore & Atkinson, ...'.
- Instrumental Intensity:** A dropdown menu showing '< User Defined Int...'

- Magnitude:** 7
- Latitude:** 41.004
- Longitude:** 28.9957
- Depth:** 27.2
- Location String:** Istanbul

Scenario-1		Scenario-2	Scenario-3
Lat., Long.	40.871, 28.870		40.785, 29.046	40.725, 29.228
Magnitude	a) 7.3	b) 7.1	6.8	6.7
Depth(km)	a) 12-14	b) 10-20	10-18	8-20
Vs30	USGS		USGS	USGS
GMPE	Boore Atkinson 2008, Strike Slip		Boore Atkinson 2008, Strike Slip	Boore Atkinson 2008, Strike Slip
MMI	Bilal&Askan, 2014		Bilal&Askan, 2014	Bilal&Askan, 2014

Using ELER v.3 tool, several scenarios have been modeled having different input parameters.
