Land degradation and soil conservation in the Barlad Plateau, Romania: a case study from Racova catchment

**“Al. I. Cuza” University of Iasi, Faculty of Geography and Geology,
Horia Hulubei National Institute for Physics and Nuclear Engineering,
Life and Environmental Physics**

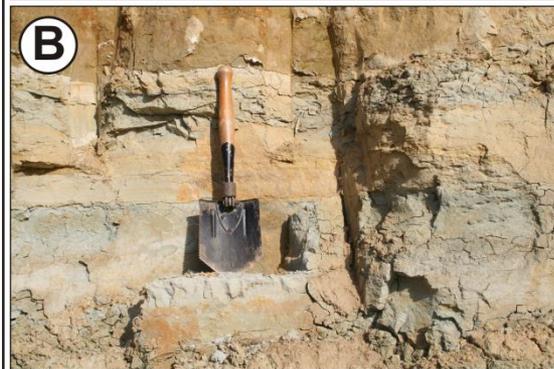
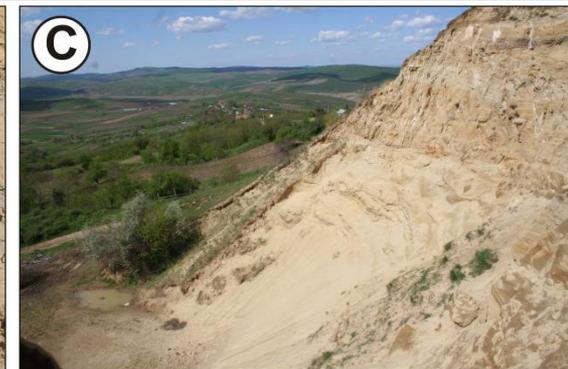
Geology of the study area

Late Miocene

(Sarmatian and Maeotian) layers have outcropped due to erosion

- clayey-sandy and sandy-clayey formations, almost exclusively deposited in deltaic facies

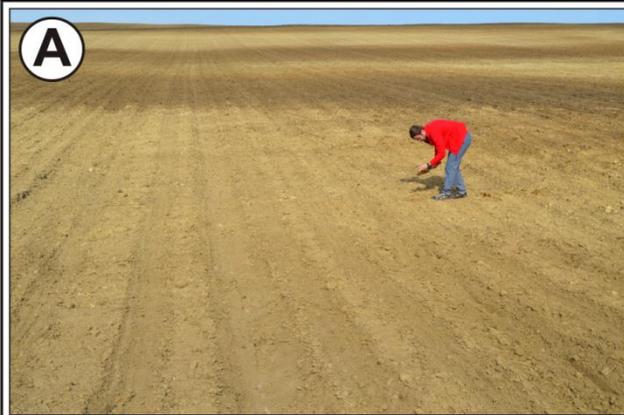
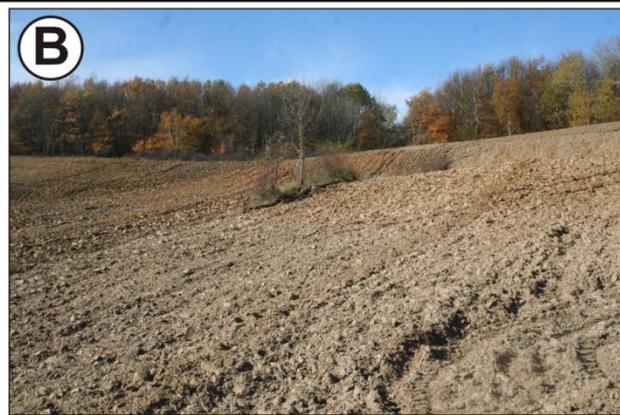
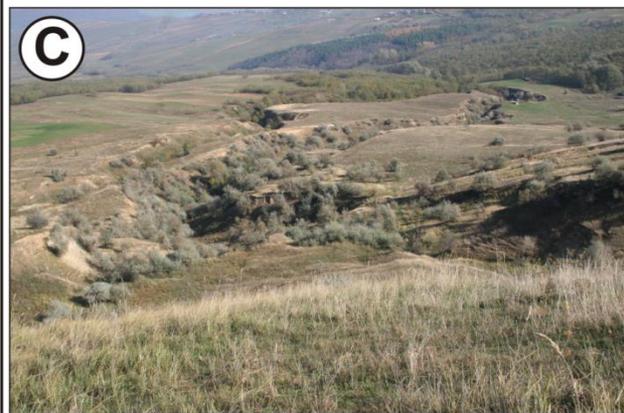
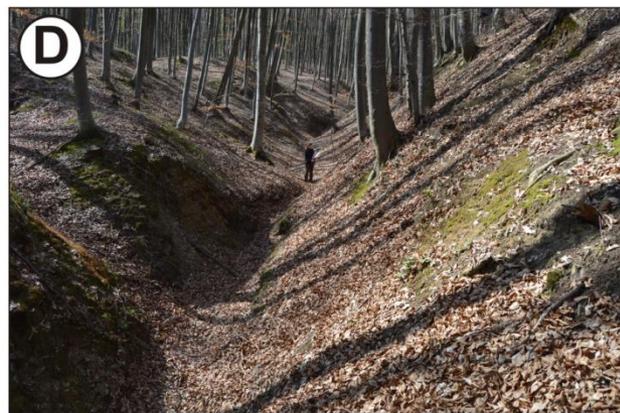
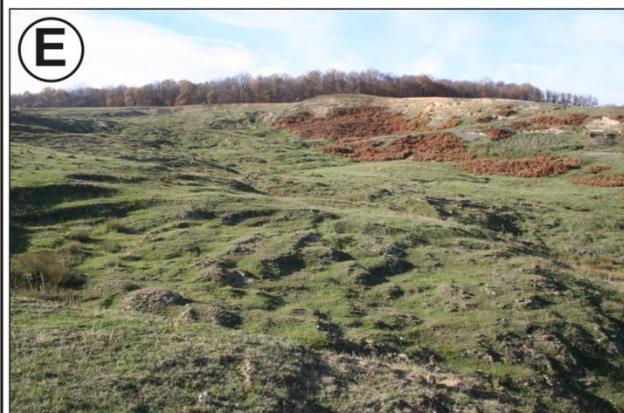
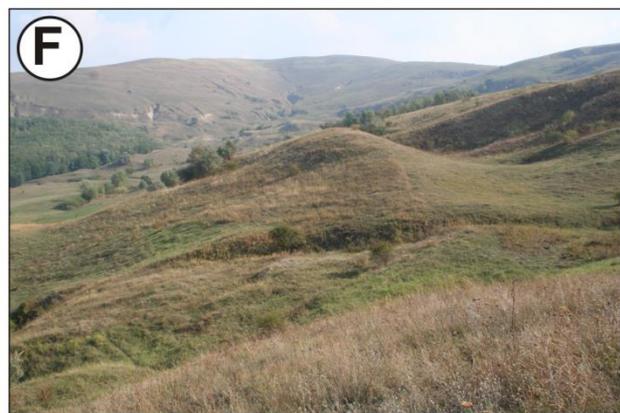
Consequence: Land degradation

Land degradation –
major cause of environmental
degradation !

Highly susceptible to

- soil erosion,
- gullying and
- landslides,
- sedimentation

- damages the local landscape
- depleting soil resources,
- decreasing agricultural productivity

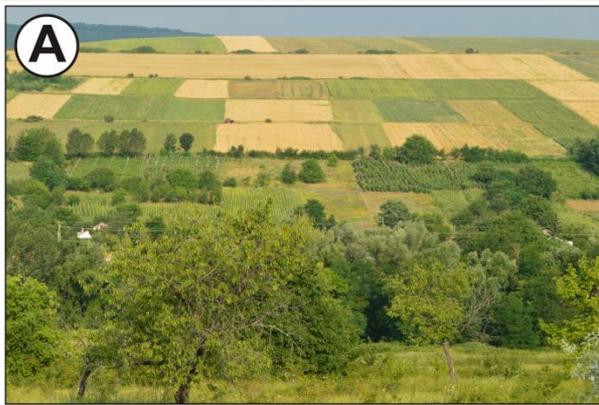
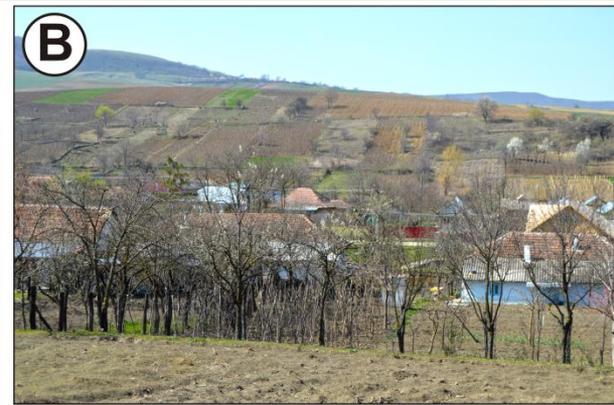
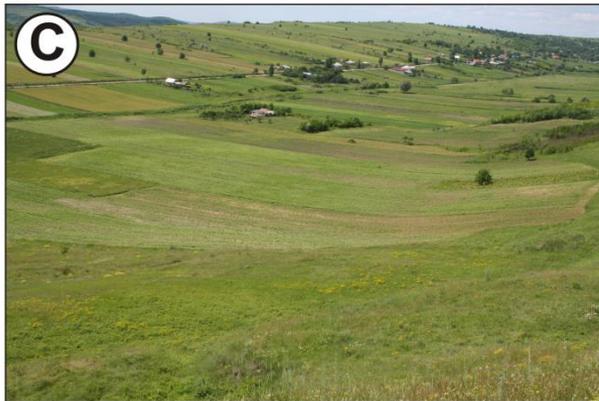
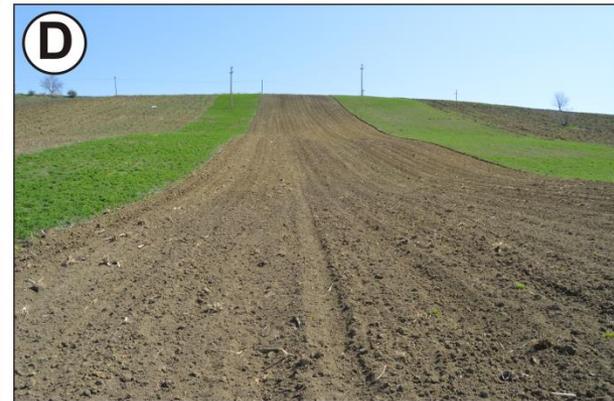
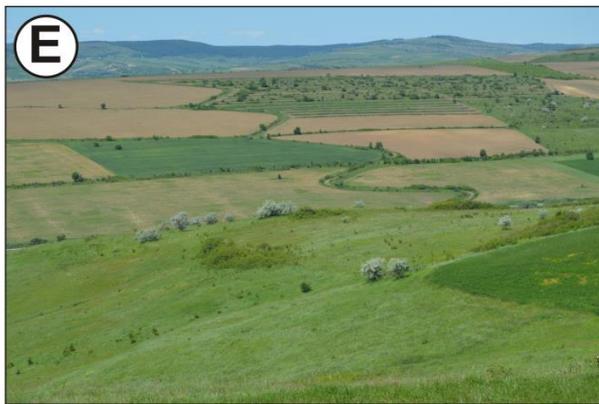
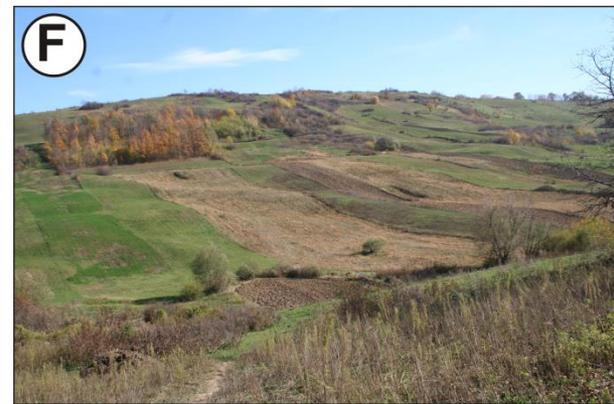
soil conservation measures

Between 1970-1989 much soil conservation work was accomplished, especially by IEELIF Vaslui

- design and construction of **dams and reservoirs**: Puscasi (1973, 257 ha NRL), Trohan (1982, 21 ha at NRL), Pungesti-Garcei (1976, 61 ha at NRL).
- design and construction of **check-dams** to control gully erosion in the tributaries
- design and implementing **soil conservation practises** on slopes in large farms (strip-cropping, buffer strip cropping and especially bench terraces).
- design and building **drainage systems**.
- filling small gullies, **land reshaping** using topsoil and **improving pastures**.
- large-scale **afforestation** on 1,704 ha on landslides and gullies

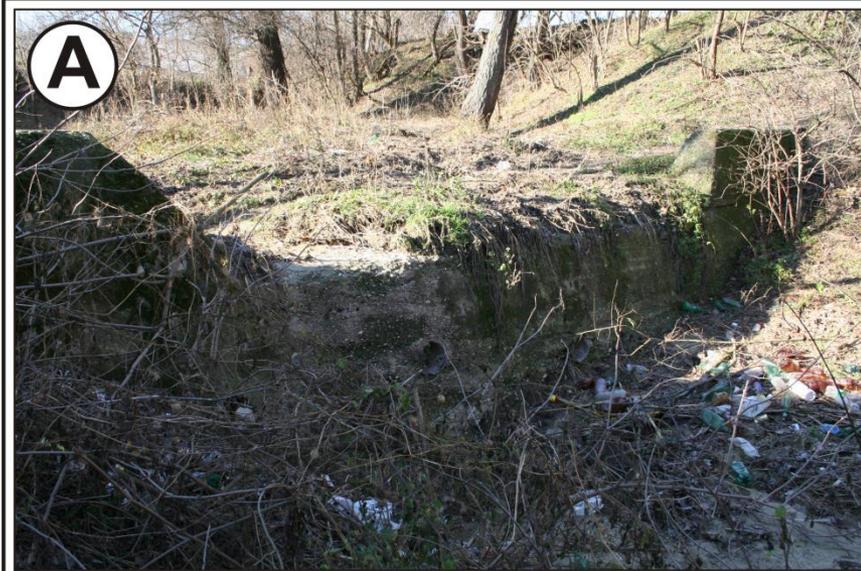
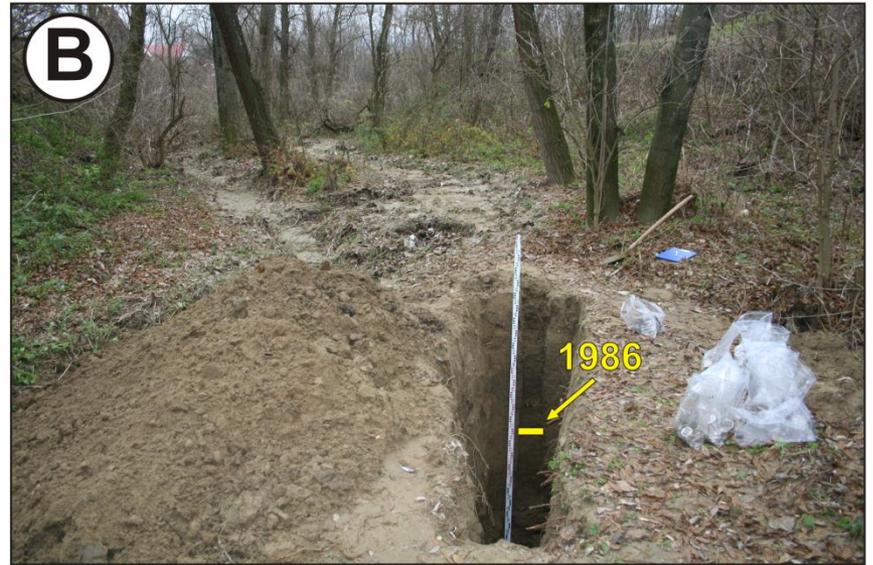
Balica gully

Influence of conservation measures on sedimentation rates:

5.2 cm y⁻¹ (1974-2016)

3.8 cm y⁻¹ (1986 - 2016)
