EGU2020

Vegetation restoration technology for Pisha Sandstone Area

Peiqing Xiao, Wenyi Yao, Pan Zhang

Yellow River Institute of Hydraulic Research

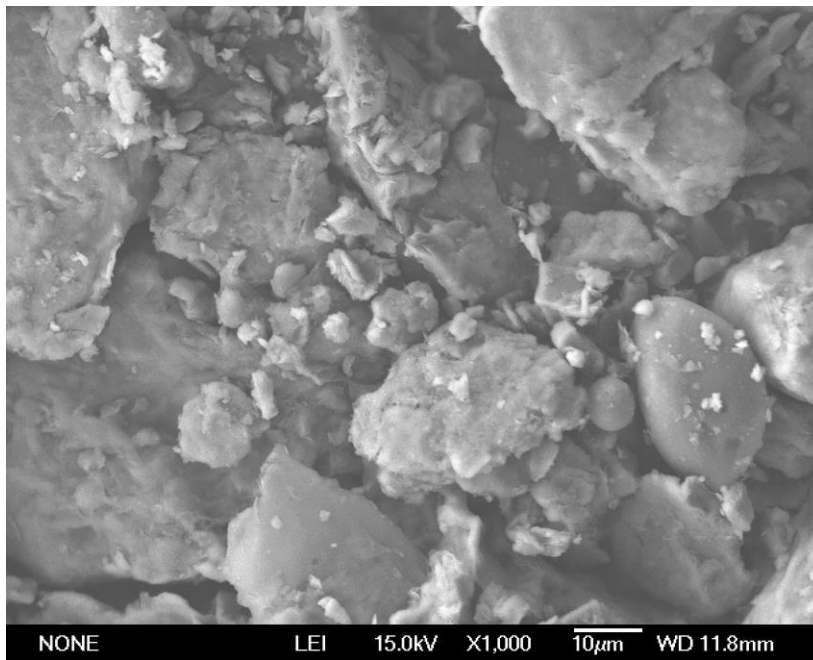
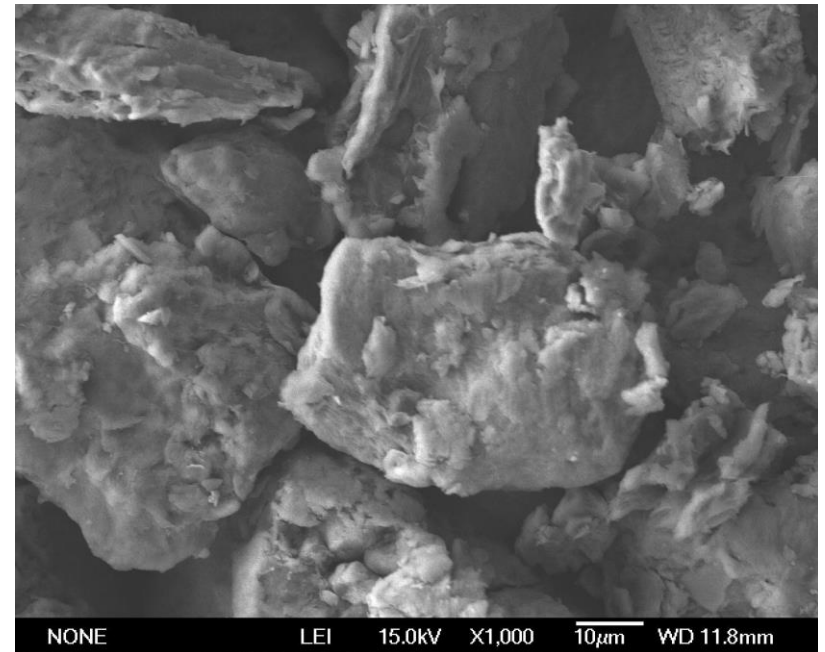
- Sediment particles are coarse, more than 80% of particles larger than 0.05mm.
- Obvious boundaries, few bonding substances and most of them are carbonates and clays.
- Porous cementation, strong friction and meshing force without water.

SEM images in 1000 times magnification

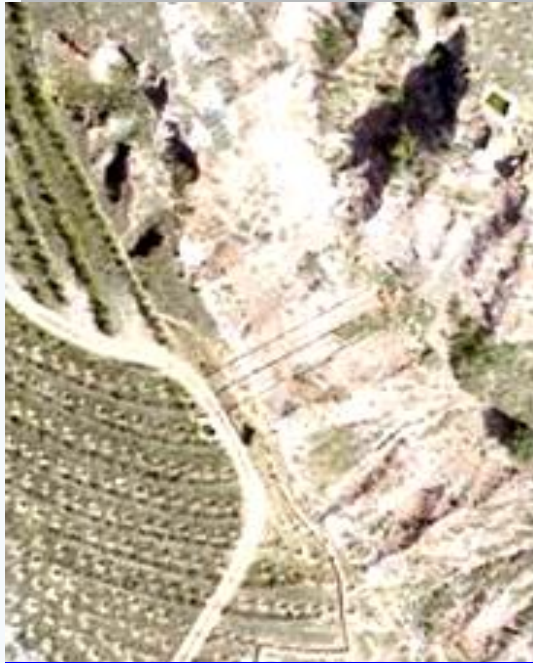
**Before governance
in 2013**

The vegetation coverage increased from 25% to more than 75% after extensive promotion.

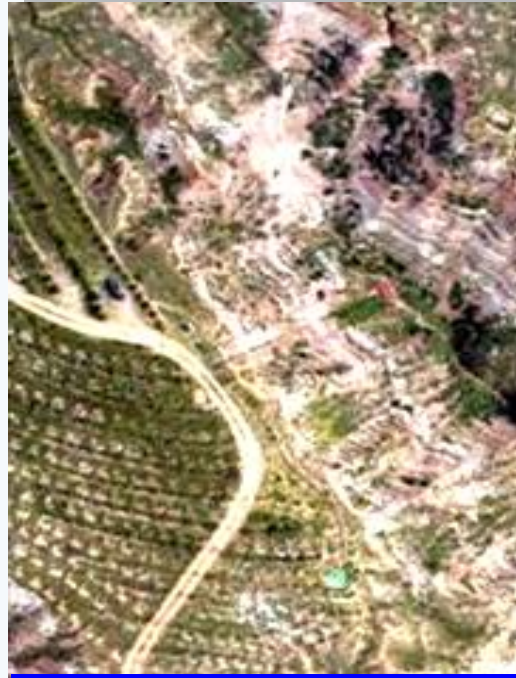
**After governance
in 2016**

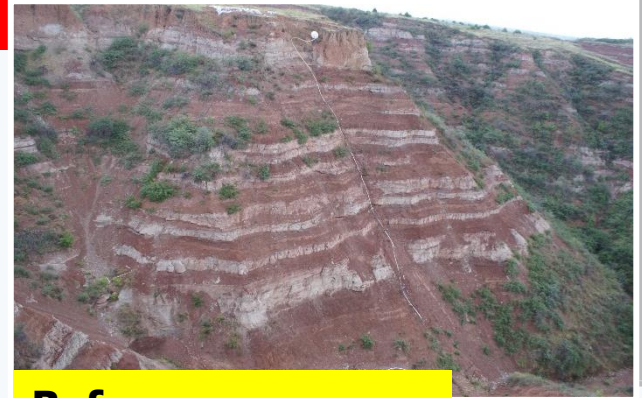
Before governance

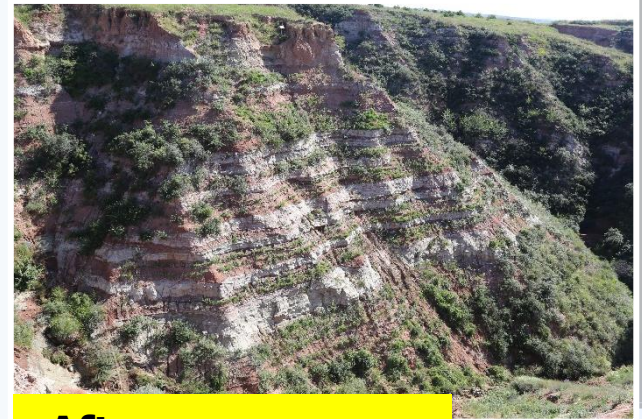
After governance
