Rockfall Alarm System with Automatic Road Closure for major European North-South Route

Lorenz Meier, Susanne Wahlen, Gian Darms
GEOPREVENT AG – Zurich, Switzerland

Overview of installed early warning system

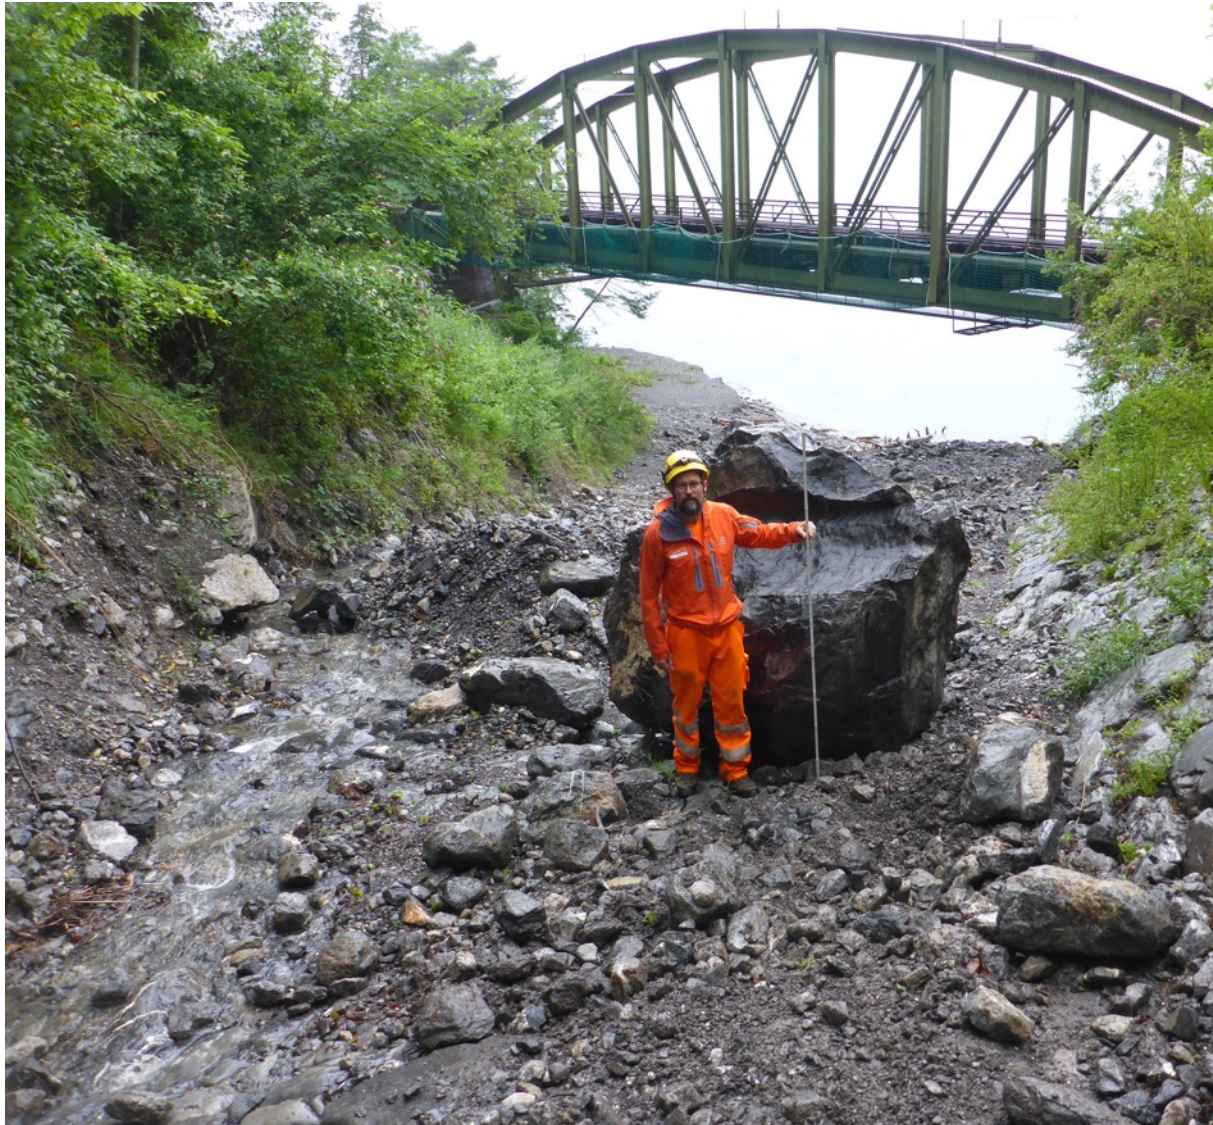
- Axenstrasse = major North-South connection through Swiss Alps
- 16'000 vehicles/day
- Juli 18, 2019: heavy rainfall triggered rockfall in Gumpisch valley above road
- 12-ton boulder crossed road and stopped below
- Large debris accumulations still present from recent rockfall event upvalley
- Road operator closed route for safety reasons
- Design & development of early warning system in only few weeks

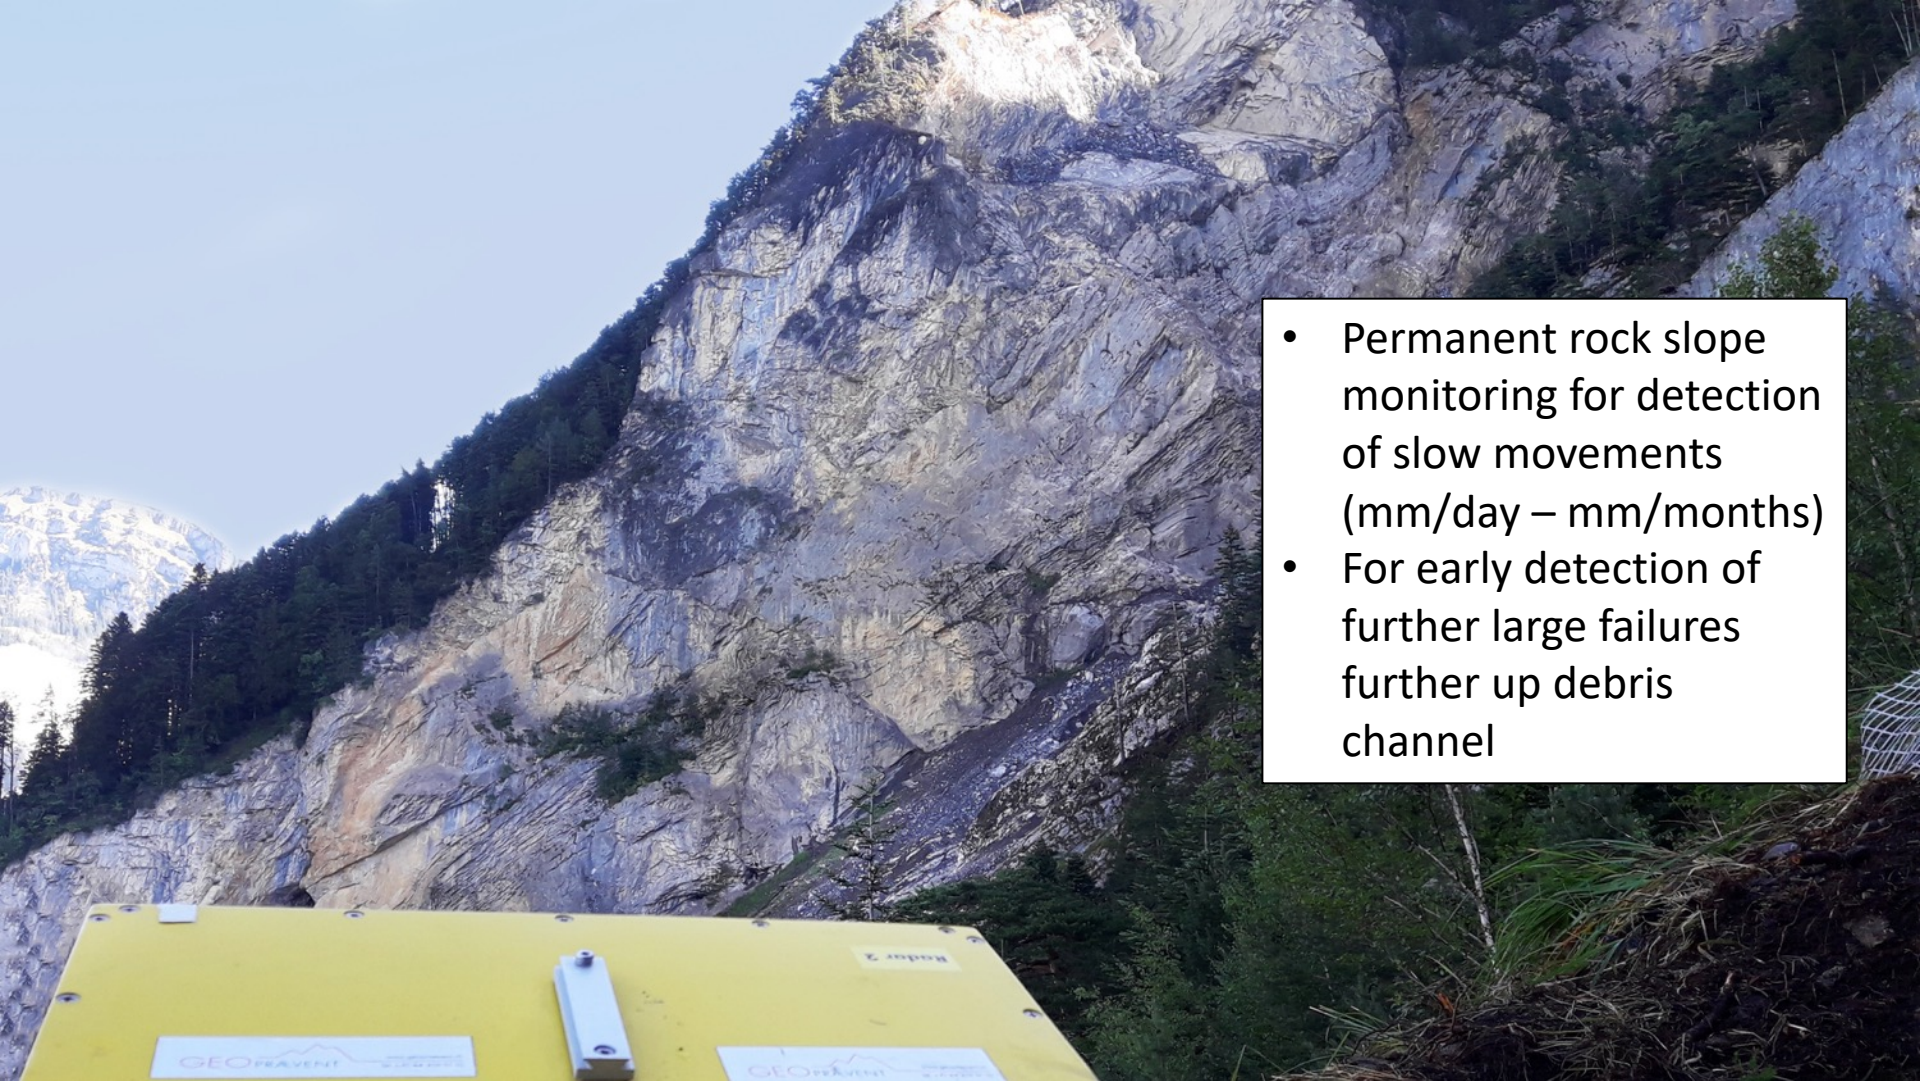
- Permanent rock slope monitoring for detection of slow movements (mm/day – mm/months)
- For early detection of further large failures further up debris channel

- interferometric radar with autonomous power supply (fuel cell and solar panels)
- Connected with online data portal

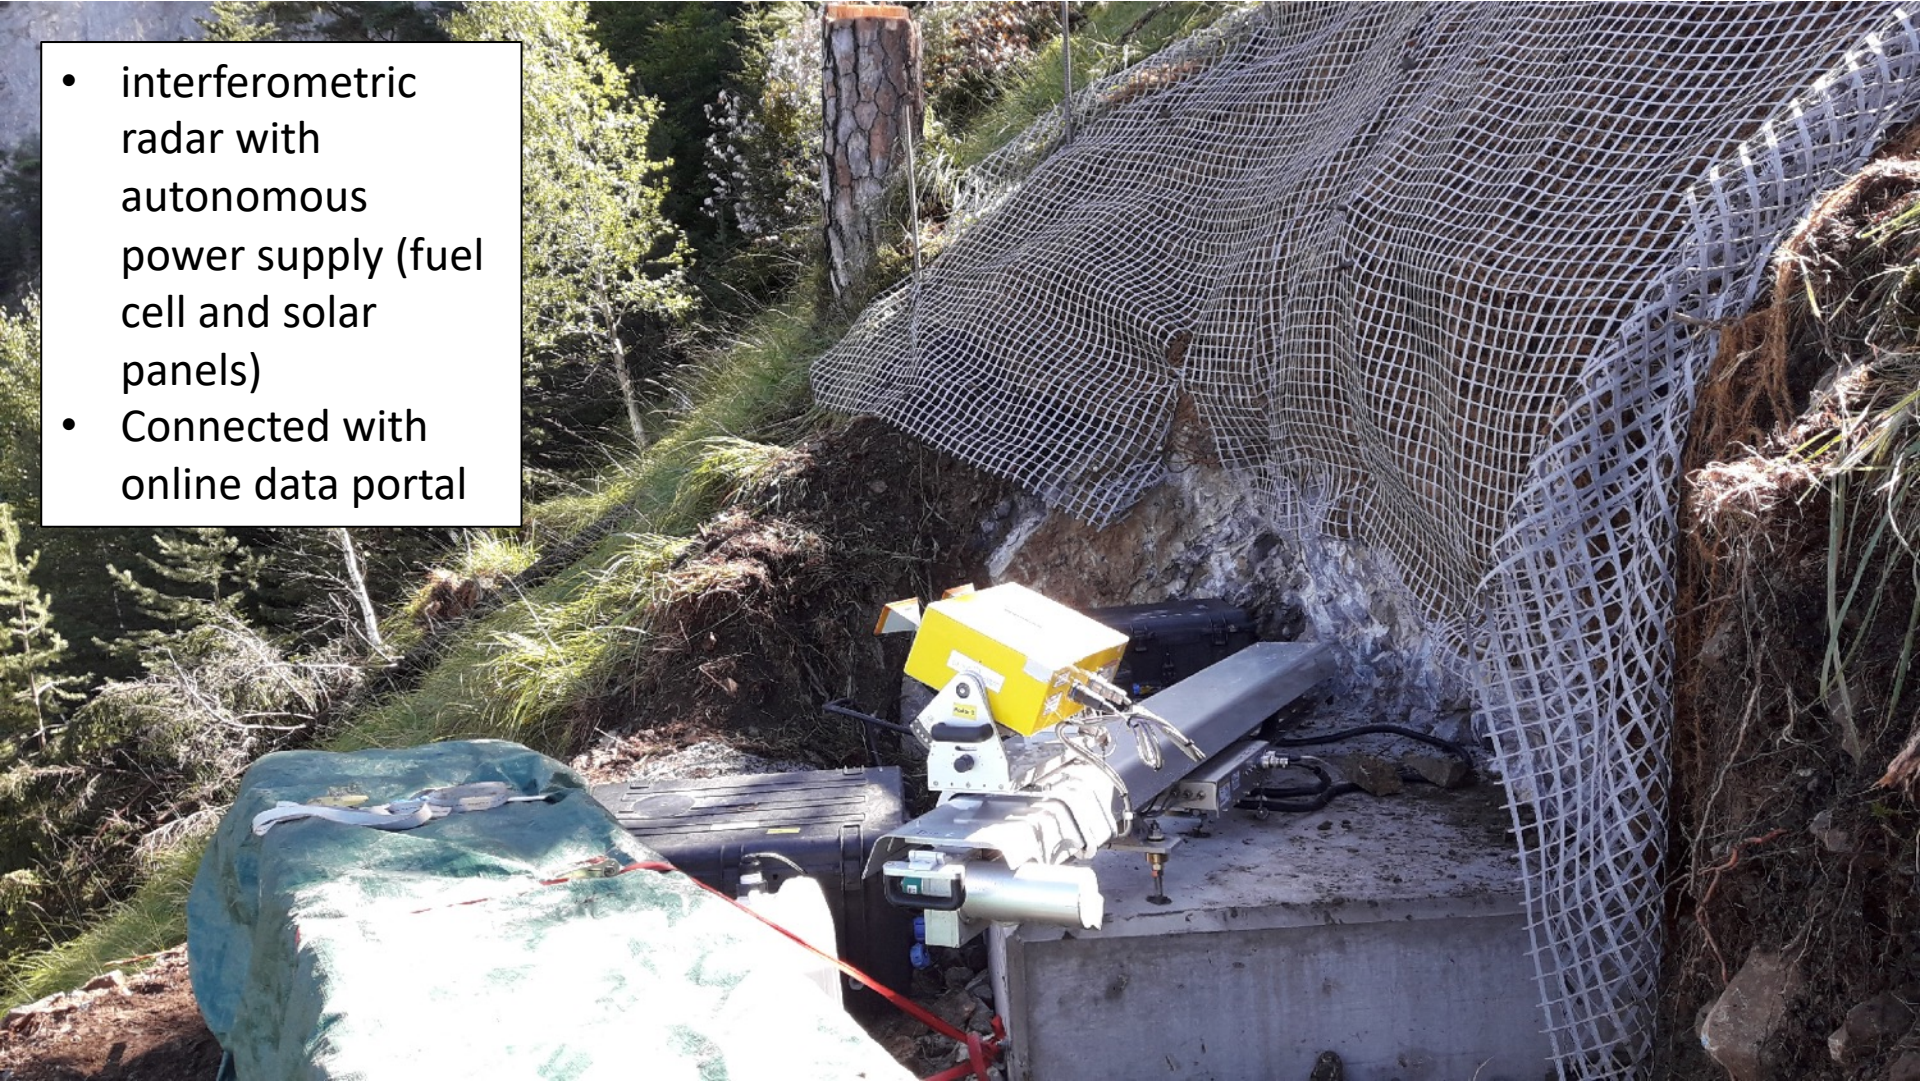
Deformations in mm after 10 days

Deformation mm 9.8 days between 19.09. 03:22->20.09.19 01:20 and 28.09. 20:31-29.09.19 05:31 (res<0.28/nGood=100)

- Proprietary algorithms for analysis of very slow movements (mm over several days/months)
- Standard algorithm for mm/day

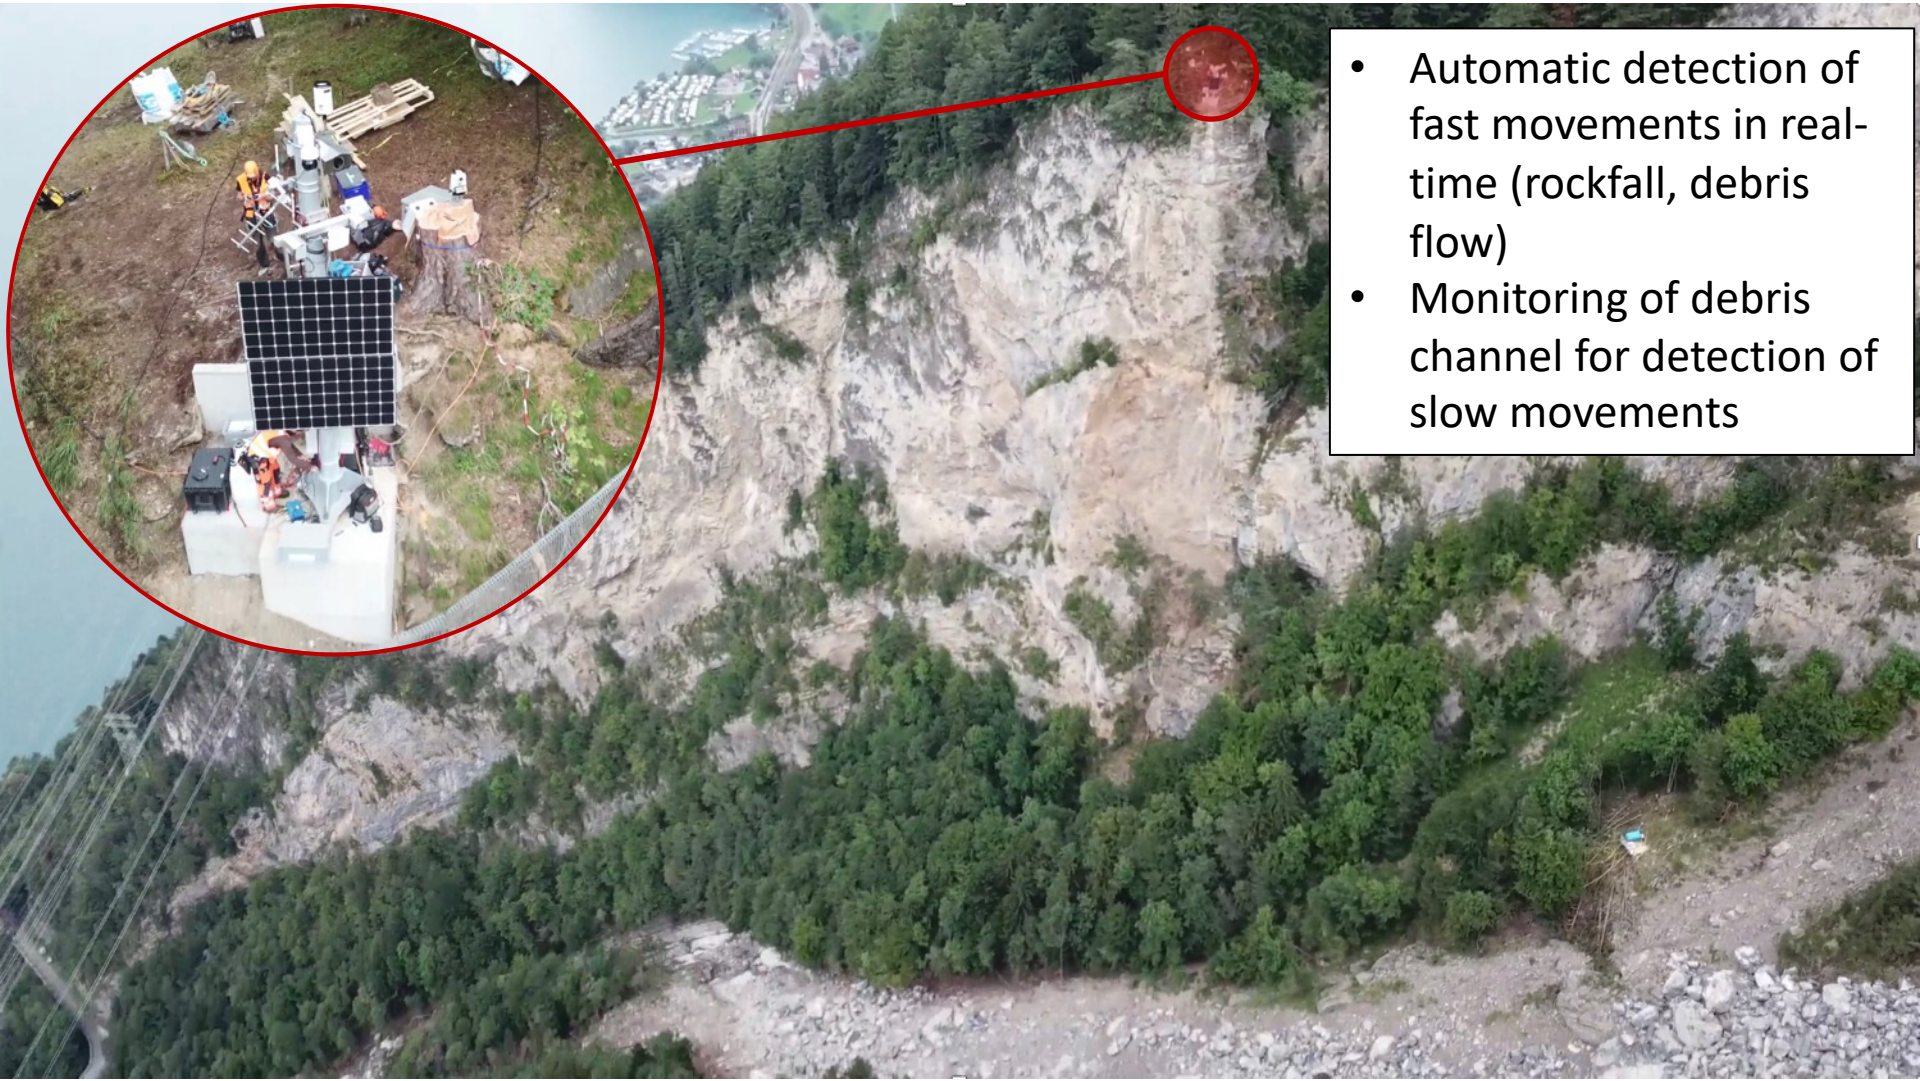
- Automatic detection of fast movements in real-time (rockfall, debris flow)
- Monitoring of debris channel for detection of slow movements

- Technology combination for maximum detection reliability:
 - 2 Doppler radars
 - 3 high-sensitivity seismic sensors
- Both in real-time
- In any weather (fog, rain, snowfall)

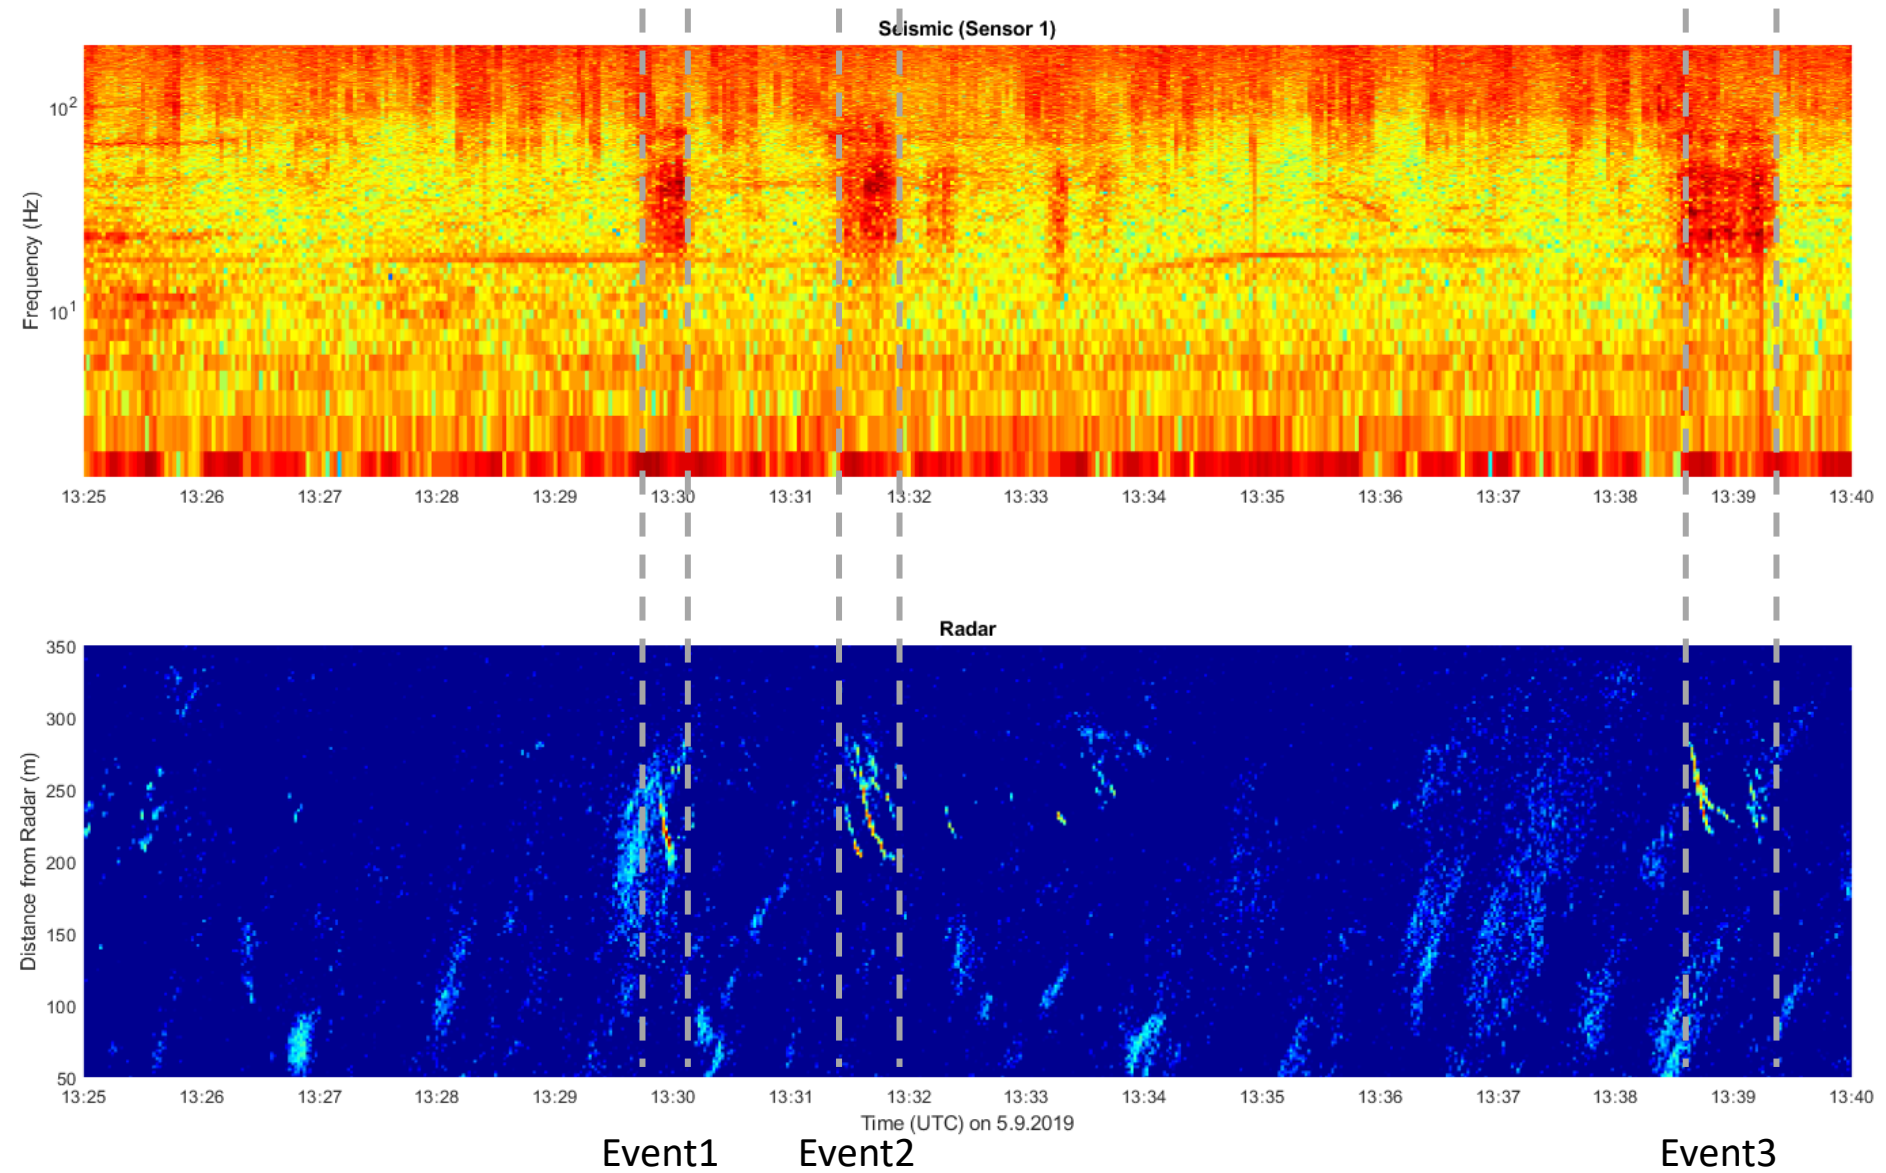
Examples: 5. September 2019

- Upper radar detected movement and triggers alarm at road
- Radar activates camera upon detection of rockfall
- Creation of automatic event image series

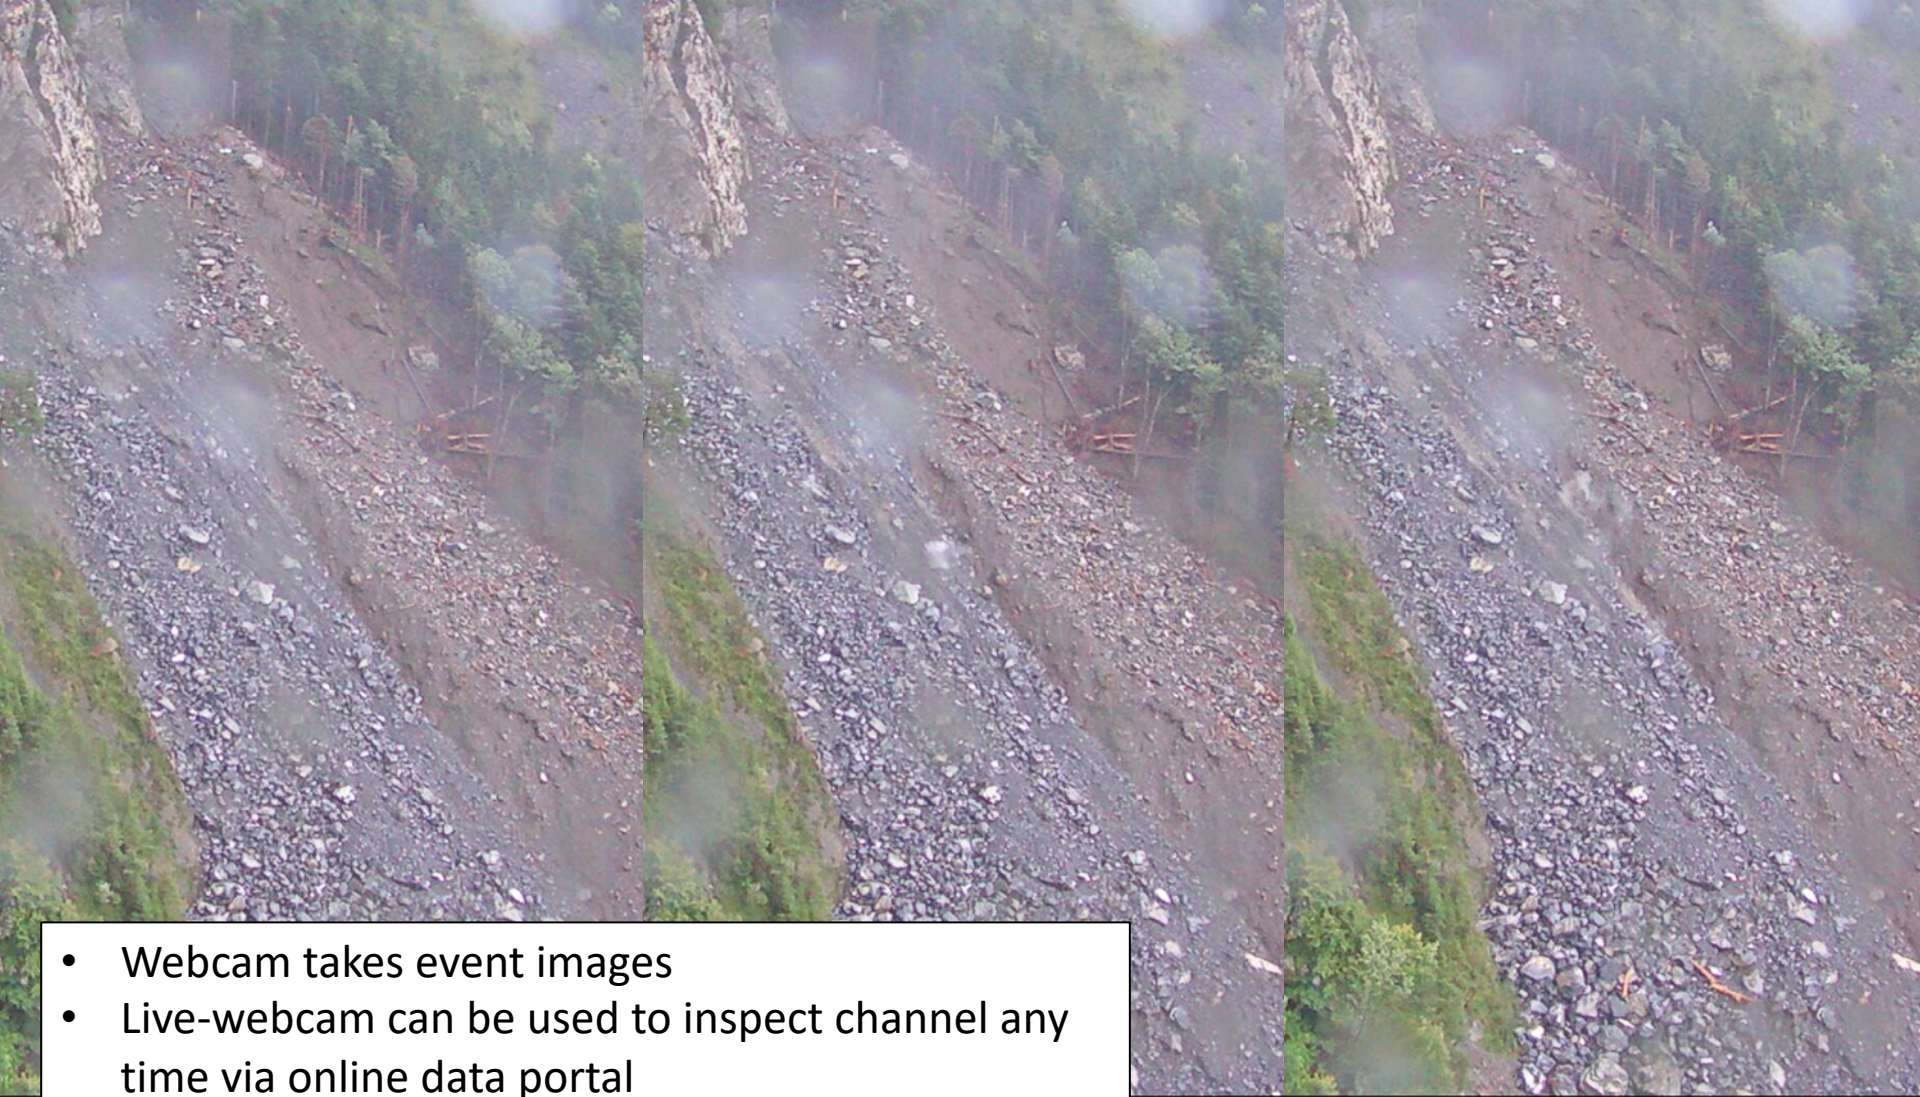
- Webcam takes event images
- Live-webcam can be used to inspect channel any time via online data portal
- Pan-tilt-zoom functionality

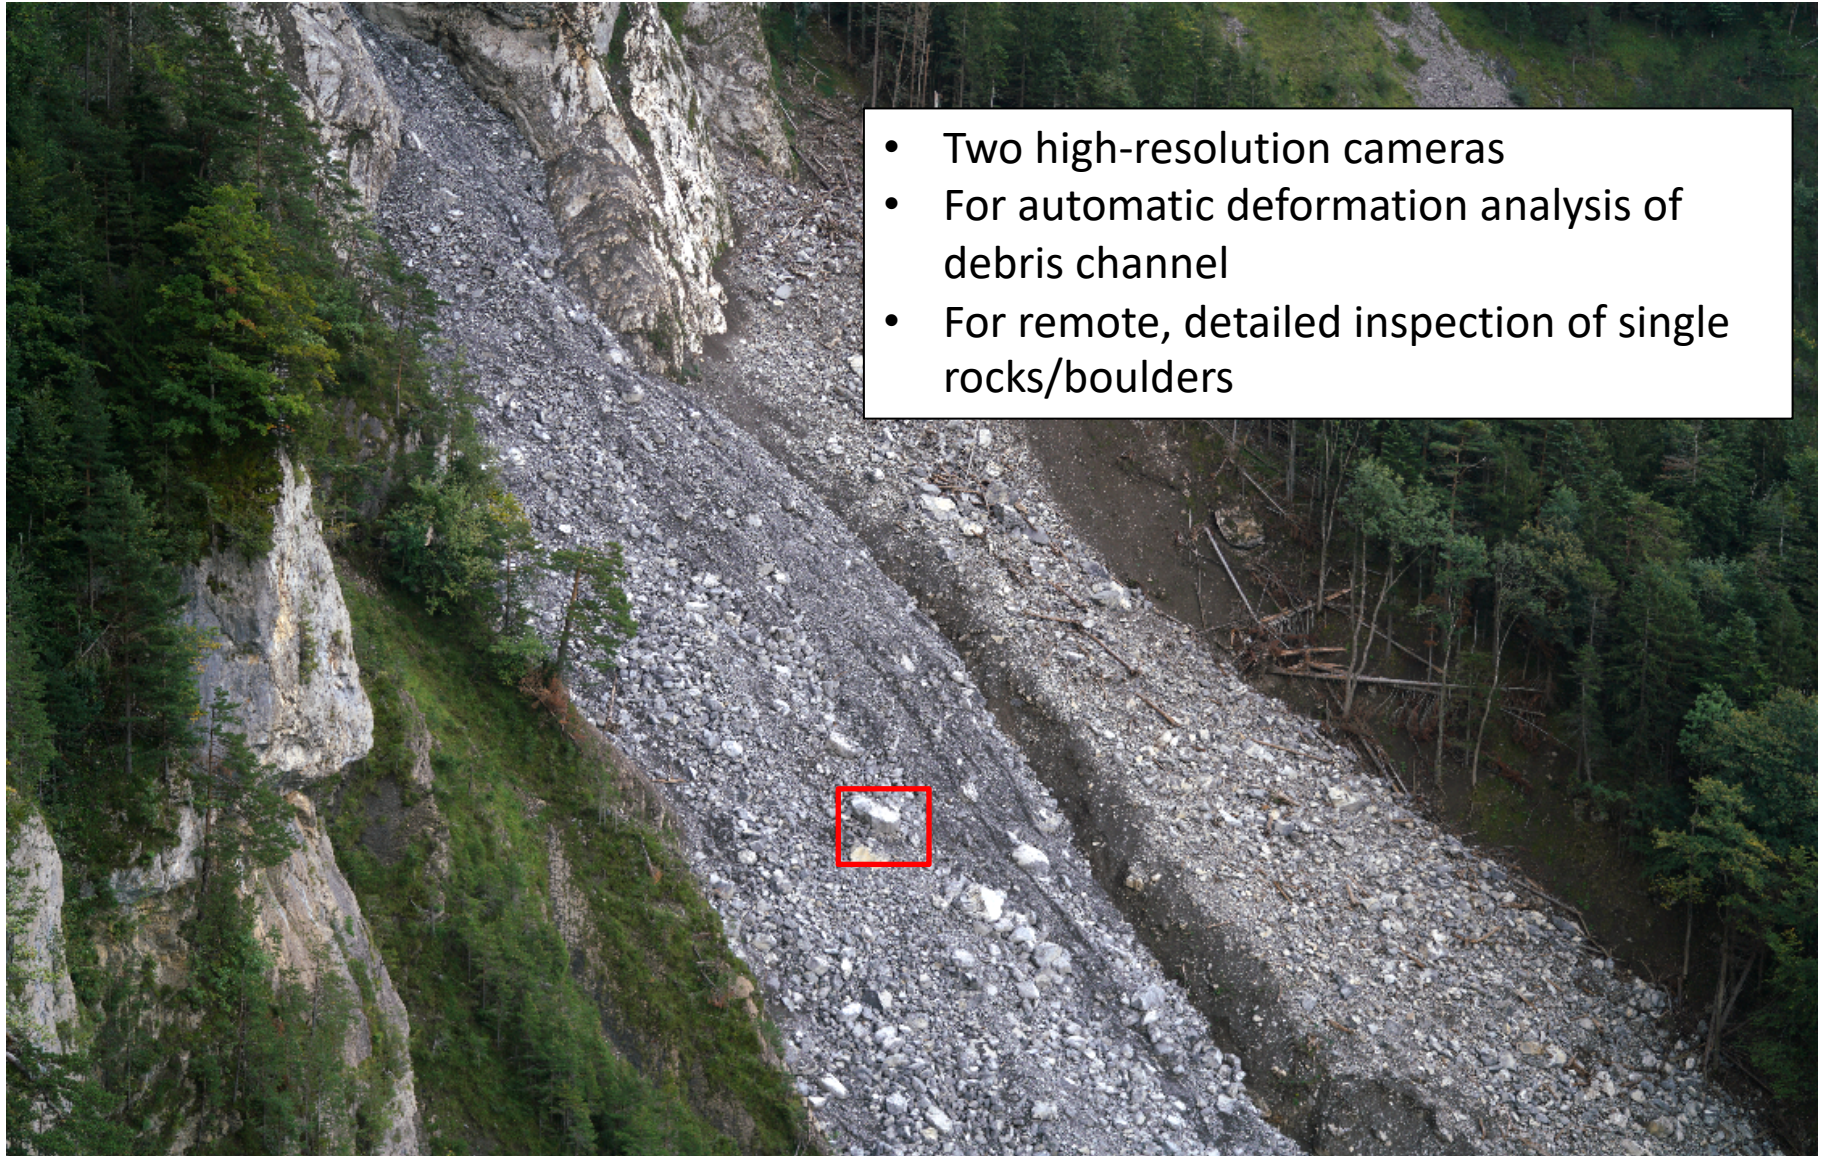
- Two high-resolution cameras
- For automatic deformation analysis of debris channel
- For remote, detailed inspection of single rocks/boulders

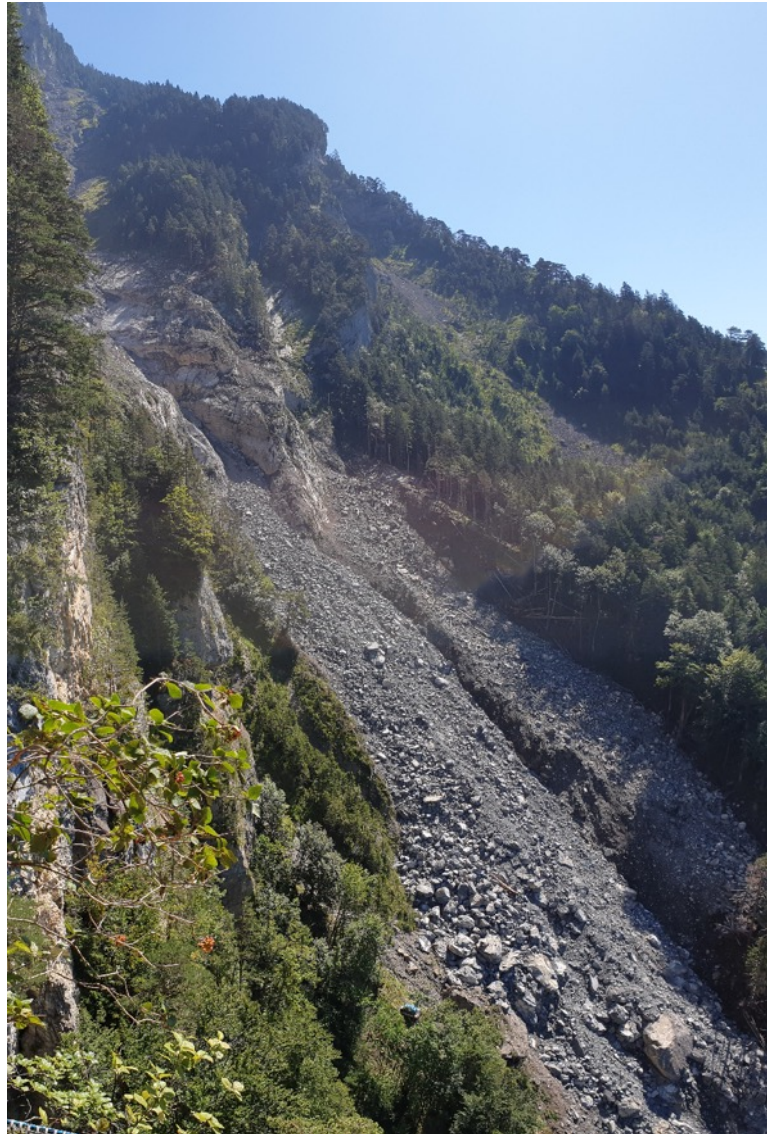
- View of debris channel
- Short warning time of 20-30 s → immediate road closure required
- But many events remain small and do not reach road?
- How to avoid unnecessary closures?

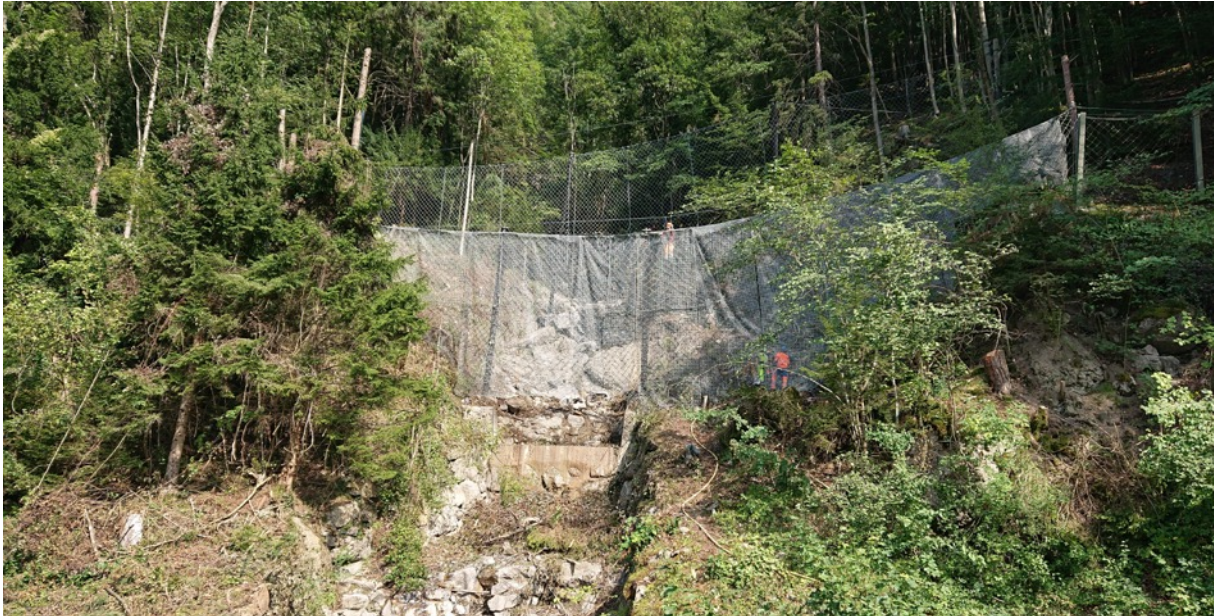
- Installation of combination sensors in protection barriers above road
- Automatic detection of impact by boulder or debris flow passage

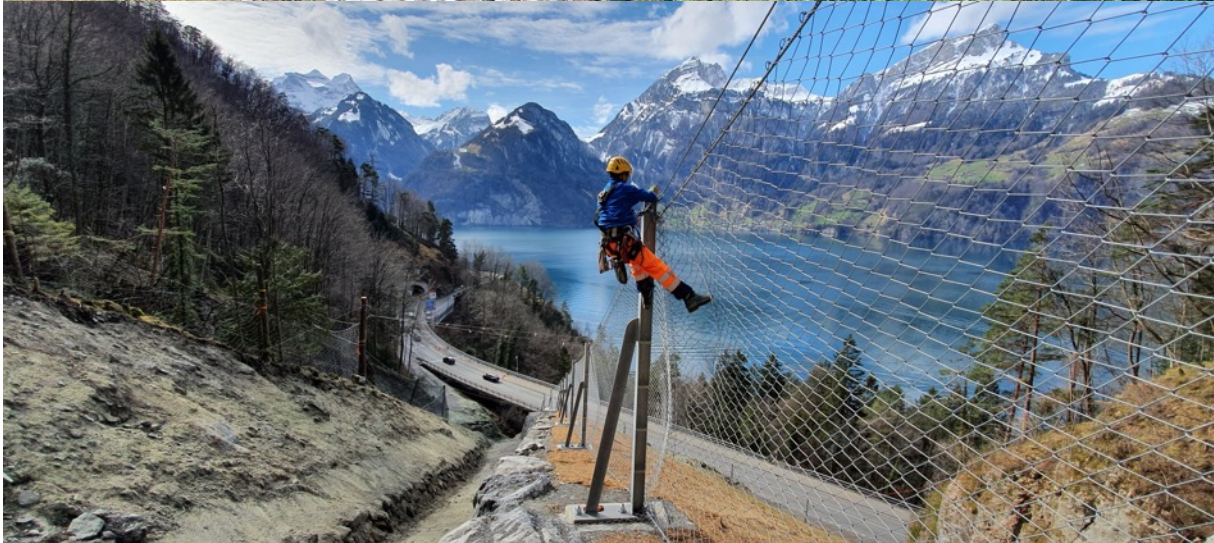
Example:

- Radar detects rockfall in debris channel above → immediate road closure
- No impact in protection barriers → automatic reopening of road after 2 min

→ Only short closure for road users
