***Daily rainfall above 75mm is a major trigger to landslides  
in the Muhunguzi, western Burundi***

# Muhunguzi watershed is located in the Mumirwa region

## • Study of the Muhunguzi watershed, Mumirwa region

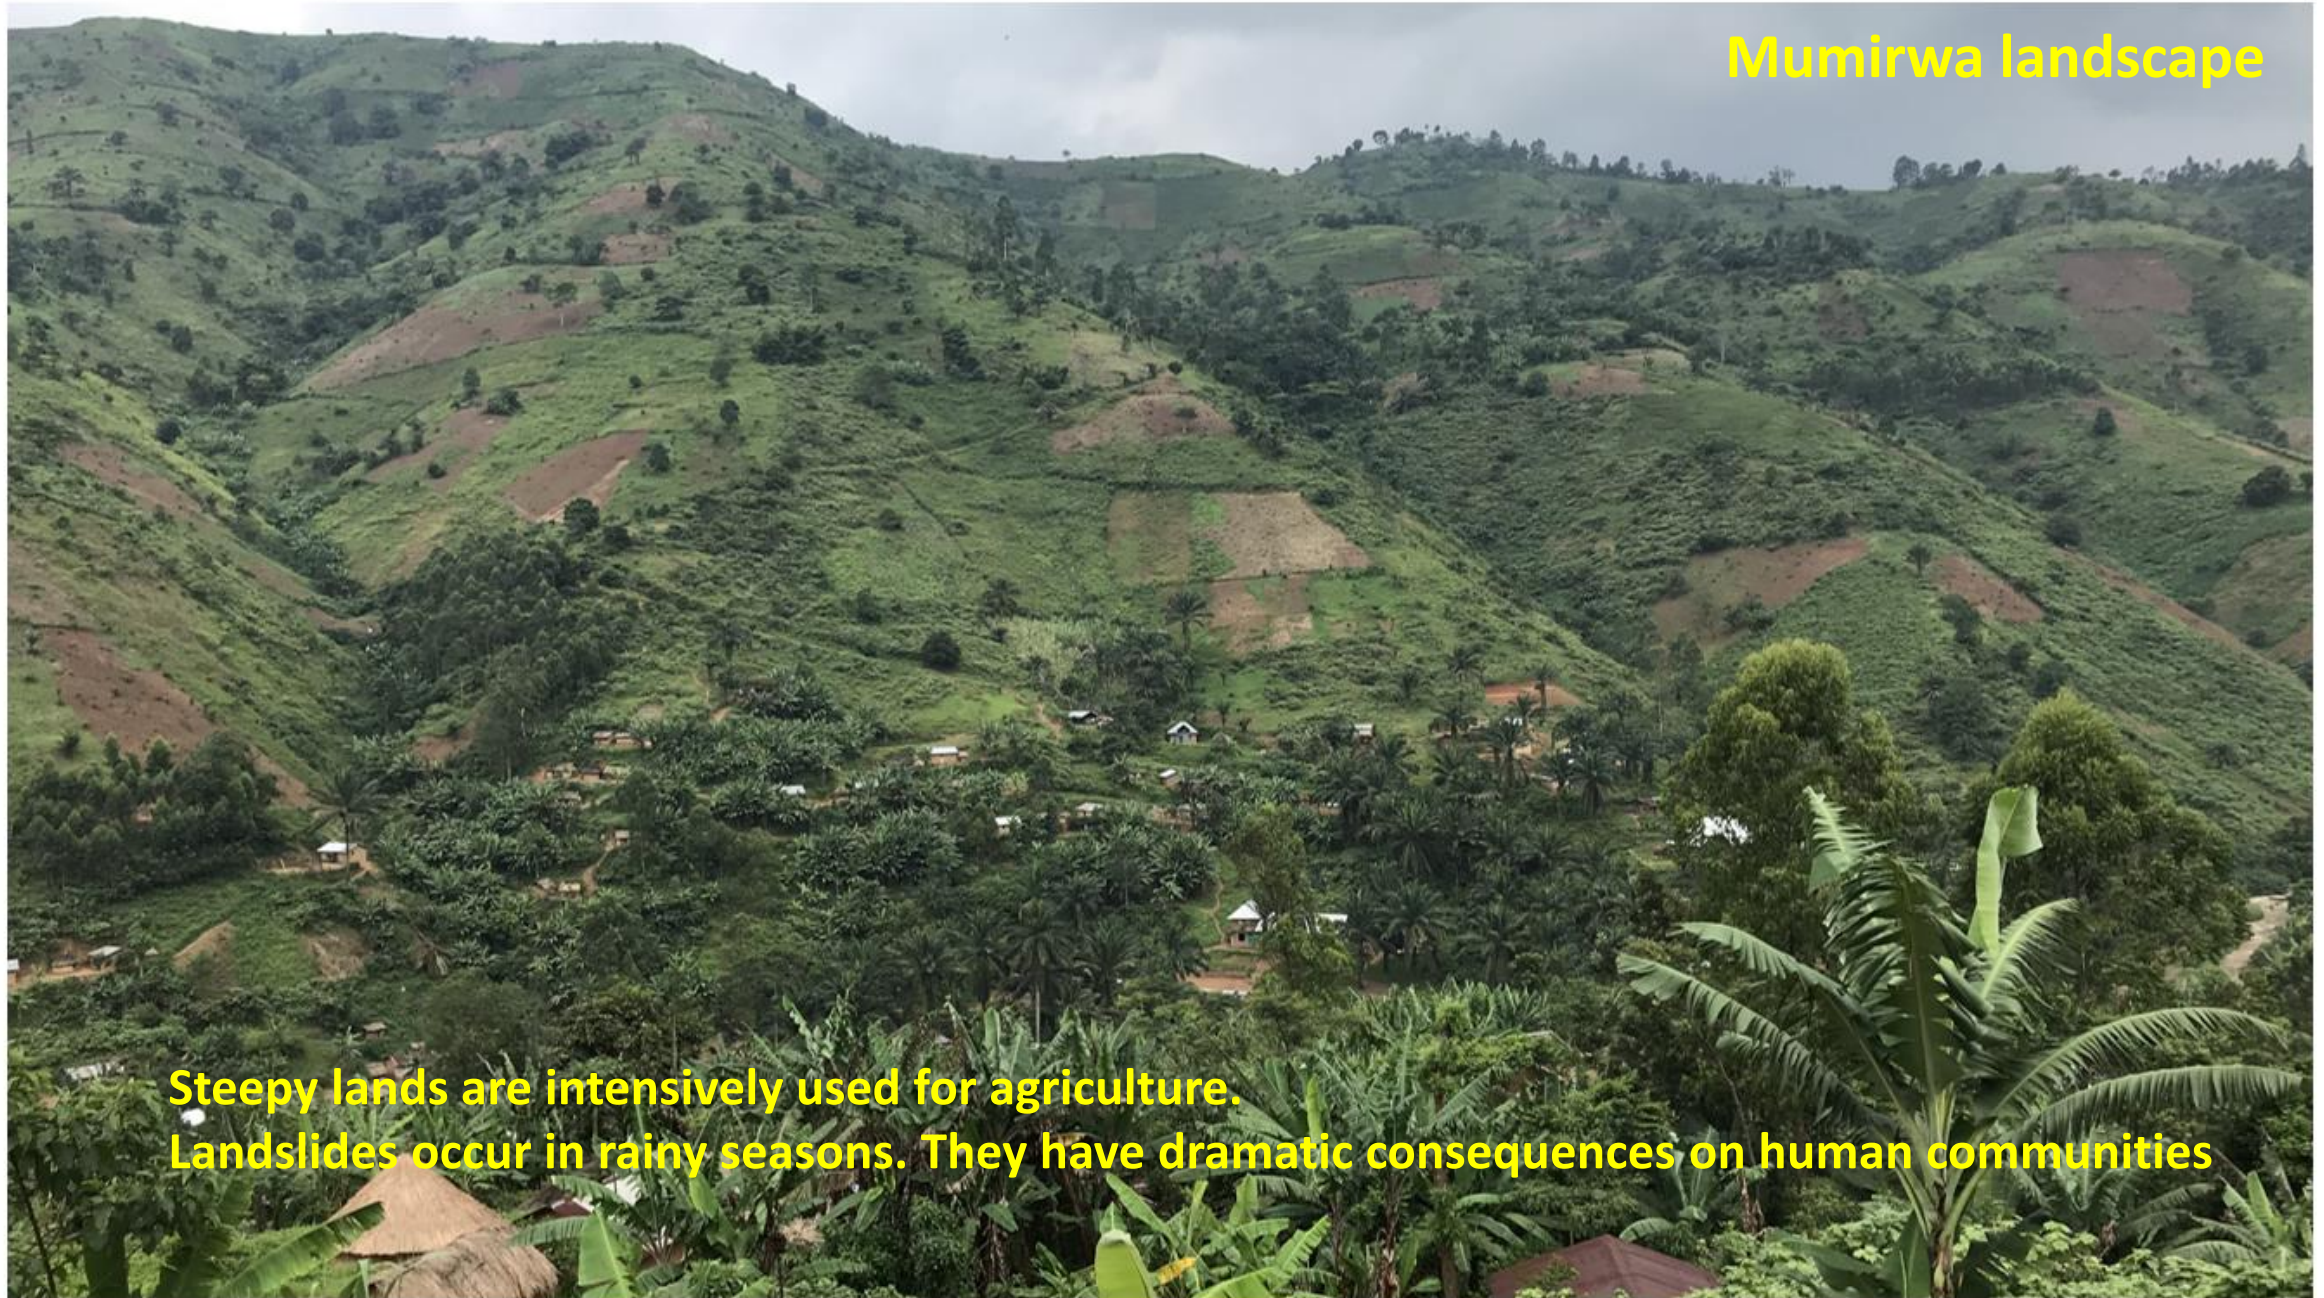
## Mumirwa landscape

**Steepy lands are intensively used for agriculture.  
Landslides occur in rainy seasons. They have dramatic consequences on human communities**

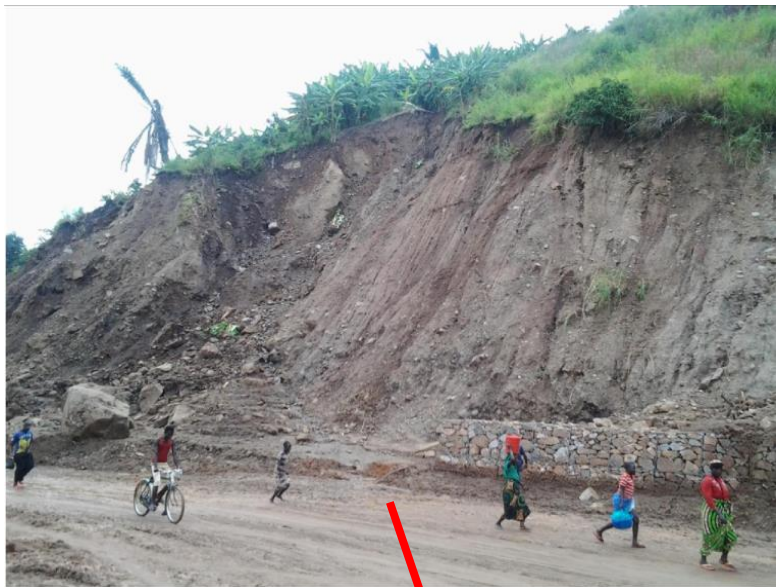
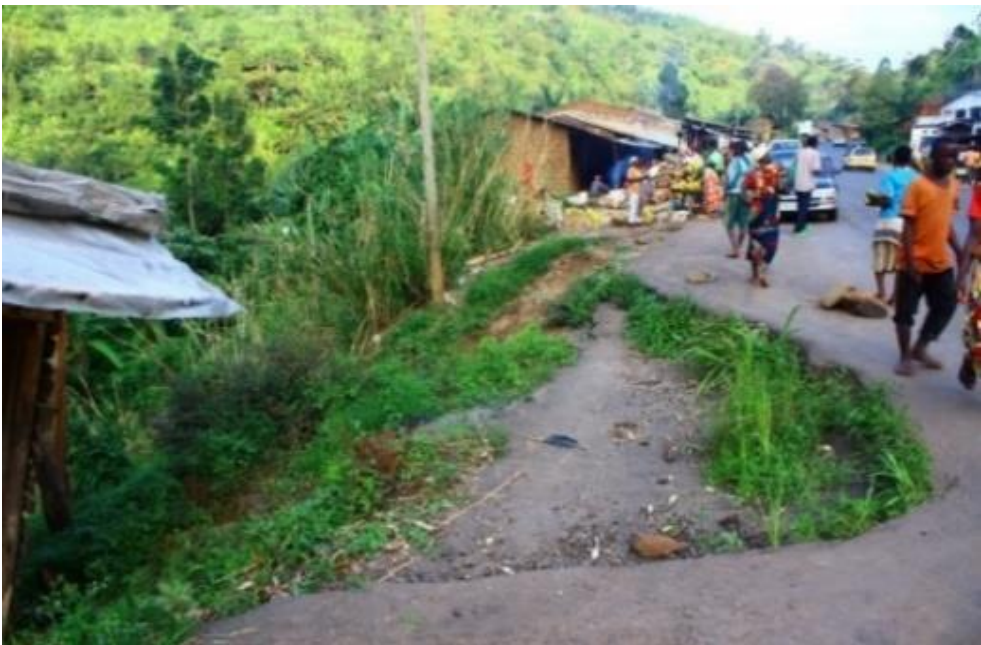
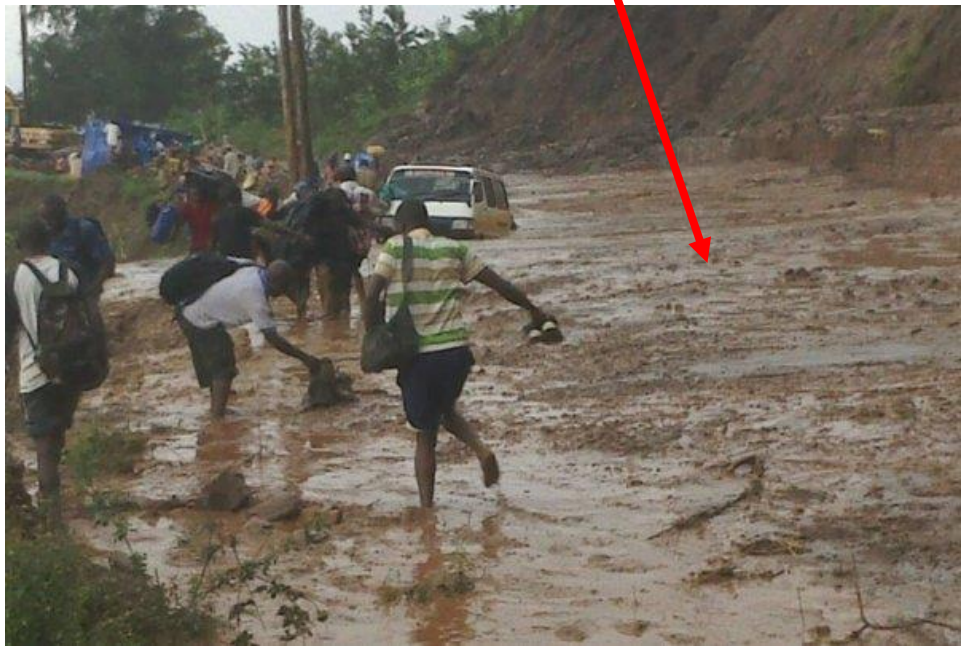
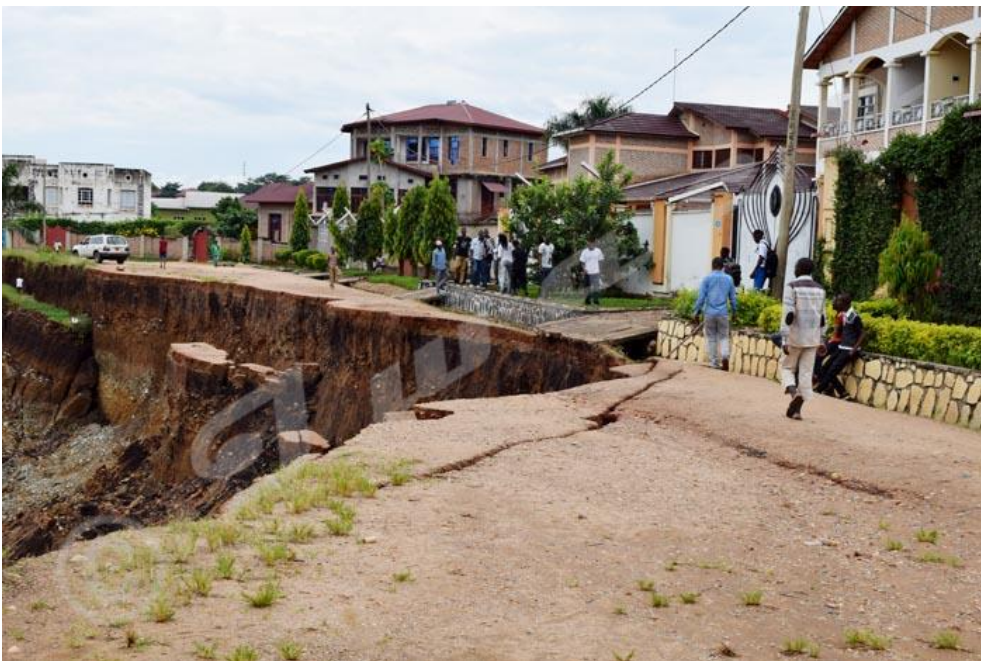
# Mumirwa landslides

- ✓ environmental degradation
- ✓ loss of cultivated land
- ✓ loss of life
- ✓ destruction of infrastructures ...

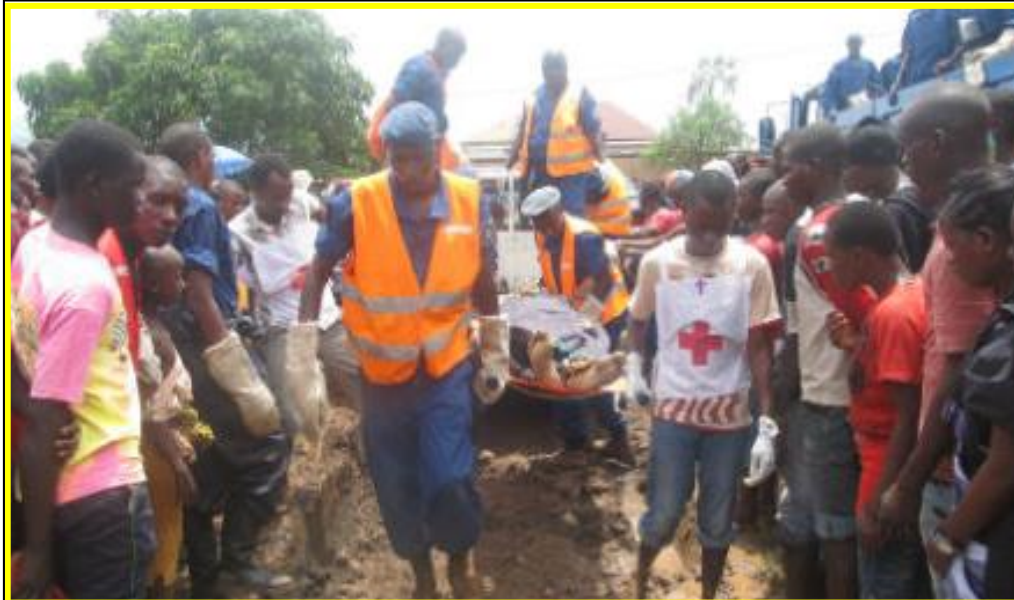
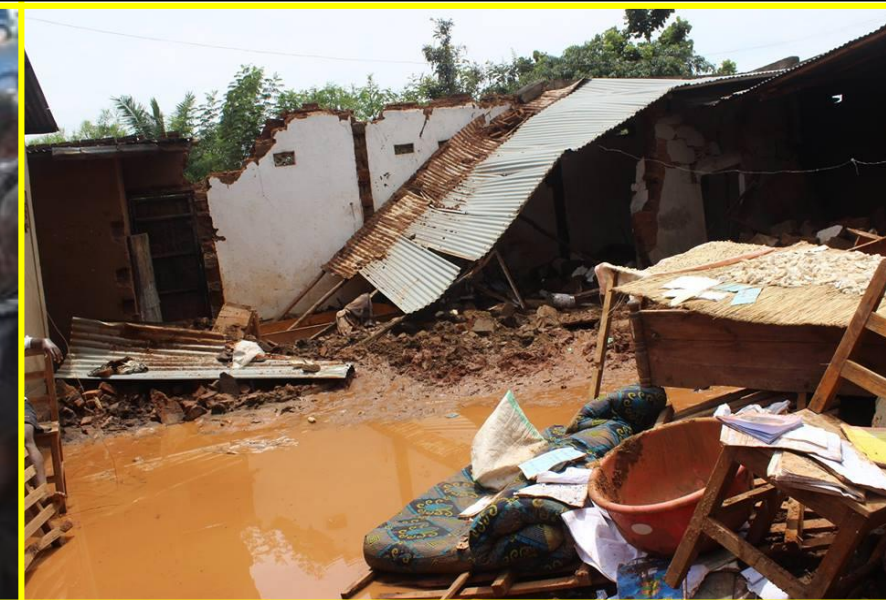
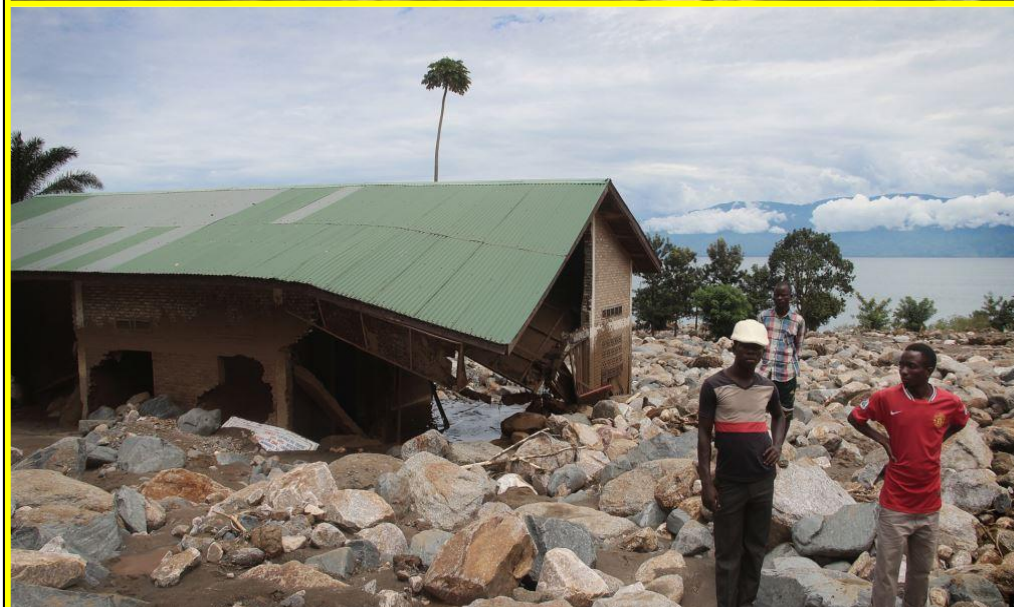
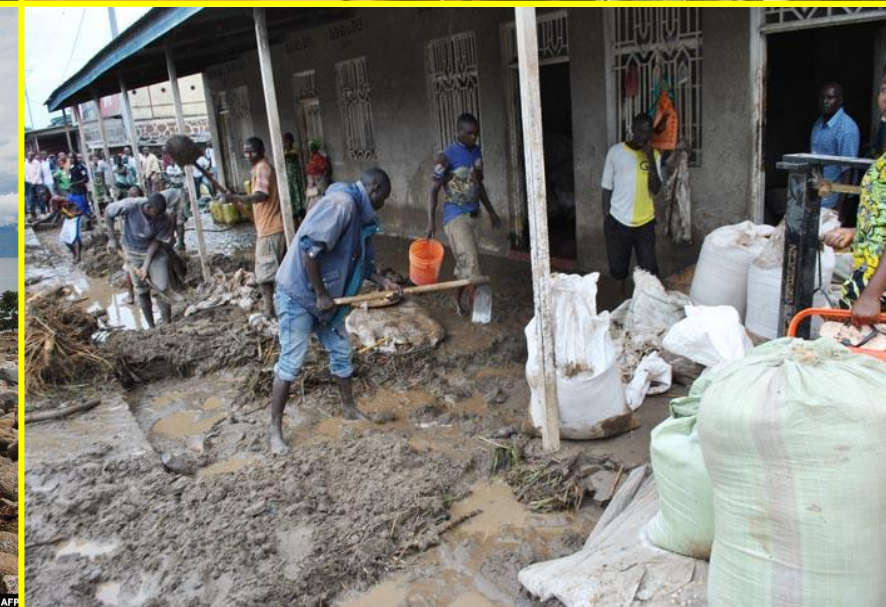
# Consequences of the Mumirwa landslides

## uplands

- ✓ loss of croplands
- ✓ destruction of houses
- ✓ loss of life....

## lowlands

- ✓ deaths
- ✓ mudslides
- ✓ floods....

Bujumbura city is regularly threatened by floods from muddy rivers heavily loaded with stones of varying sizes torn off during landslides.

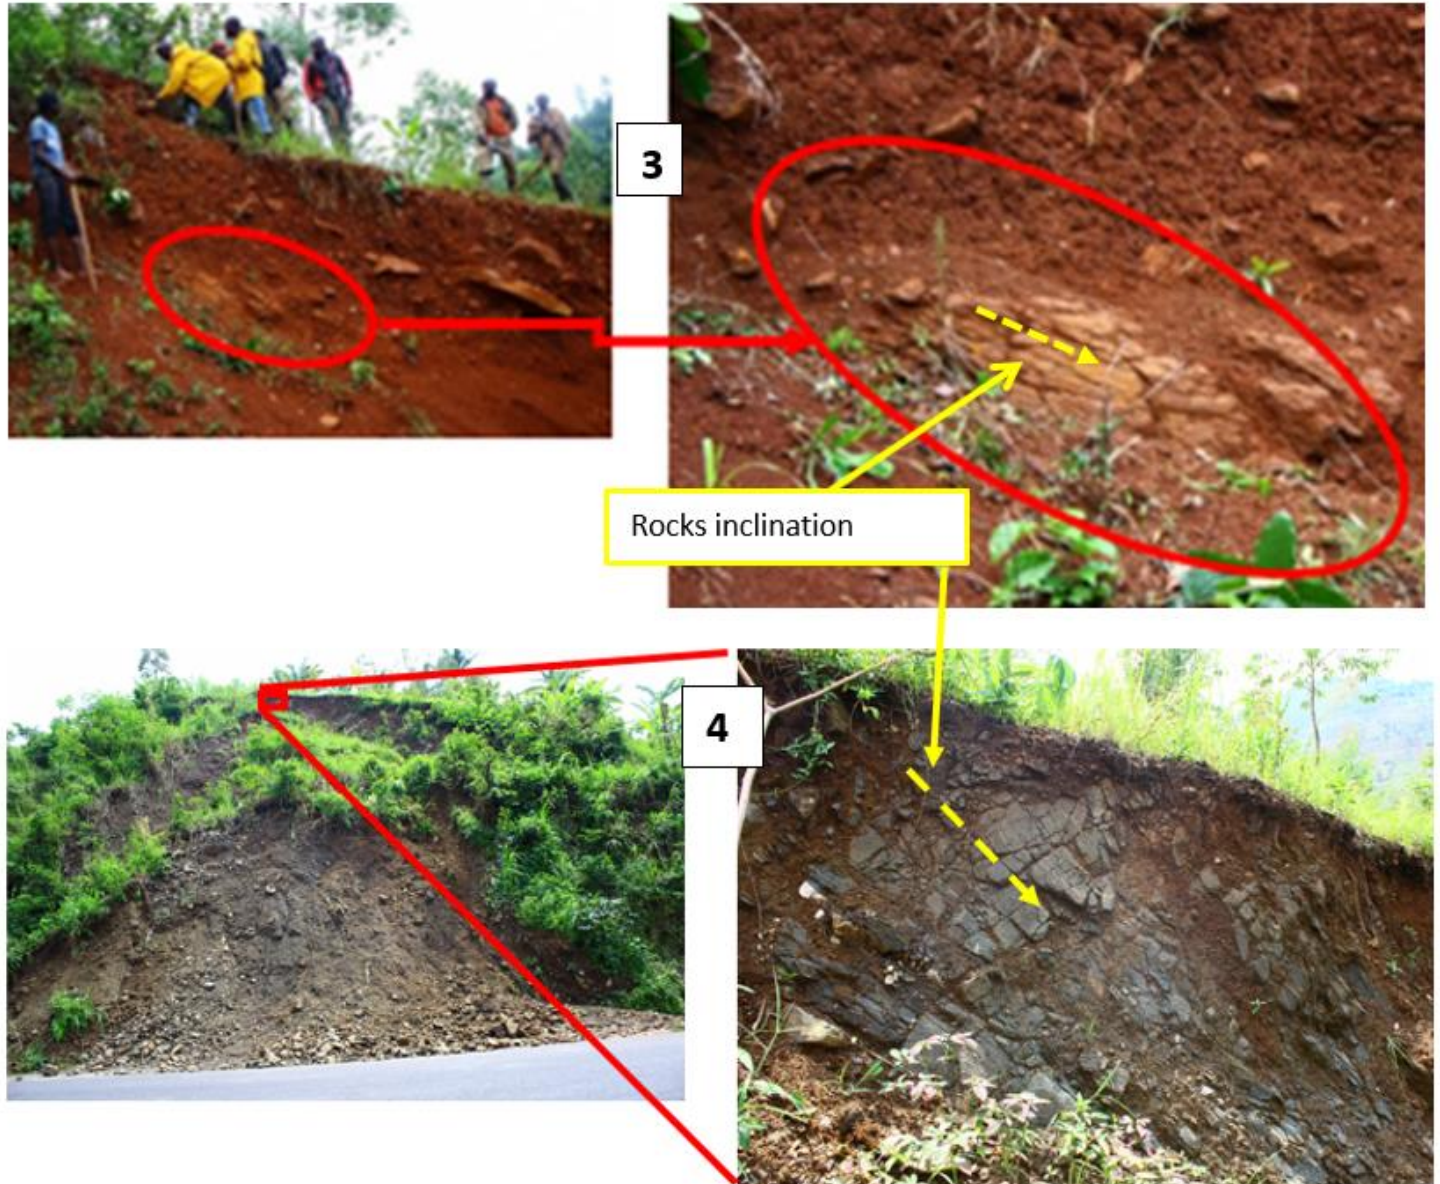
- **Geology**

Schists occupy a large proportion of the lithology of the study area.

These formations, fractured and visible on the fracture surface or at the foot of the slide fracture surface, are inclined parallel to the inclination of the slopes.

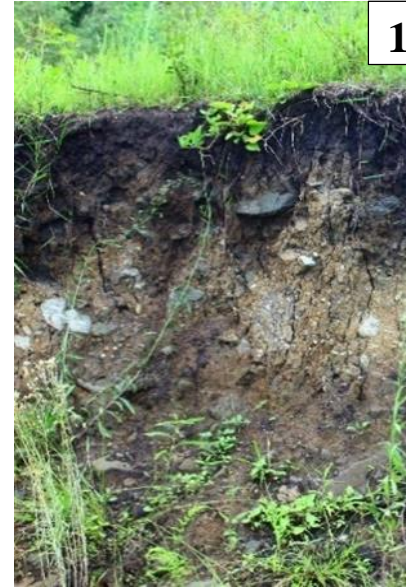
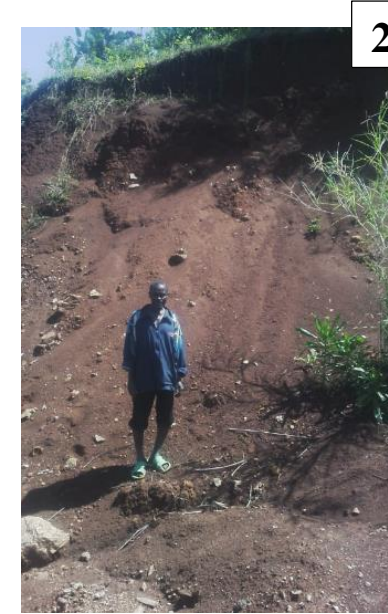
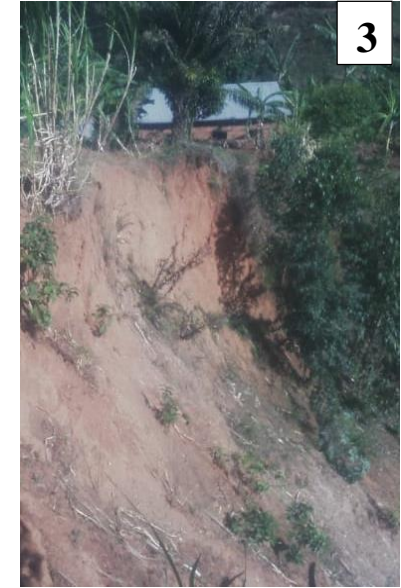
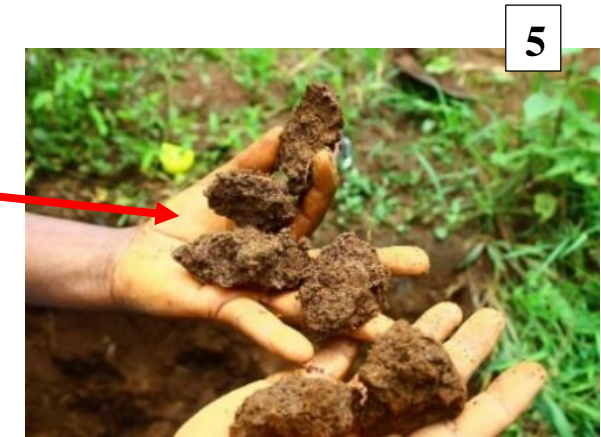
## • Illustrations of Nitisols in the studied area)

- (1) illustrates a typical stony/rocky profile,  
(2) and (3) are two typical deep soils,  
(4) illustrates the A-B-C soil profile development suggesting limited to moderate weathering,  
(5) shows subangular and angular blocky aggregates in the weathered B horizon of profile (3), a Nitisol.

- ✓ Nitisols cover the entire Muhunguzi watershed.
- ✓ Nitisols generally derived from basic rocks, but they also develop on schists and micaschists.
- ✓ Nitisols are characterized by a relatively high clay content and nitic properties, characterized by a.o. well developed blocky structure.

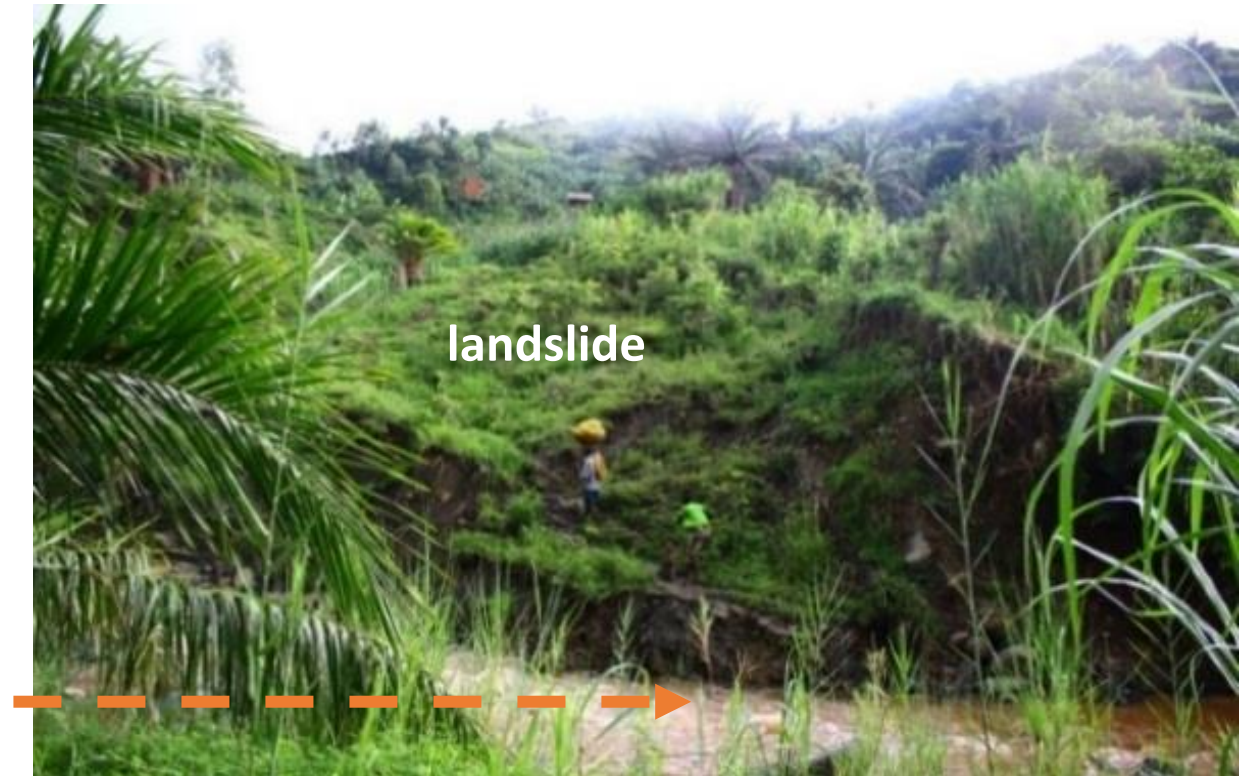
## • Location of landslides in relation to hydrography (river network)

- ✓ 44% of landslides affect rivers.
- ✓ Bank undercutting is located locally on concave parts of the river.

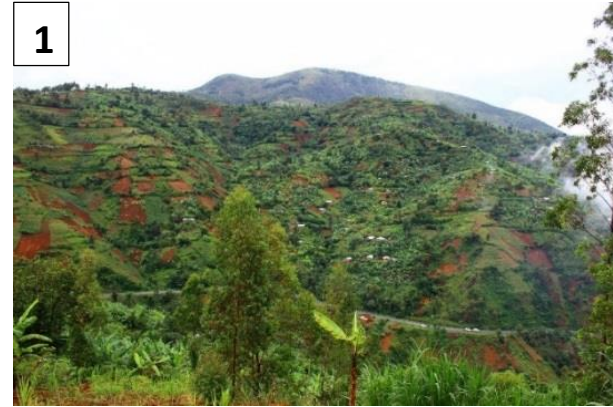
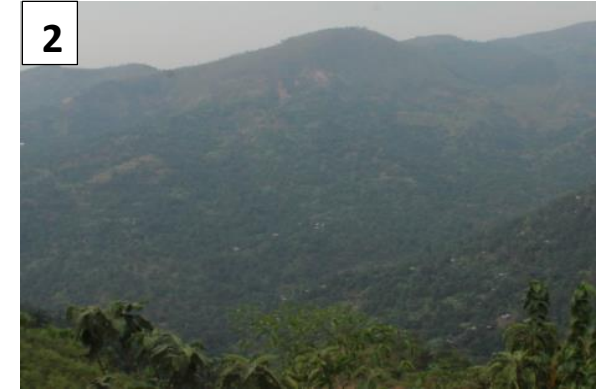
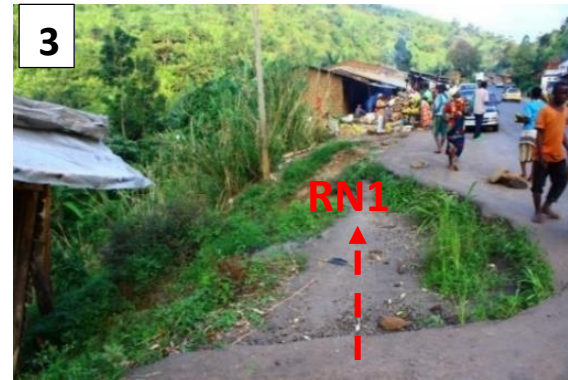
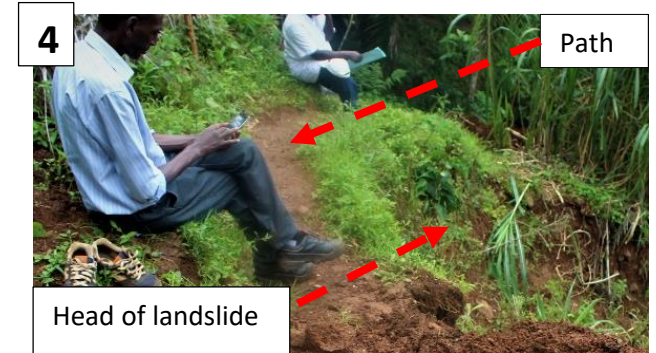
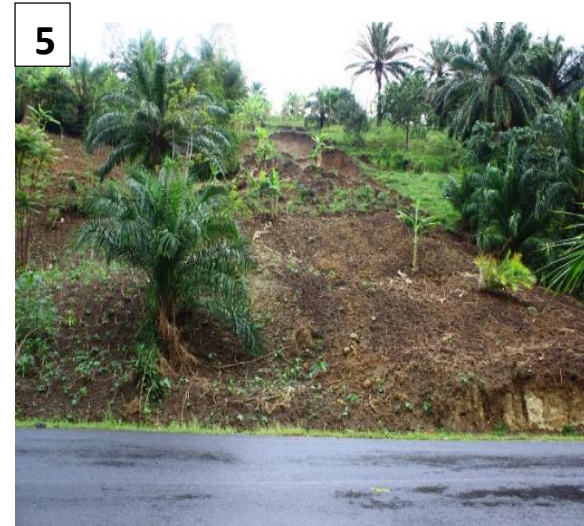
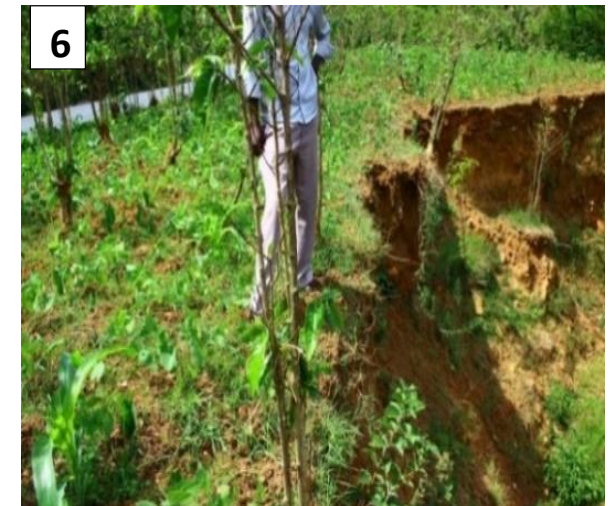
## • Anthropogenic influence

- ✓ All uplands are occupied by farms and houses, even on very steep slopes(1).
- ✓ Only the top parts of the Muhunguzi watershed are covered by state forest of eucalyptus trees.
- ✓ Landslides are absent on areas permanently covered with vegetation consisting mainly of oil palm or banana crops that are less dispersed as in figure (2).
- ✓ Of the 43 landslides, 11 have affected the national road RN1; two of them have damaged roads as illustrated in figure (3).
- ✓ At the head of most landslides, there is a path of about 30 cm wide as shown in figure (4).
- ✓ The majority of landslides occurred on farm fields under seasonal crops as in figures (5) and (6)
