Using RPAS derived images and LiDAR DEM's for the assessment of geomorphic changes in a cultural heritage site affected by recent landslides

¹Mihai Ciprian MĂRGĂRINT, ¹Mihai NICULIȚĂ, ¹Mihai Cosmin CIOTINĂ, ¹Georgiana VĂCULIȘTEANU, ¹Valeriu STOILOV-LINU, ²Paolo TAROLLI

European Geosciences Union – General Assembly, Vienna, Austria, 4-8 May 2020

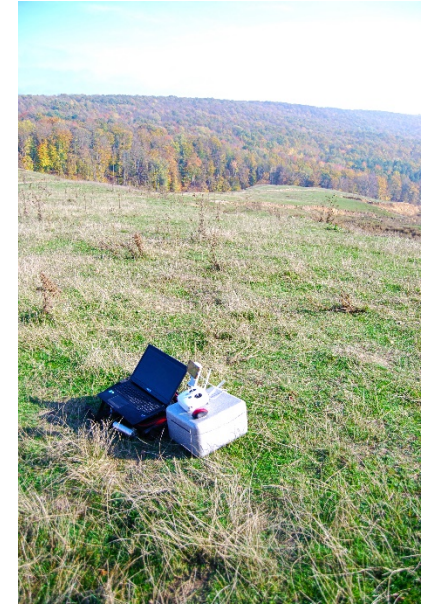
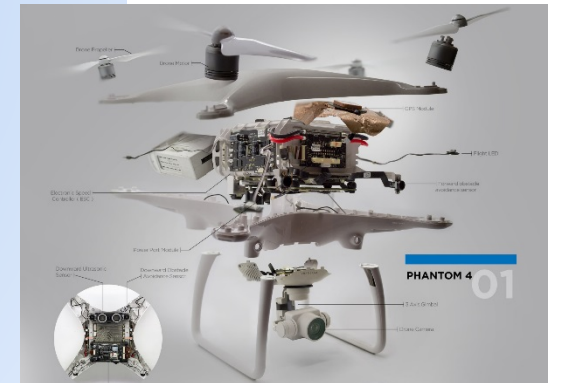
- The usage of a quadcopter allow the coverage of up to 15 ha per battery in a framework that allow high accuracy and precision of the topographic data.
- The Phantom 4 Pro quadcopter was used to capture the images in stereo pairs (models) as a string & block photogrammetric flight path with 80% side and forward (end) overlap . The altitude of the flight was 50 m relative to the terrain surface, the flight plan being computed and executed by UgGS software.

The camera acquired images at 20 MP resolution, in 3:2 Aspect Ratio with a size of 5472x3648 pixels image and RAW format. The nominal pixel size was ~ 0.012 m. SfM was performed in Visual SFM.
