Engineering-geological Characterization and Activity Analysis of a deep-seated Rockslide near Laatsch (South Tyrol)

EGU General Assembly 2020, Session NH3.1:

Large slope instabilities: characterisation, dating, triggering, monitoring and modelling

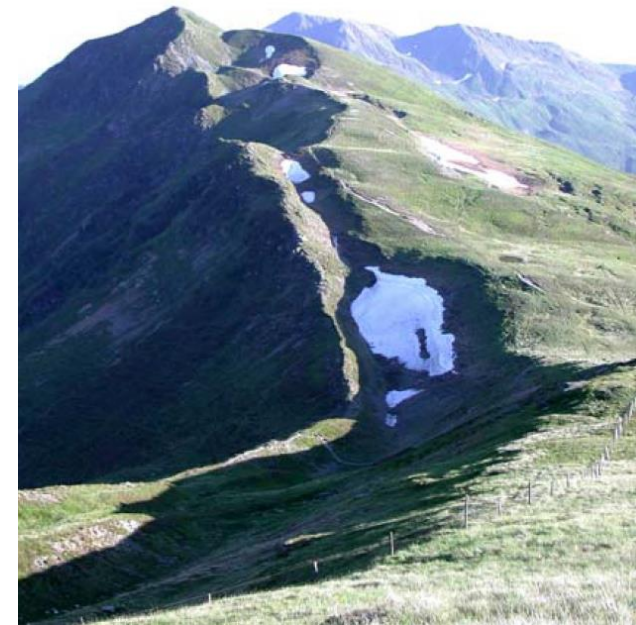
Lateral spreading of mountains in the Kitzbüheler Alps in Salzburg, Austria
(Photo from N. Tilch, Geolog. Survey of Austria)

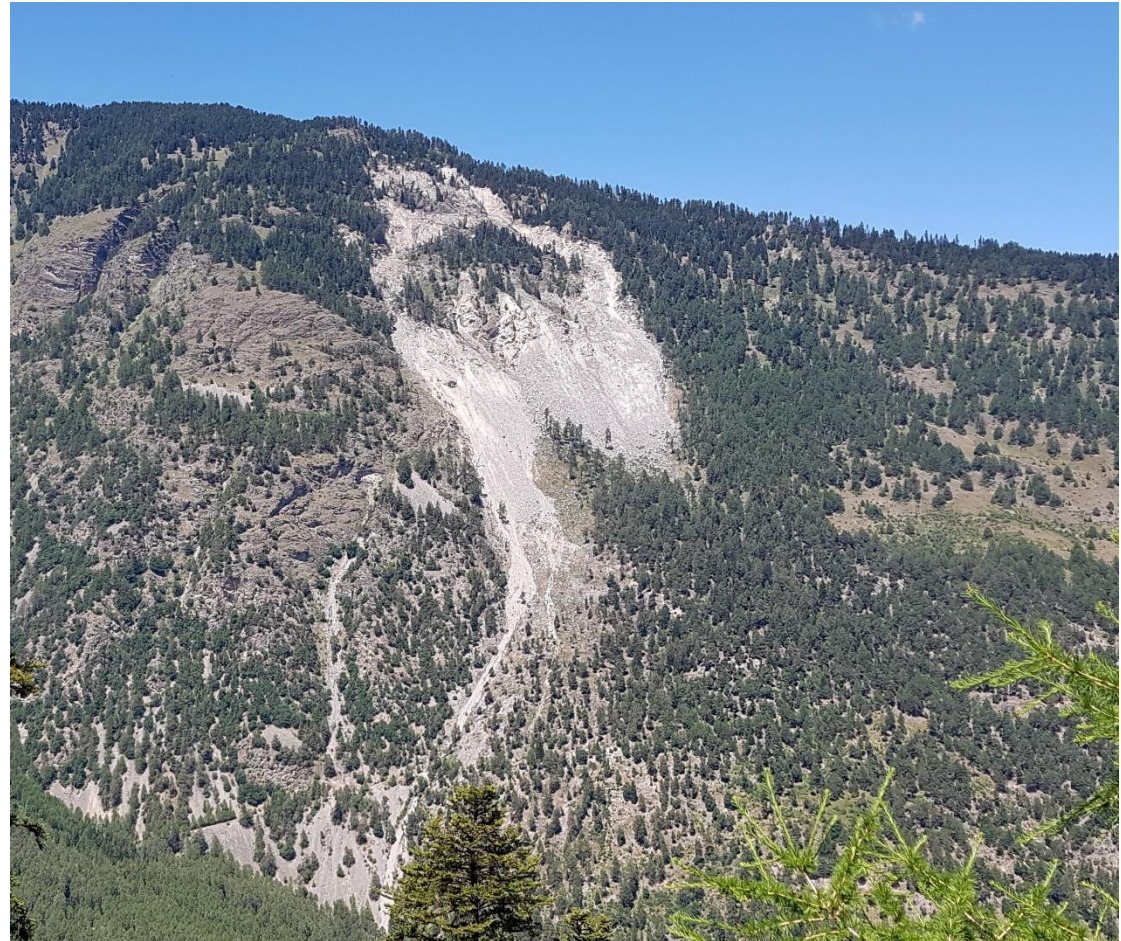
- Scarps and secondary scarps
- Deep weathering of disintegrated rock mass at fracture surfaces
- Tension cracks
- Individual slabs showing translational movement with minor internal deformation
- Rock fall

Photograph of rockslide, view to NW (July 2019)

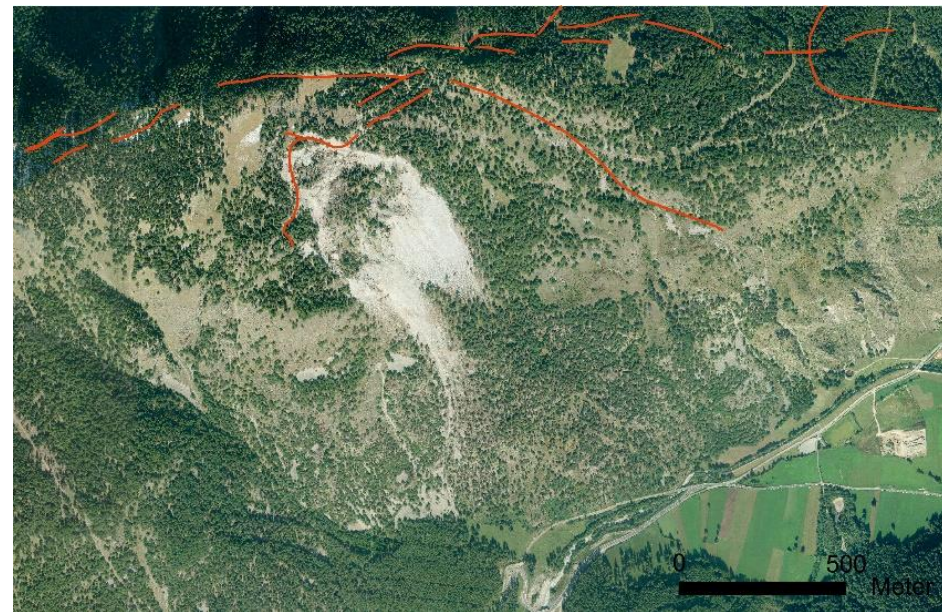
Orthophoto from 2014

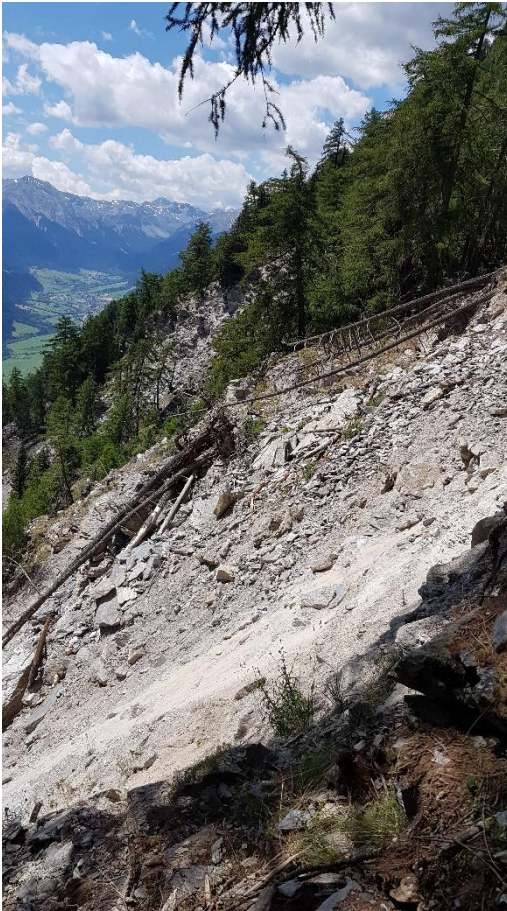
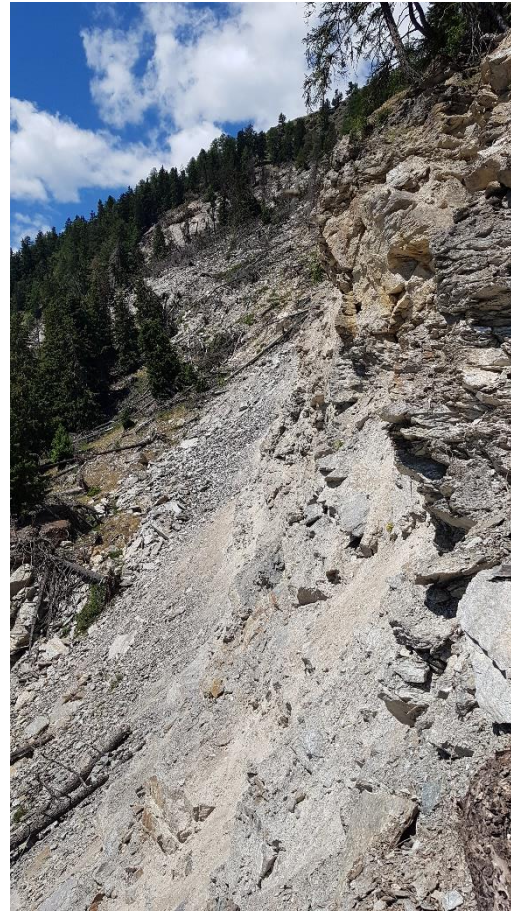
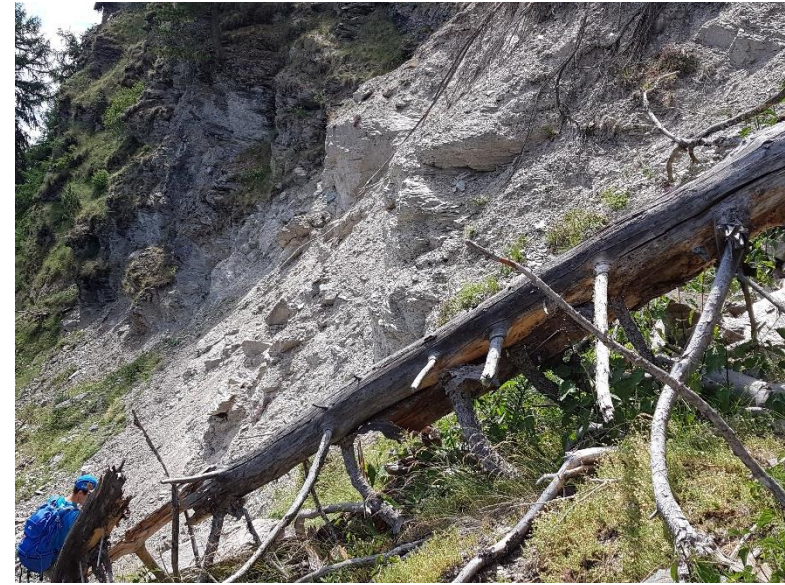
- Steep dipping scarps (ca. 70°) and slab development
- Weathering of Gneiss rocks along scarps / pre-existing joints

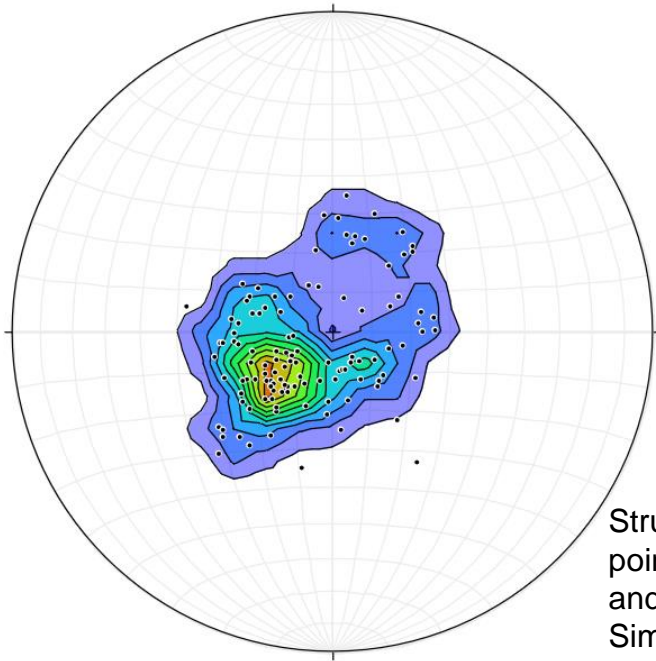
- Gentle-dipping foliation (ca. 20°) to the Northwest
- Foliation dipping towards the slope, therefore not favouring slope failure in terms of sliding

Structural plot: pole points of foliation (Mapping and data processing by Simon Ziernhöld)

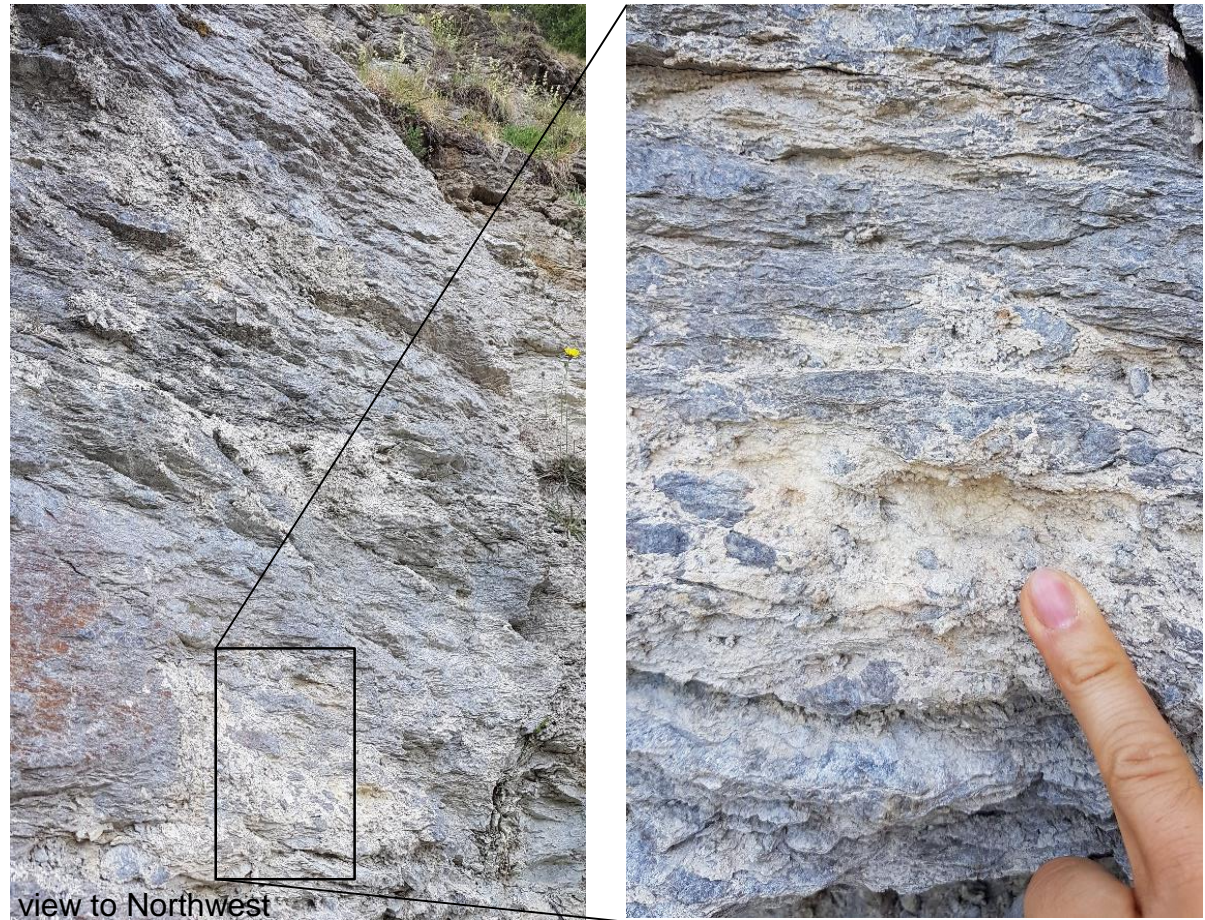
- Fracture fillings from exposed crack / joint surface activated as scarps

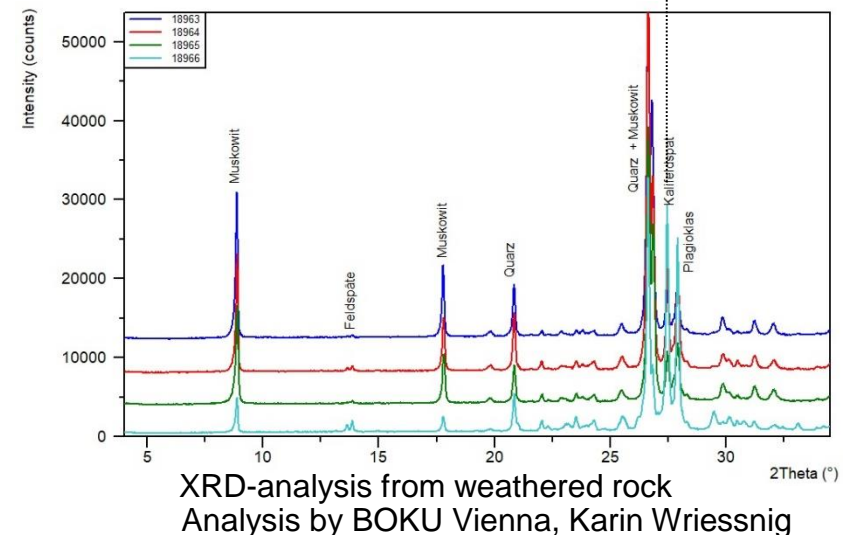
XRD Analysis from base and weathered rock

- Various Gneiss types mainly consist of Quartz, Feldspar, Muscovite and Calcite
- At the scarps/weathered joint surfaces, potassium feldspar and plagioclase are reduced, Quartz and Muscovite therefore are dominant
- Thin sections from different Gneiss samples show fine to coarse grained structure; foliation is mainly caused by Muscovite layers; Muscovite-rich shearing planes could also be identified

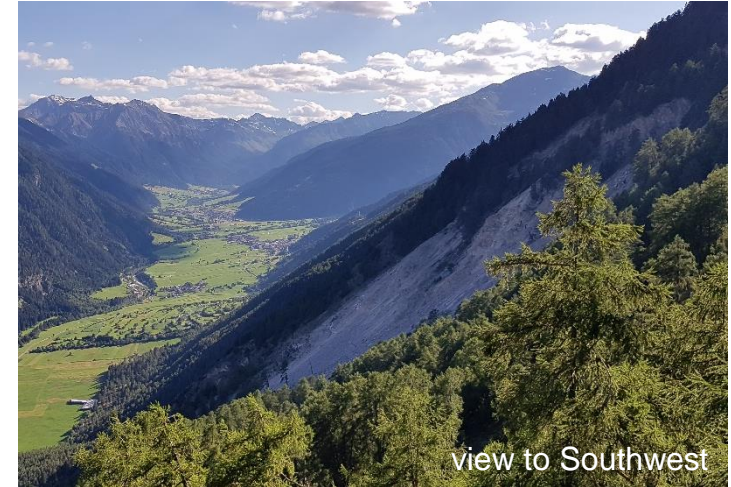
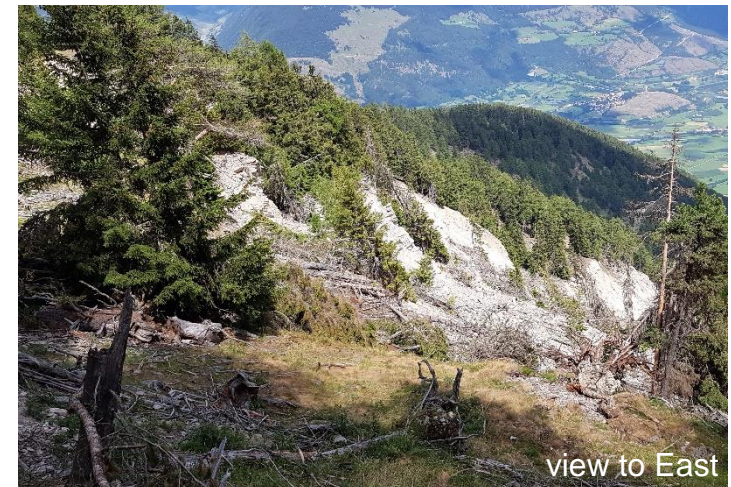
- Since several years, the highly active rockslide shows displacements of several metres per year
- In 2014, the road SS41 was relocated over a length of ca. 800 m to the other side of the Rambach due to ongoing rock fall events
- Destabilization of a large area at the mountain ridge → primary and secondary scarps, tension cracks, up-hill facing scarps and development of a double ridge
- Scarps deviding the rockslide into different slabs

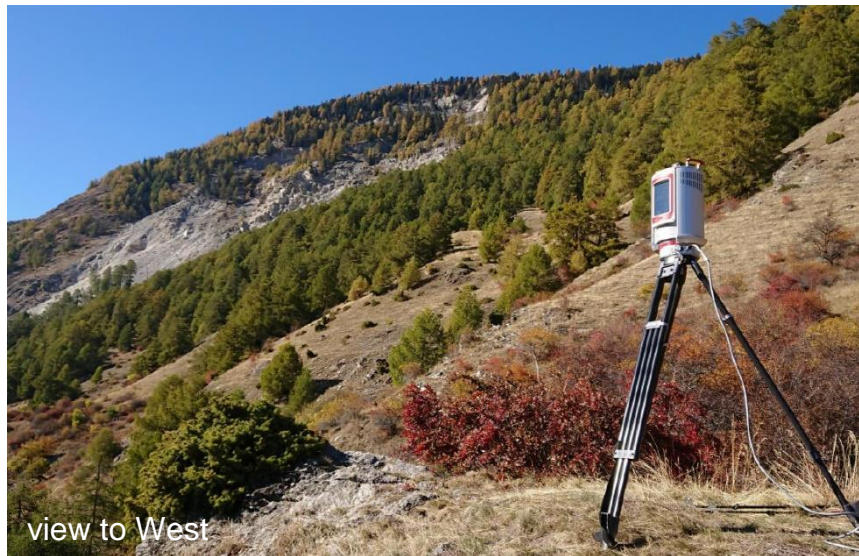
- Terrain model data analysis (TLS, ALS, Photogrammetry)
- Laserscanning measurements from various scan positions
- Displacement calculation in different time periods

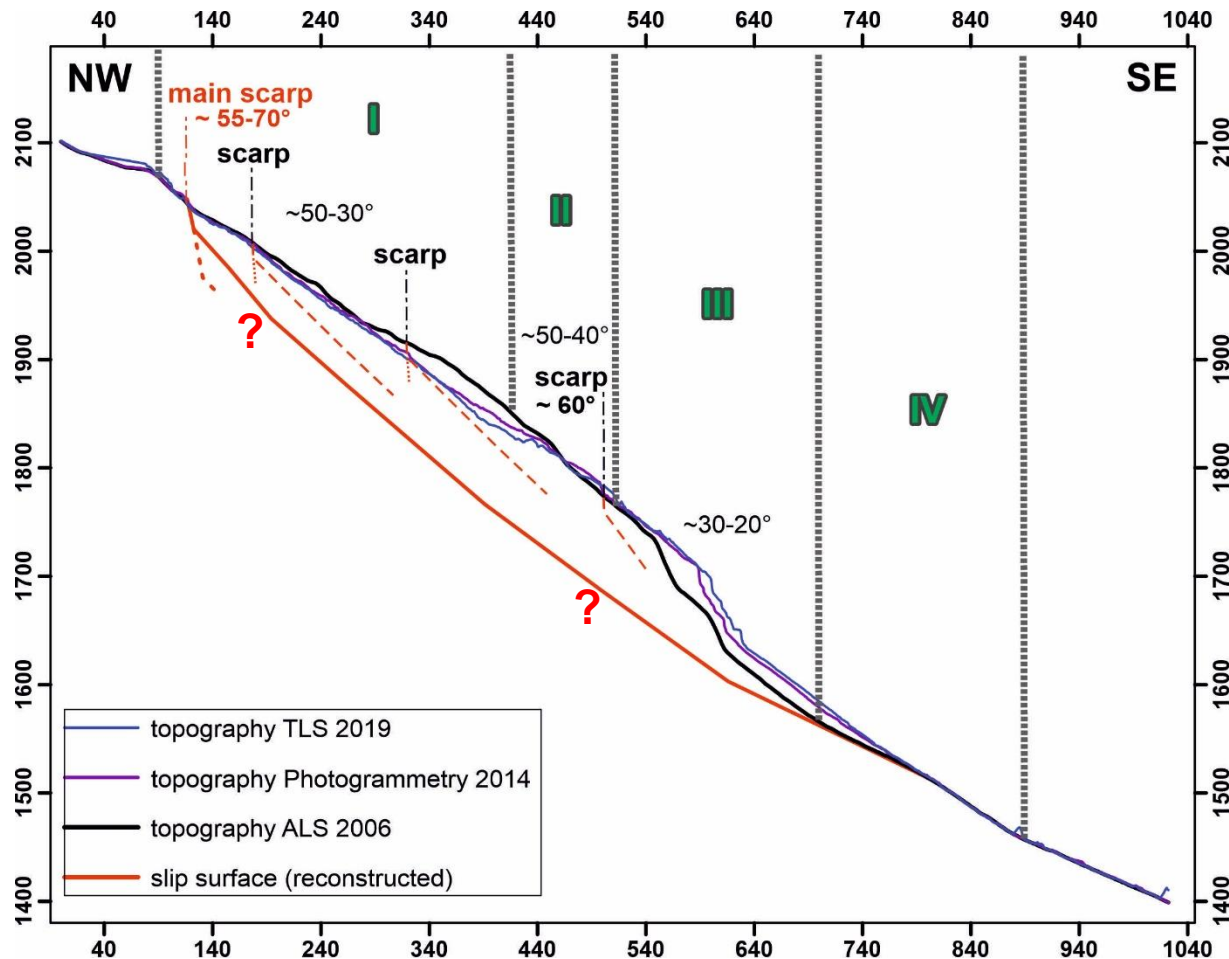
- Multiple scarps from Orthophoto and field investigation
- Individual sub-areas with varying deformation rates identified by Laserscanning

Cross section interpretation on the basis of terrain model and field investigation (Christina Rechberger)
