# UAS Imaging Applications to Monitor Restored Peatlands

Hydrology LIFE Project; <sup>1</sup>University of Oulu, Water, Energy and Environmental Engineering Research Unit, Finland; <sup>2</sup>Metsähallitus Parks and Wildlife Finland; <sup>3</sup>University of Eastern Finland, Department of Geographical and Historical Studies, Finland; \*lauri.ikkala@oulu.fi

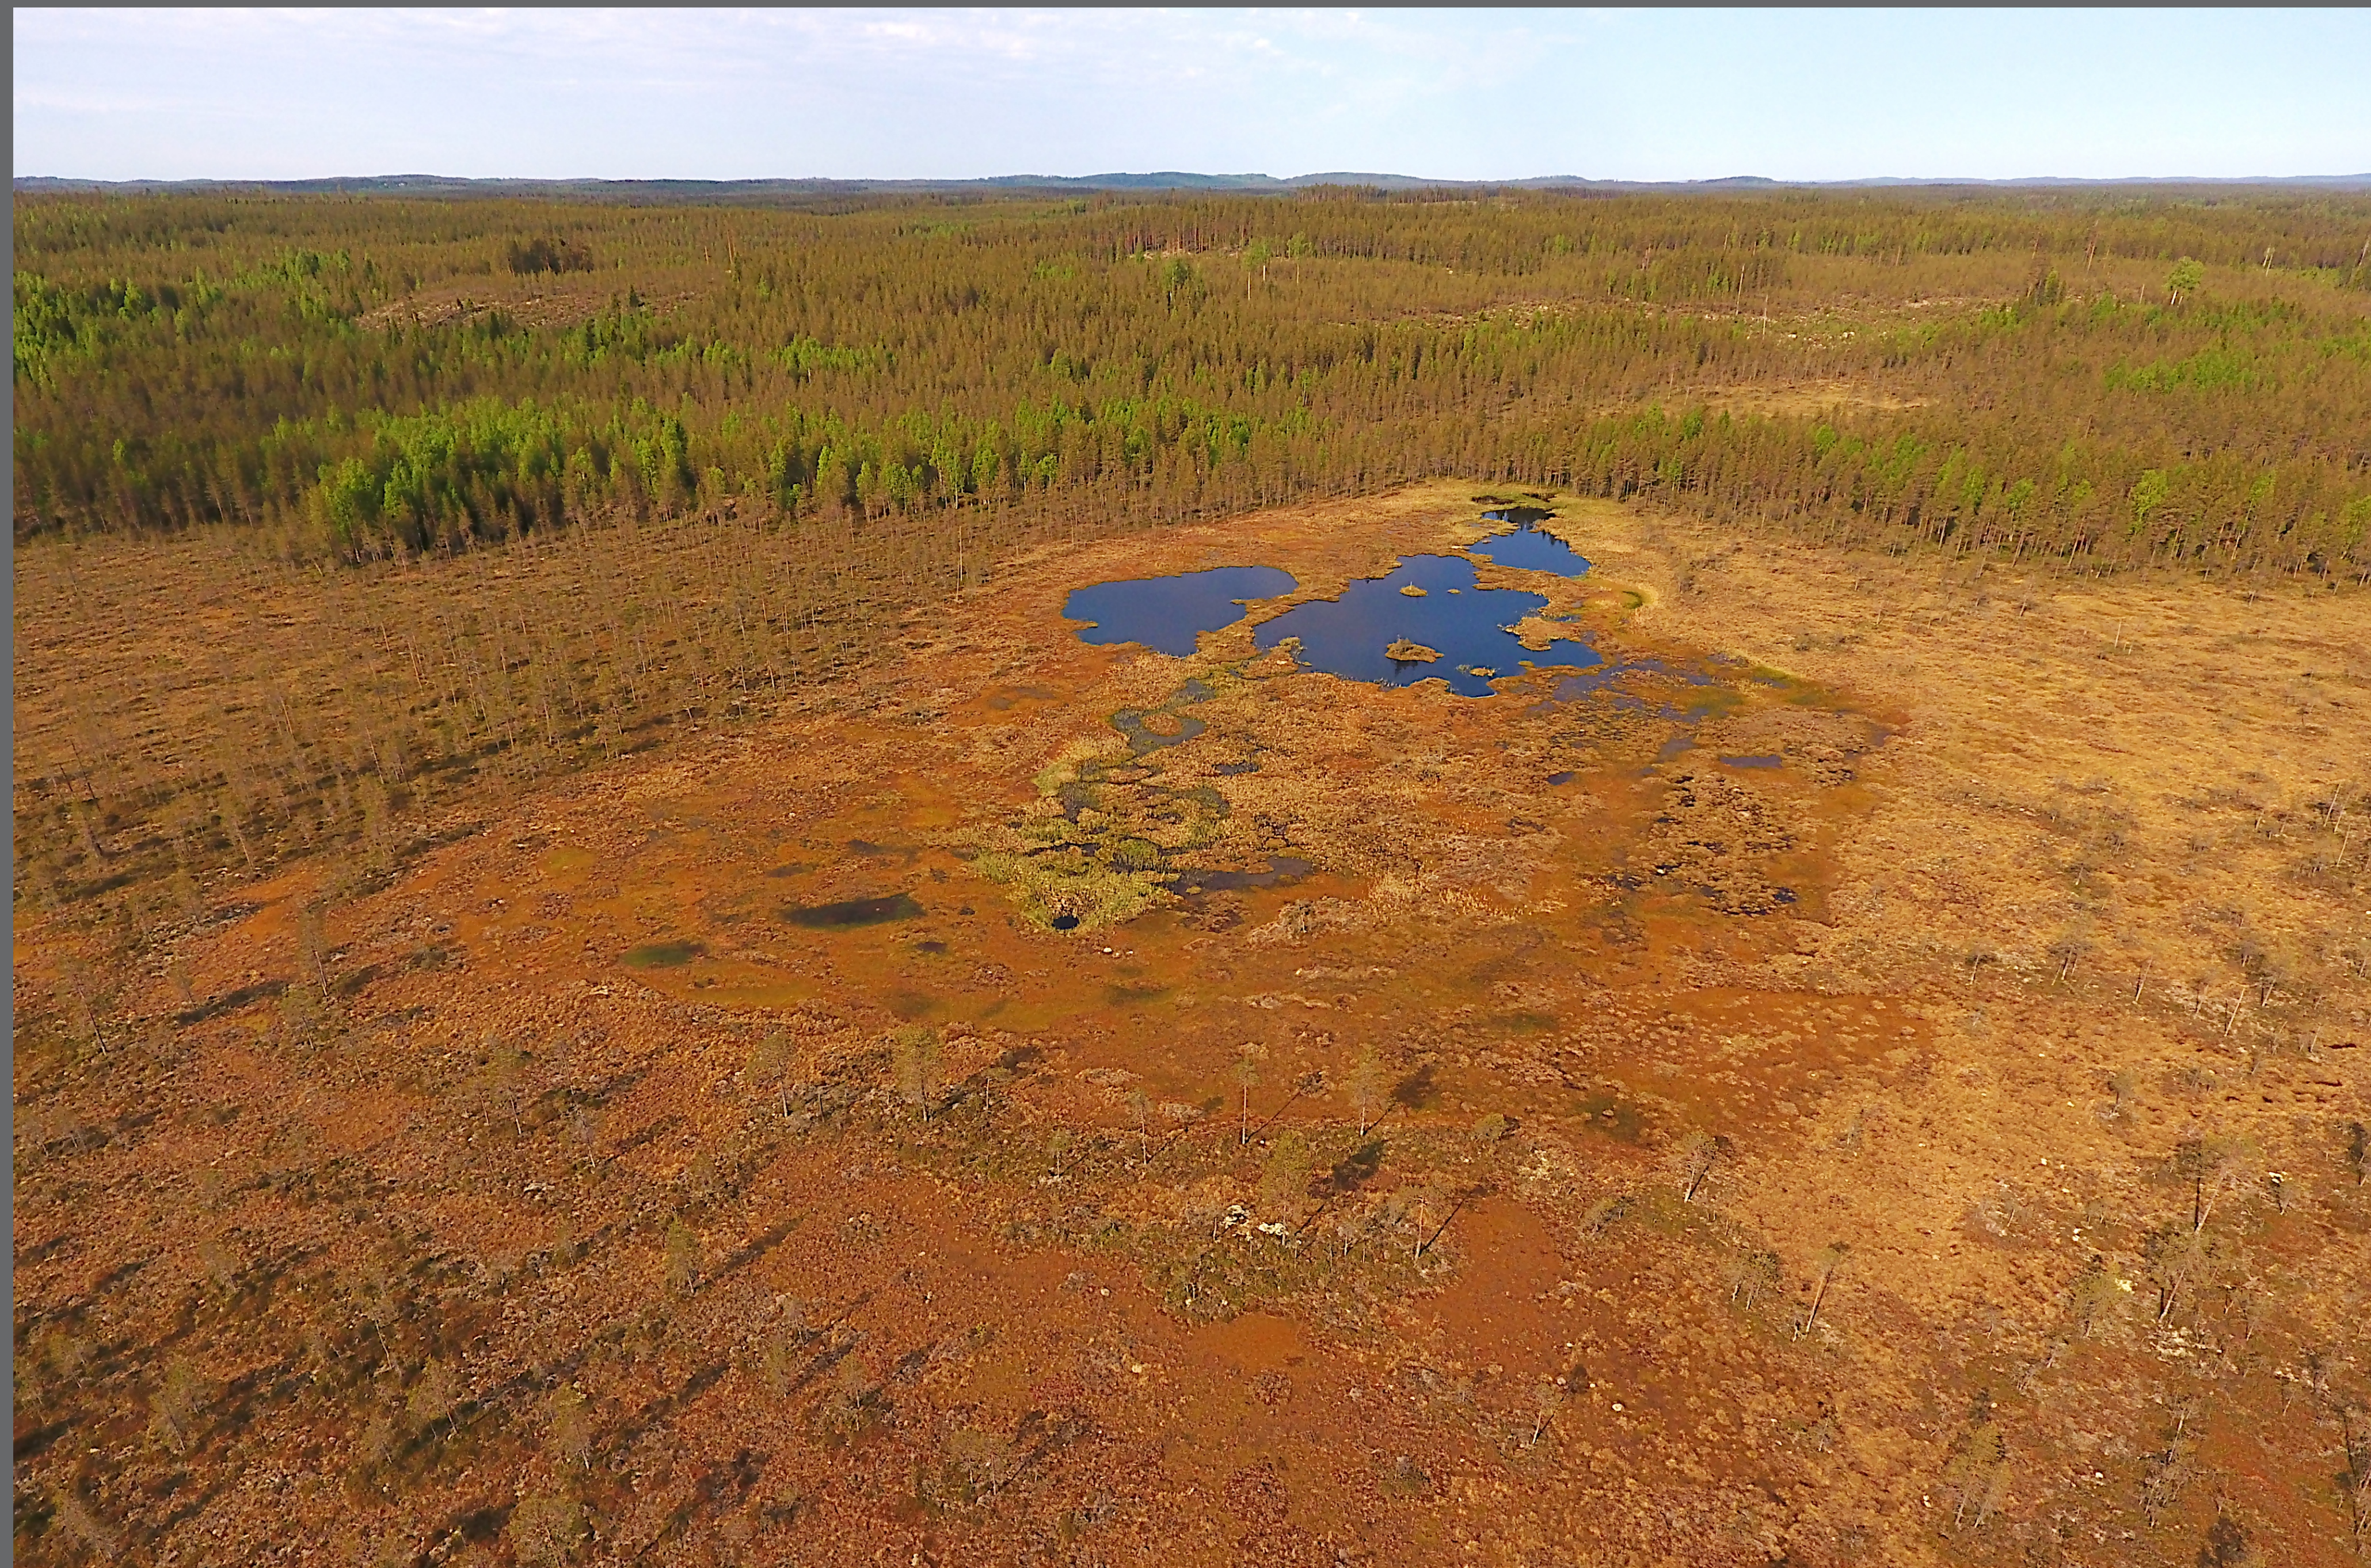
- Hydrology LIFE project produces UAS imaging data for the study:
  - i) Visible (VIS)
  - ii) Near-infrared (NIR)
  - iii) Thermal infrared (TIR)
- Restoration success indicators to be derived from the data:
  - i) Manual and automated interpretation of the orthomosaics
  - ii) Classification of vegetation cover types
  - iii) Digital elevation models (DEM) for the site run-off model
  - iv) Vegetation and moisture indices
  - v) Water table elevation
- UAS-carried "wild cards" to be tested:
  - i) Lidar
  - ii) Hyperspectral
  - iii) Ground penetrating radar
- Reference data:
  - i) Manual visual field observations
  - ii) Soil moisture observations
  - iii) Vegetation and hydrological long-term monitoring
  - iv) Satellite imagery
