JAMUNA RIVER EROSIONAL HAZARDS, ACCRETION & ANNUAL WATER DISCHARGE—A REMOTE SENSING & GIS APPROACH

E.U.Pahlowan^{a,*}, A.T.M. S. Hossain^b

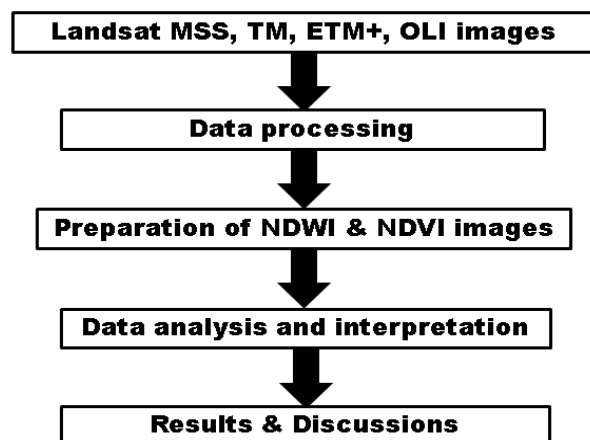
Figure 2. Methodology

Satellite images for years 1977 and 2014 are used to get the important information about the study area. A detail methodology for extraction of the information from LS images is shown in Figure 2.

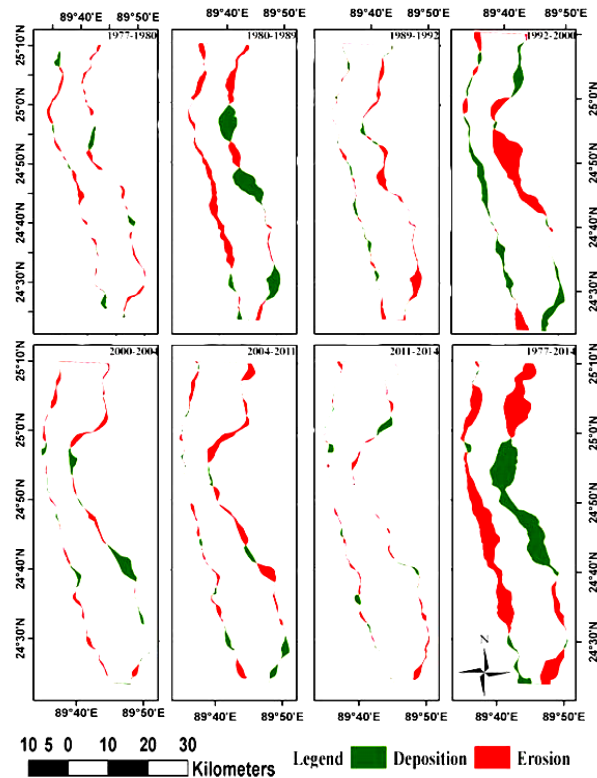
Figure 3. Erosion and Accretion rate

From the analysis, a series of different Landsat images from 1977 to 2014 reveal the yearly rates of erosion and accretion and their differences with different time in Figure 3 & Table 2. Through the time erosion and accretion are varied at different periods. The highest erosion rate was $21.15 \text{ km}^2\text{year}^{-1}$ in the period of 1989-1992 and the lowest erosion rate was $8.61 \text{ km}^2\text{year}^{-1}$ in the period of 2011-2014. However, erosion rates swing between $17 \text{ km}^2\text{year}^{-1}$ to $10 \text{ km}^2\text{year}^{-1}$ in the other periods. The summation of erosion rate from 7 different periods is $14.58 \text{ km}^2\text{year}^{-1}$ and total land loss due to bank erosion was 540 km^2 . The highest accretion rate was $13.57 \text{ km}^2\text{year}^{-1}$ in the 1980-1989 periods and lowest was $3.65 \text{ km}^2\text{year}^{-1}$ in 2004-2011 period but rate remains in between (4 to 9) $\text{km}^2\text{year}^{-1}$ in other

periods. Again, summation of 7 individual periods, total land gained by accretion was 185 km^2 . The total land loss from 7 individual periods due to erosion was 160 km^2 and net land loss because of erosion was 107 km^2 . So the remaining 53 km^2 land was reworked during the period of 1977-2014. From this analysis, it is established that accretion and erosion were vigorous during this period. The total land change was about -107 km^2 , pointing out the overall loss of land was the dominant for the same period.

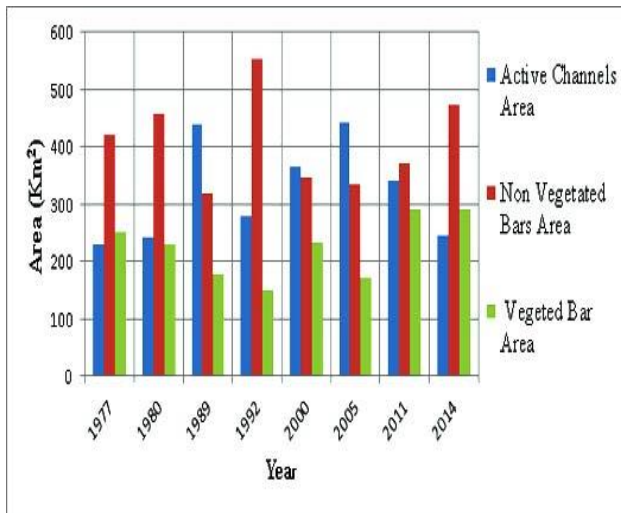
Figure 4. Bars area with time

The total area of river have been divided into three areas they area active channel area, Unvegetated Bar area and Vegetated Bar area. From Figure 4 maximum active channel area was 442 km² in 2005. Minimum active channel area was 228 km² in 1977. The maximum vegetated and unvegetated bar area was 291.71 km² and 552.58 km² during 2014 and 1992 respectively. In addition, minimum vegetated & unvegetated bar area was 148 km² and 318 km² during 1992 and 1989 respectively. Vegetated bars remain stable for several years and flooded during full stage of bank. Whereas unvegetated bars are composed by newly deposited sediment and reworked during every monsoon. The area of unvegetated bars remains higher than vegetated bars in every measurement. It indicates the dynamic nature of Jamuna on its bar depositions and erosions. These erosions and depositions have greater influence on riverbank erosion and accretion.

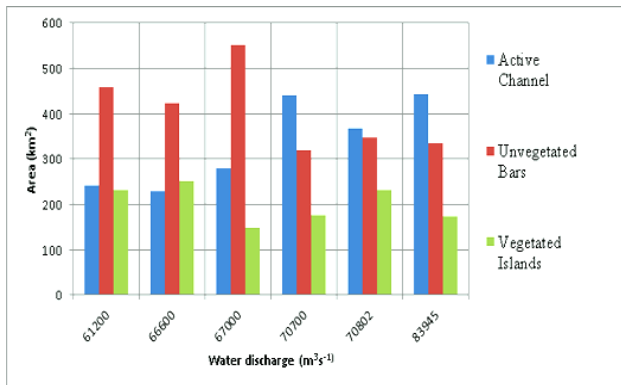
Figure 5. Bar dynamics with discharge

It can be seen from figure 5 that shows that water discharge control the river dynamics. Unvegetated bars area and active channel areas are fluctuated with increasing water discharge. But it significantly change when average annual maximum water discharge reached 67000 m³s⁻¹. Unvegetated bar area remains higher than active channel area before average annual maximum water discharge reach 67000 m³s⁻¹. After crossing average annual maximum water, discharge 67000 m³s⁻¹ channel area tends to be greater than the area of unvegetated bars. The excess water, which is more than 6700 m³s⁻¹, firstly erodes the unvegetated bars after those vegetated bars. These bar erosions help to change the river morphology during monsoon.

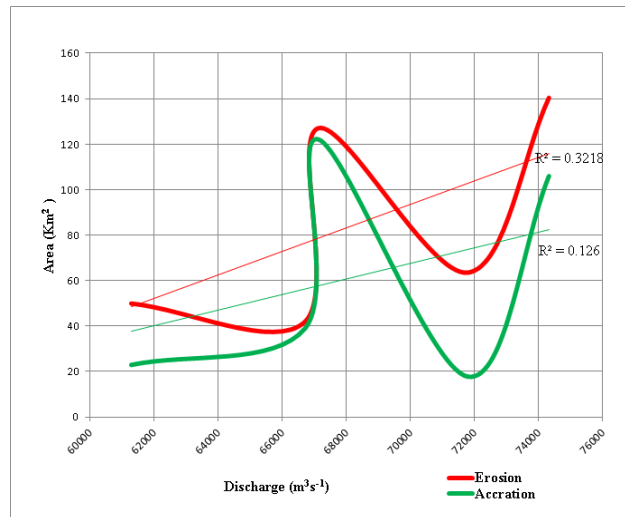
Figure 6. Erosion and Accretion with discharge

A relationship between river erosion accretion with discharge is shown in figure 6. It is observed that the erosion always greater than the accretion. Erosion show large fluctuation of area in a range of 42 km² to 140 km² over the past 37 years with general increasing trend. On the other hand, accretion ($r = .126$) shows less variation than erosion ($r = .321$) with general increasing pattern's. The erosion and accretion showing with increasing average annual water discharge but the difference between erosion and accretion remains low before water discharge reaches 67000 m³s⁻¹. Erosion and accretion tend to be higher after crossing annual average maximum water discharge 67000 m³s⁻¹. The calculated 35 year average maximum water discharge of the Jamuna River at Bahadurabad is 67435 m³s⁻¹ from 1971-2006 which is more than 67000 m³s⁻¹. In the future year Jamuna will continue to increase its discharge due to ongoing climate change, which will increase its average annual discharge. Therefore, average annual maximum water discharge 67000 m³s⁻¹ is a minimal discharge value for controlling the erosion and the accretion of Jamuna River. Erosion can be reduced by withdrawing excess water discharge from Jamuna.

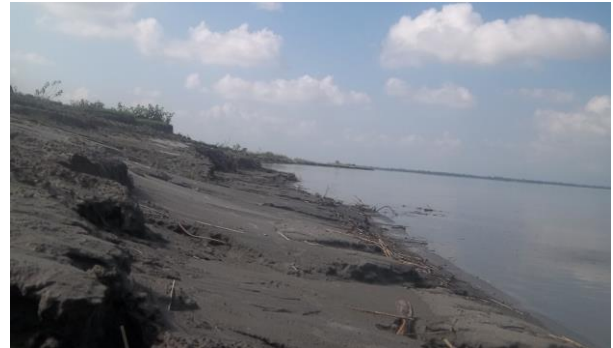
Figure 7. Unvegetated bar erosion at Char Maina Jamuna River, Jamalpur.

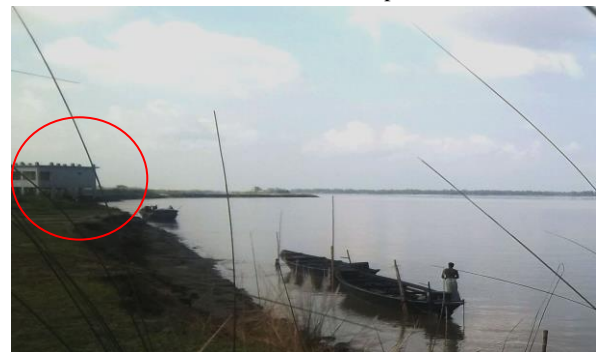
Figure 8. Govt. Primary School at Belgacha facing serious threat of bank erosion .

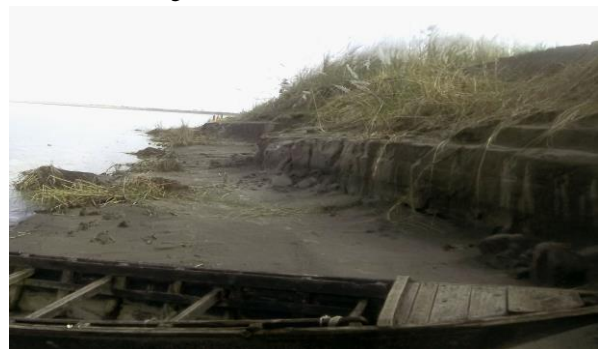
Figure 9. Vegetated bar erosion at Char Barul, Jamuna River, Jamalpur.

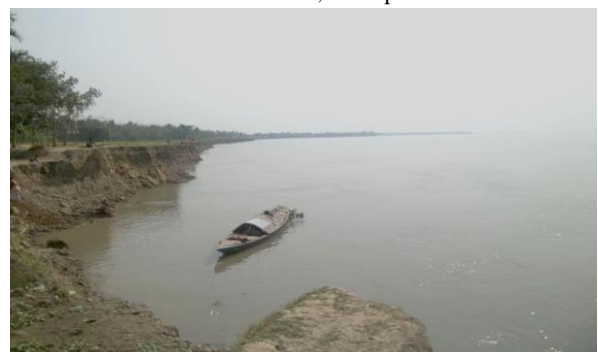
Figure 10. Bank erosion 6 km south from Bahadurabad.
