## **SM2.11:** Active tectonics of the Mediterranean as seen by recent seismic sequences

### **Factors controlling building damage distribution of the November 26 2019 Mw 6.4 Albania earthquake**

**Spyridon Mavroulis<sup>1</sup>, Efthymios Lekkas<sup>2</sup>, Panayiotis Carydis<sup>3</sup>, Dimitri Papa<sup>4</sup>**

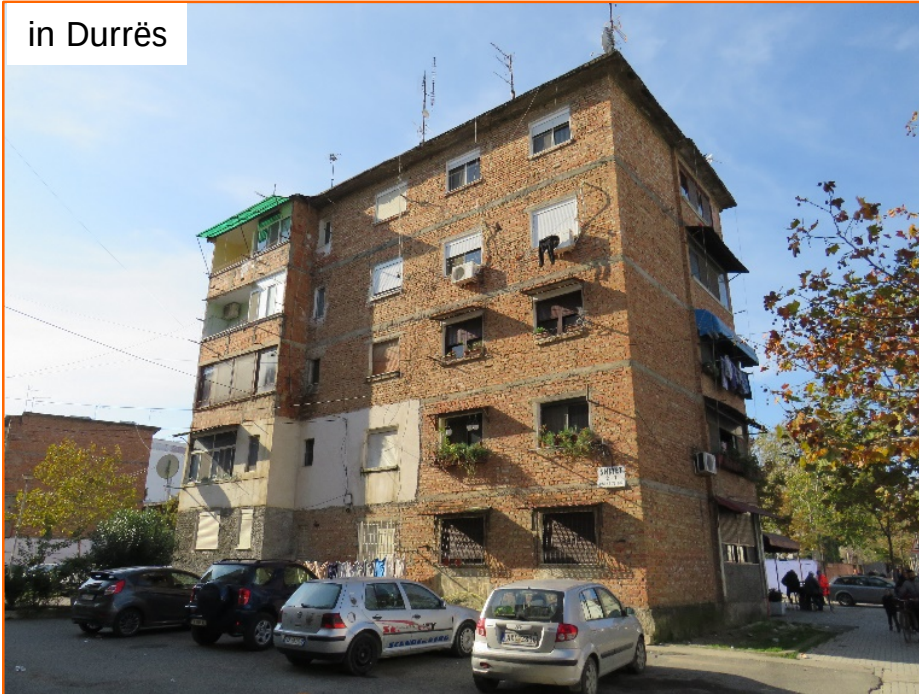
in Durrës

These buildings essentially consist of thick heavy unreinforced masonry (URM) of solid clay bricks, which supports the entire structure, including the horizontal floor slabs, which could be made of reinforced concrete members. A significant characteristic of this type of structure, not only in Albania but also around the world, is the lack of concrete columns and beams. The solid brick walls are the only and the main load bearing elements of the structure. This masonry type is unreinforced and thus it presents brittle - non-ductile behavior. Due to the construction material (solid clay bricks), they also present small stiffness resulting in good performance and flexibility during an earthquake up to a certain limit. Once this limit is exceeded, the damage is instantaneous.

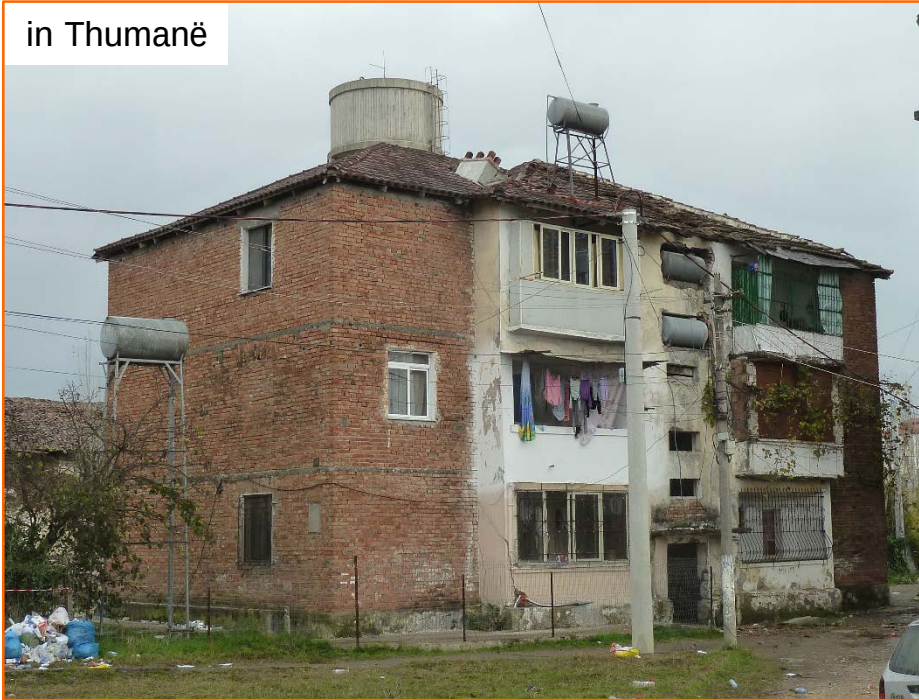
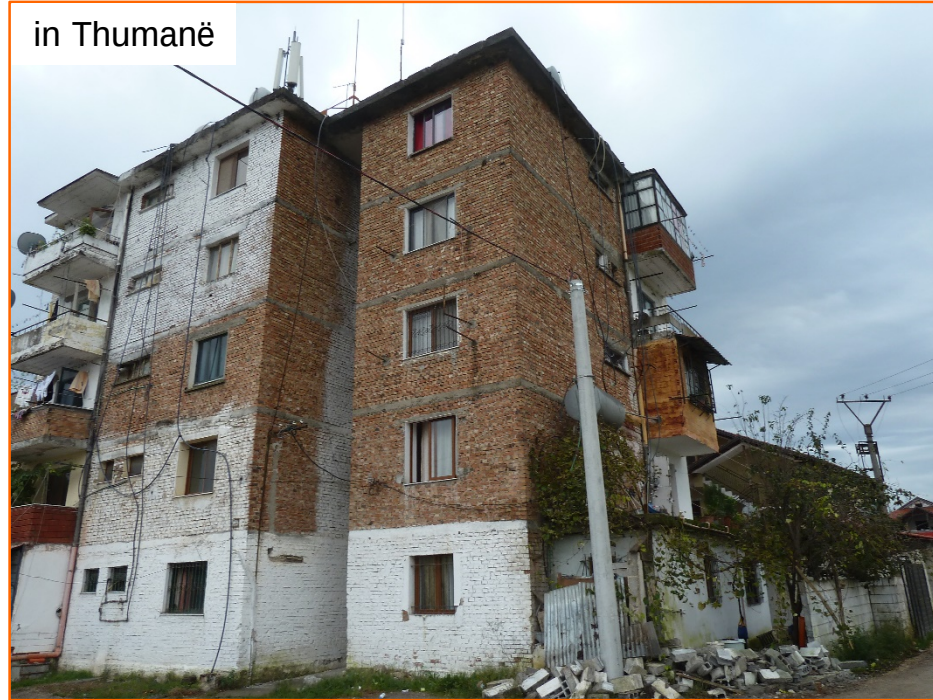
In this case, the earthquake shaking and displacement did not exceed this limit and these structures remained intact by the earthquake. A very positive characteristic in this type of buildings is that the best possible continuity between the soil and the construction is achieved, in terms of material and stiffness. These elements appear to have a positive effect on the antiseismic performance, particularly with respect to the vertical component of the earthquake ground motion. Taking into account these elements, this building type excel in antiseismic performance.

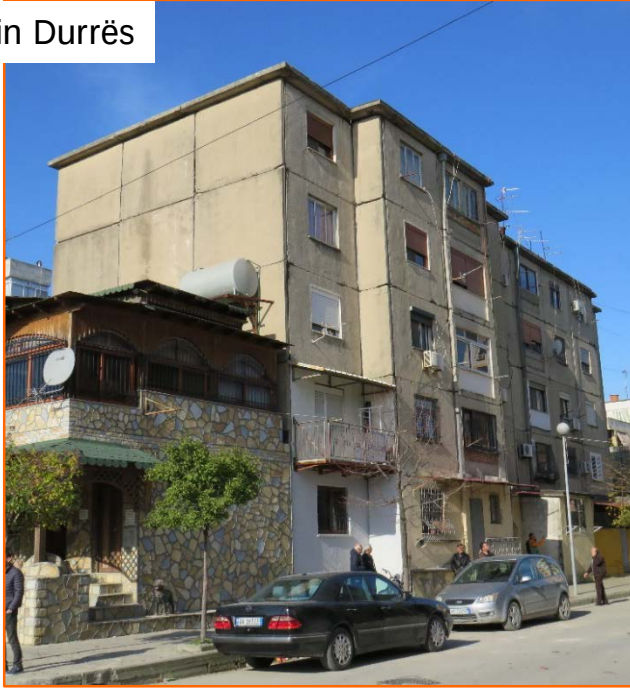
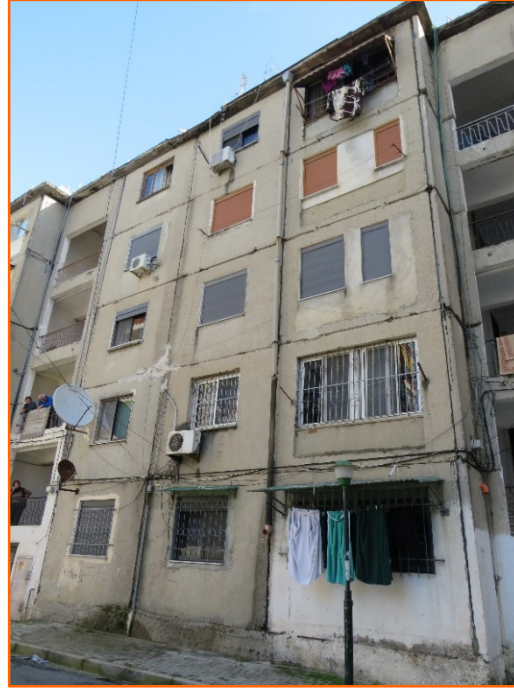
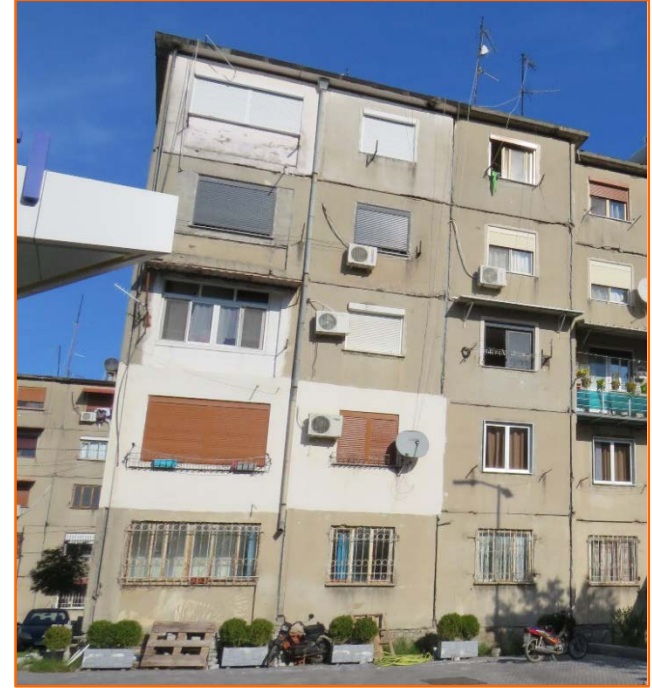
in Durrës

Heavy and light prefabricated construction methods were also applied in Albania as a mean to further lower building costs and provide rapid urbanization to meet demand. As a result of this trend, up to 60% of these prefabricated concrete wall buildings were built after the 1960s not only in the port city of Durrës, but also in Tirana and in other large cities and towns of Albania. Based on the 2001 census data, the majority of the building stock comprised brick or stone (88%) and 5% prefabricated panel construction. Even though the number of prefabricated concrete buildings is lower than in situ masonry buildings, they are usually multi-storey structures, which include residential buildings. Most of the apartment buildings constructed after 1960 were built with this methodology.

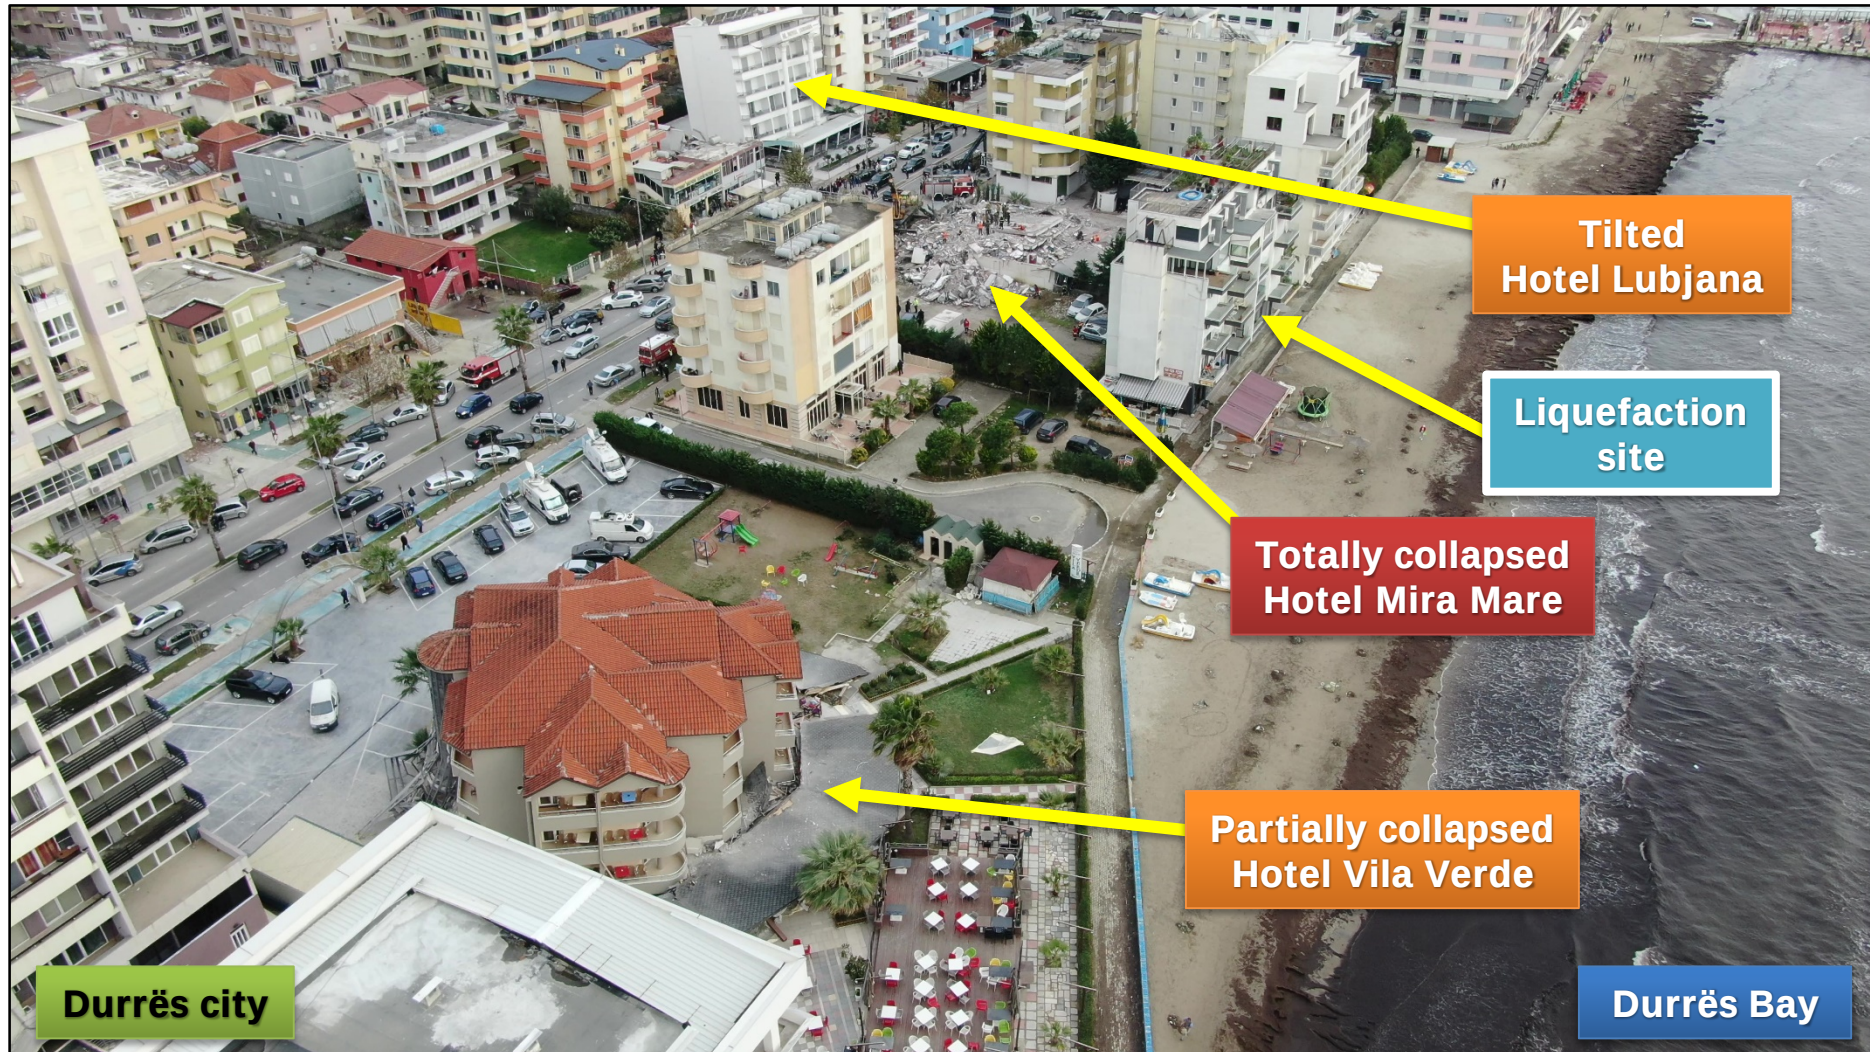
## LIQUEFACTION PHENOMENA AND VERY HEAVY STRUCTURAL DAMAGE

Ejection of liquefied material through cracks resulting in small sand volcanoes and covered pavements. These liquefaction phenomena took place few meters away from the collapsed Mira Mare Hotel and other tilted buildings in the coastal Durrës. Small scale liquefaction phenomena were also generated in the coastal area of Durrës by the September 21, 2019 Mw 5.6 earthquake ([Lekkas et al., 2019](#), Newsletter of Environmental, Disaster, and Crises Management Strategies, Vol. 13)

Close to the Mira Mare Hotel liquefaction phenomena were generated comprising ejection of sand through cracks, formation of small sand volcanoes and silt-covered pavements. The site with the three heavily damaged buildings is close to the sea and is composed of unconsolidated recent deposits that constitute the soft ground of the area.
