# **COMBINED AERIAL AND GROUND-BASED SFM MODELING FOR A VERTICAL ROCK WALL FACE TO ESTIMATE VOLUME OF FAILURE**

**Helge C. Smebye, Sean E. Salazar, Asgeir O.K. Lysdahl**  
Norwegian Geotechnical Institute, Oslo

# Rock wall failure on E18 highway between Oslo and Kristiansand

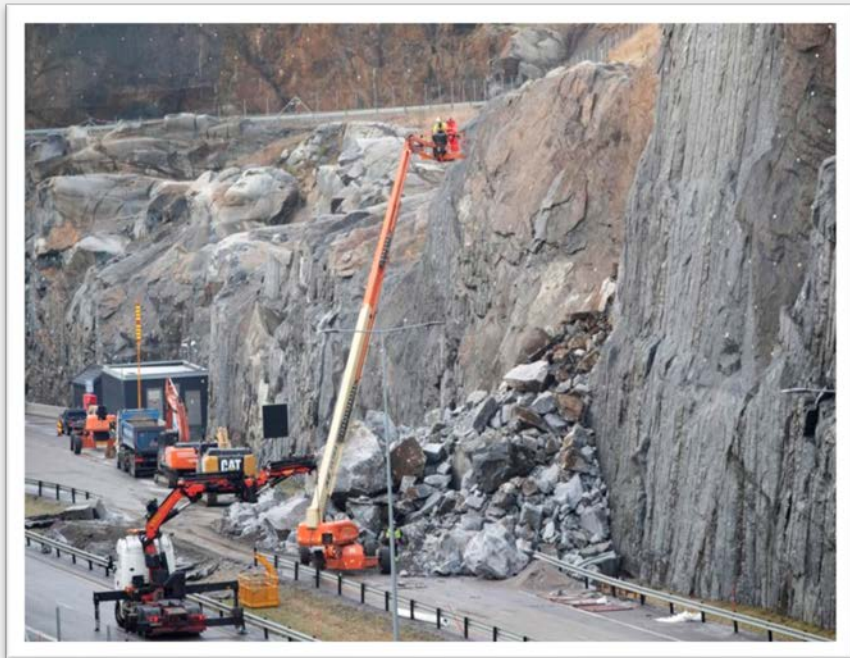
## NGI contribution to post-failure needs

- NGI part of expert group established to determine cause and suggest mitigation measures
- Needed a 3D model with colors
- Identify structures in the model
- Calculate rock volumes
- Find strike and dip, waviness and other parameters for stability calculation
- 3D model before and after failure
- Combination of DSLR images and RPAS images due to traffic on road
