# Dynamics of riparian vegetation as impacted by sedimentation in reservoirs

Olga Segura Jimenez<sup>1</sup>, Enrique González Sosa<sup>1</sup>, Pascal Breil<sup>2</sup>

**EGU** General  
Assembly 2020

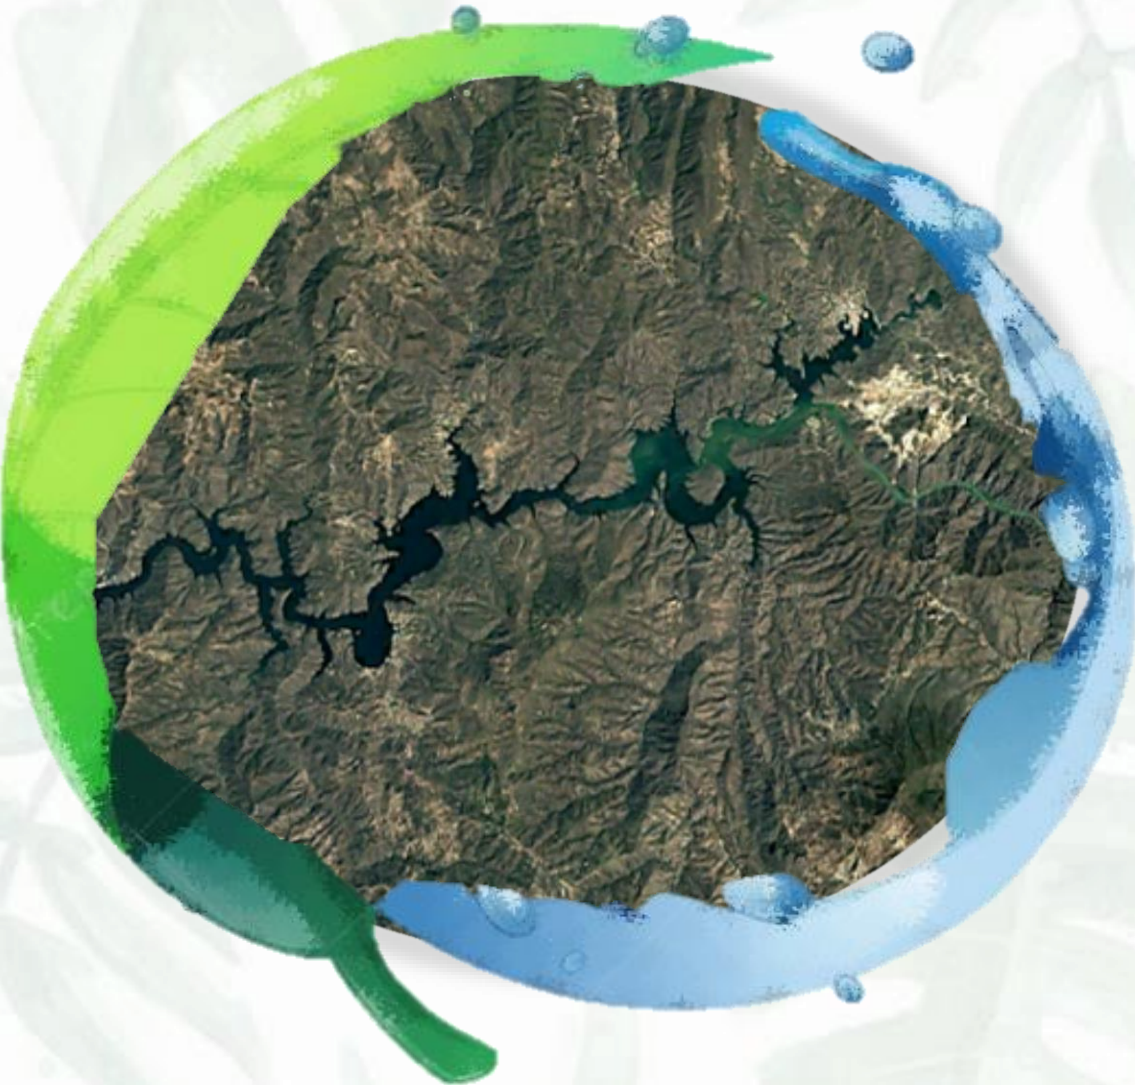
Figure 1. Hydroelectric Dam "El Caracol". Extracted from Google Earth 2019

•This work analyzes the **dynamics of the riparian ecosystems**, upstream and downstream of "El Caracol", a hydroelectric dam located in **Guerrero, Mexico**, based on Landsat TM and ETM + images corresponding to early spring (March-April) for the period of 1985-2010. The analysis was established by **mapping the dynamics of the NDVI** as an indicator of the areas affected by the migration of the vegetation and the erosion of the margins.

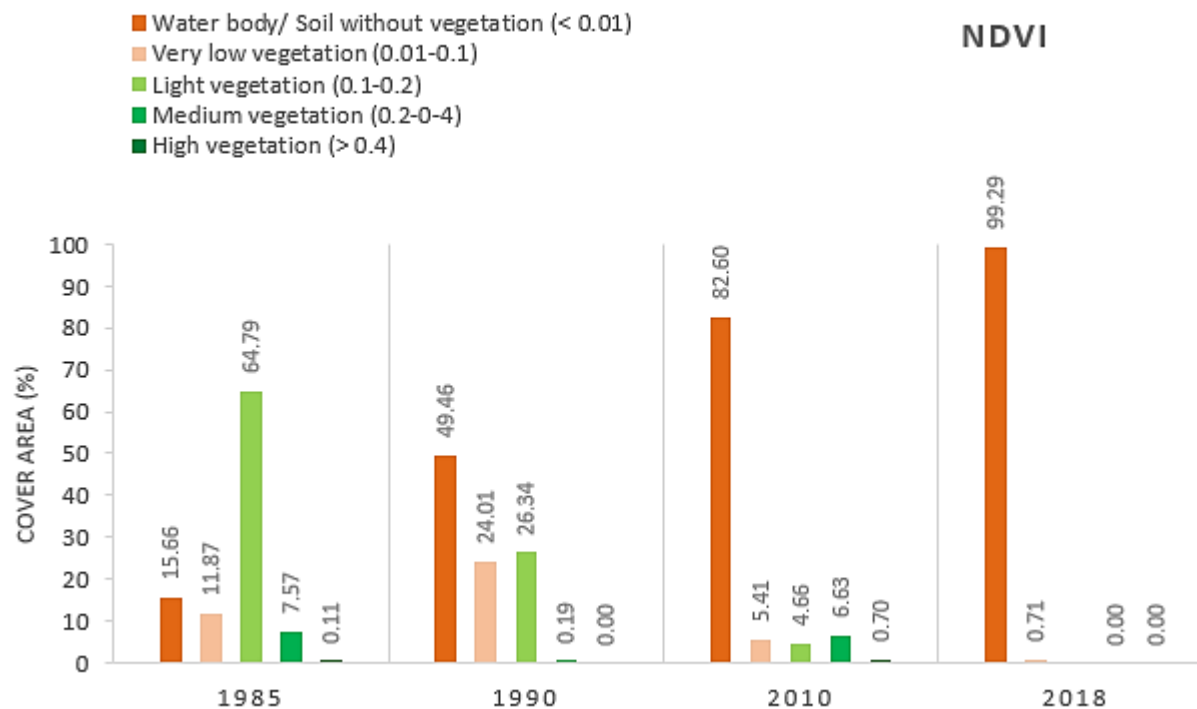
## Section #1 upstream of the reservoir

**Note:** Changes in the vegetation of sections upstream and downstream of the reservoir were analyzed. The sections are 5 km long and 0.4 km wide to study the riparian zone only.

It can be seen that upstream of the reservoir there are areas where the riparian vegetation grows on the riverbanks from 1990 to 2010, but in recent images it is observed that due to the upstream mining activity, their contamination could have generated a loss in the vegetation.

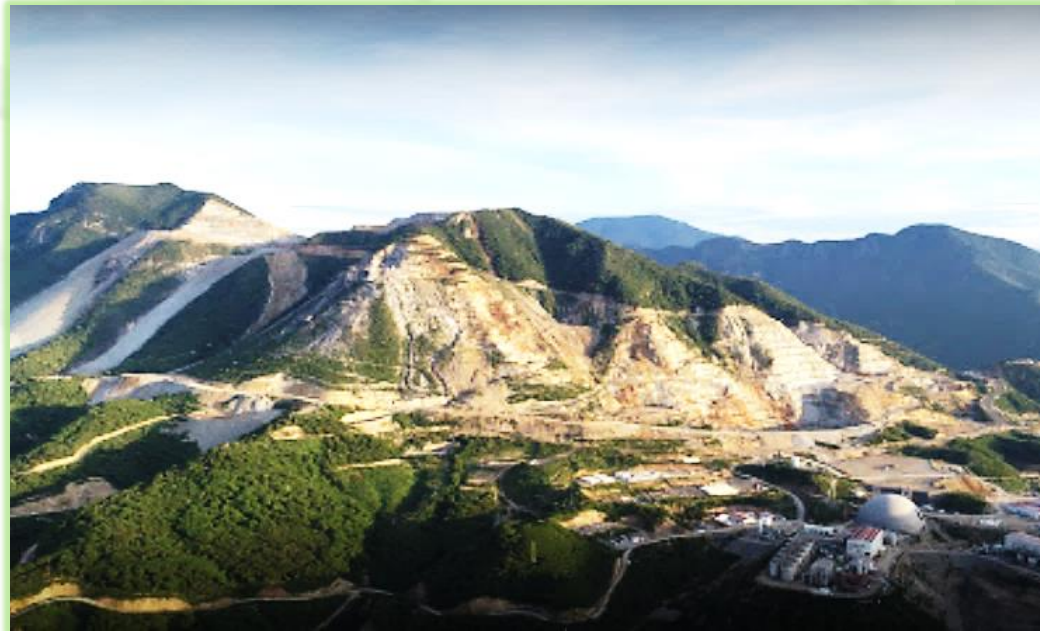
Figure 2. "El Limon" mine located upstream of the reservoir.

Since 2012 with the start of operations of the "El Limon" mine, the Canadian company Torex Gold Resources, located in Guerrero, is generating serious contamination from the chemical waste discharges it uses for the exploitation of gold and silver, which are dumped into the Balsas river and the "El Caracol" hydroelectric dam. There has been a decrease in the population of flora and fauna in the area. This is because the mine uses the cyanide leaching procedure to extract minerals, the remnants of which are directly discharged into the Balsas River.
