Modeling shallow landslides susceptibility based on statistical analysis

Helen Cristina Dias *(1), Carlos Bateira (2), Marcelo Fisher Gramani (3), Rebeca Durço Coelho (1), Vivian Cristina Dias (1), Tiago D. Martins (4) and Bianca Carvalho Vieira (1).

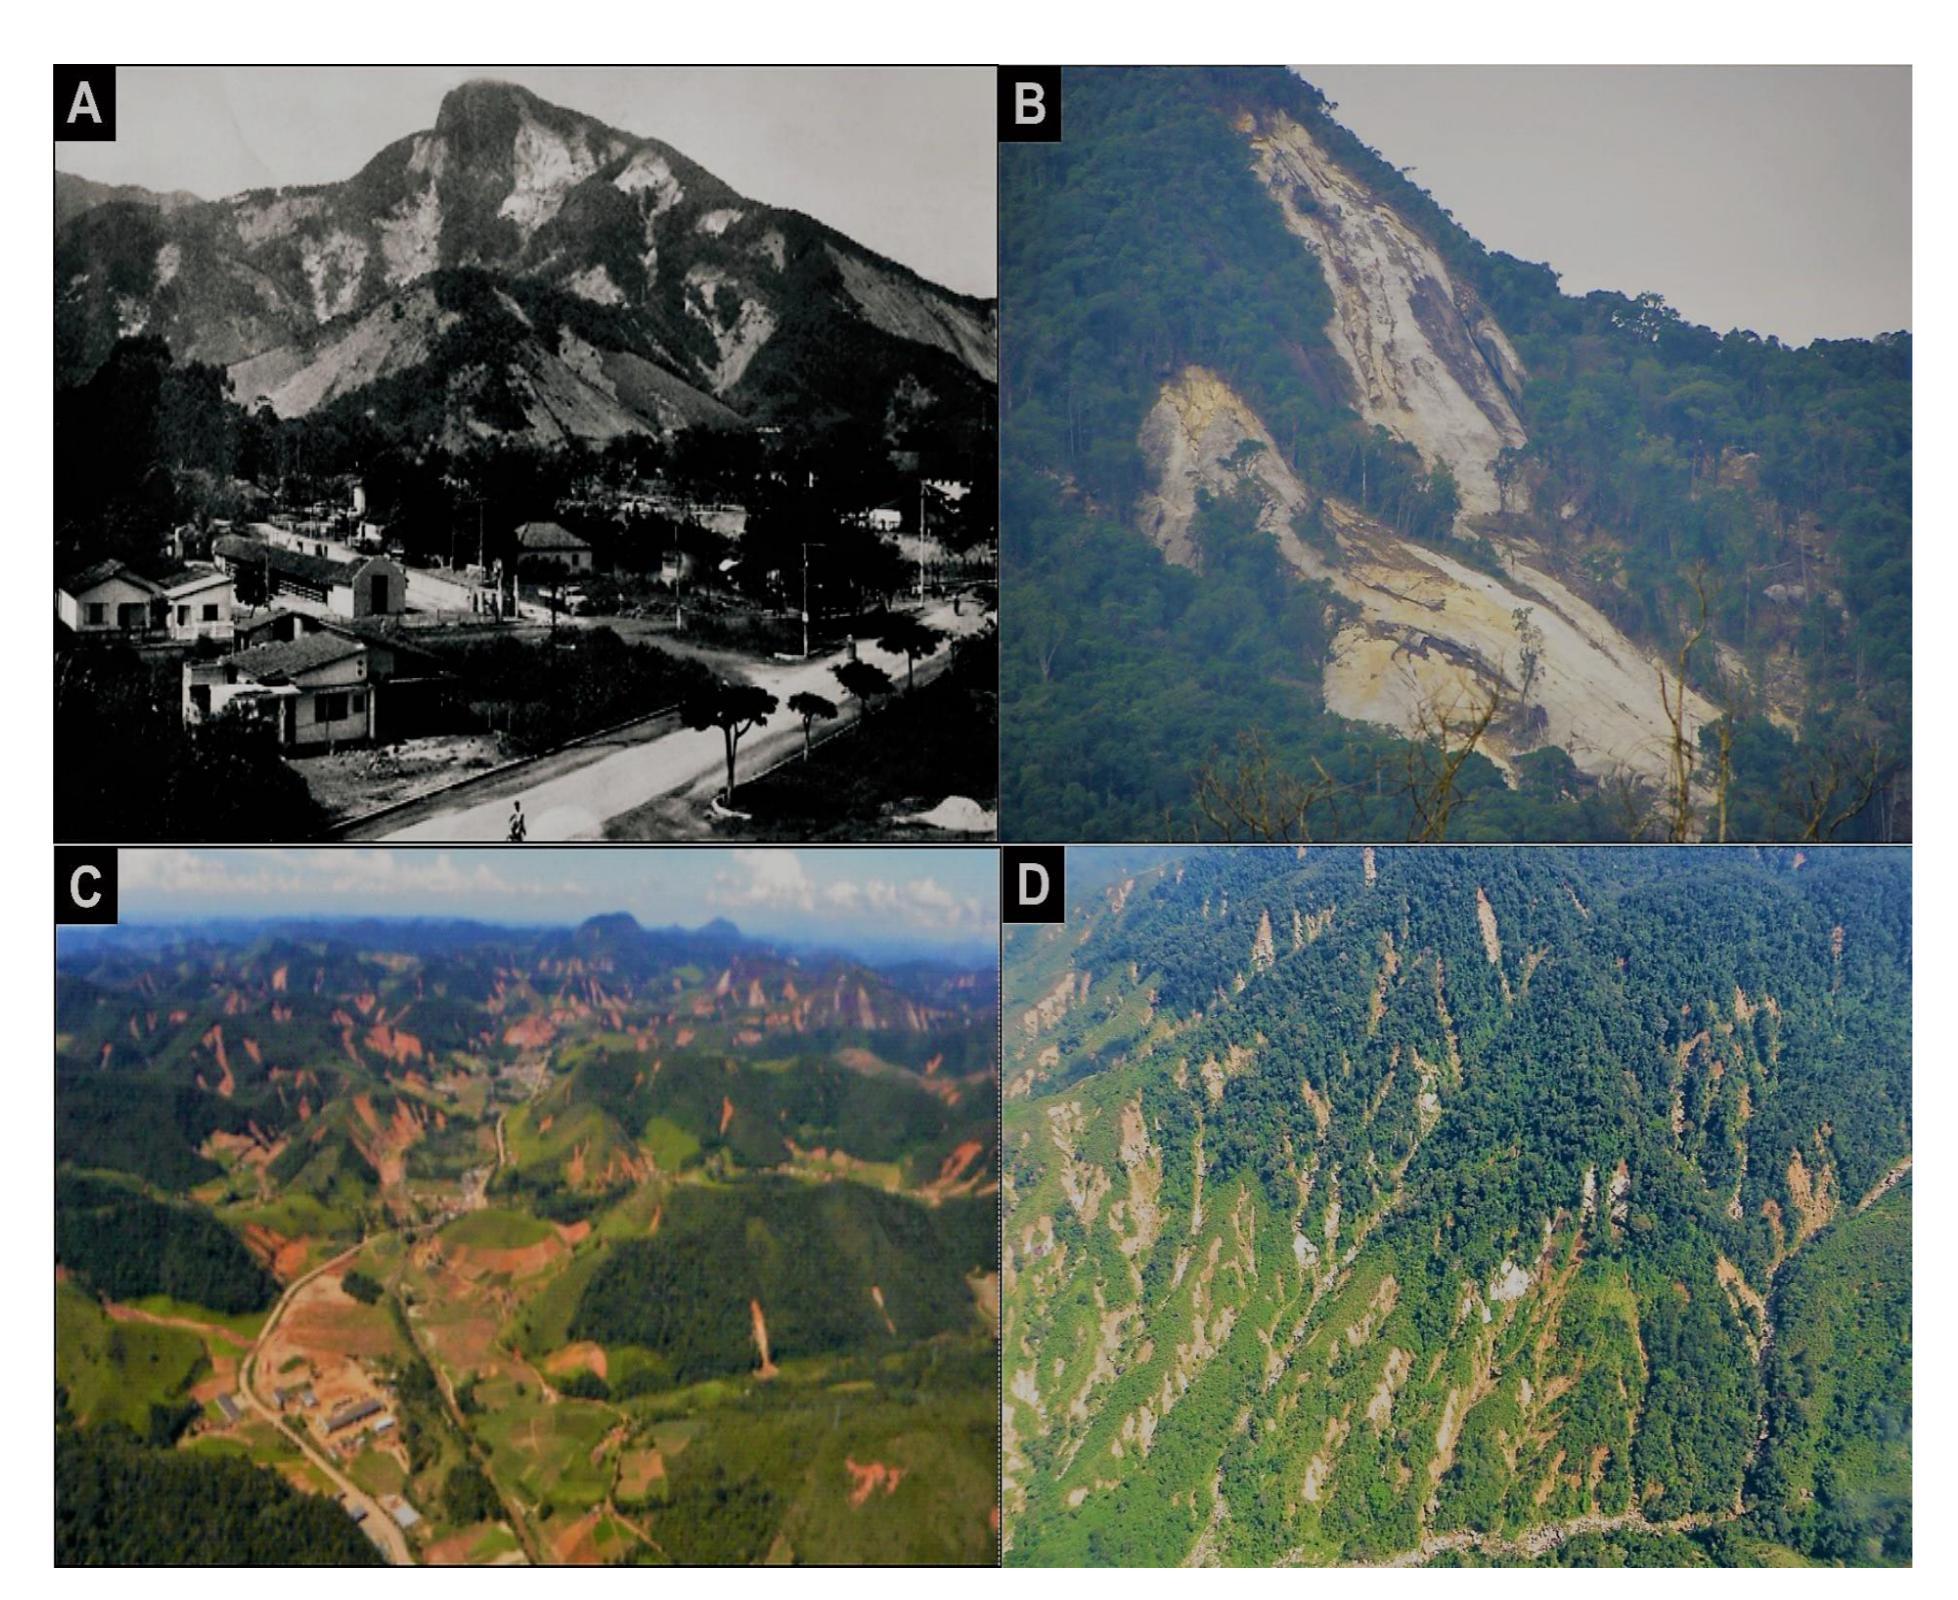
Figure 1 - Events of high magnitude occurred in Brazil in the Serra do Mar. A: Caraguatatuba, 1967; B: Serra do Mar paranaense, 2011; C: Mountain Region of Rio de Janeiro, 2011 and D: Itaóca, 2014.

Shallow landslides occur under different lithological, structural and morphological conditions. In Brazil (Figure 1) it is very common the occurrence of high magnitude events in areas with a morphological predisposition, besides favorable climatic conditions.

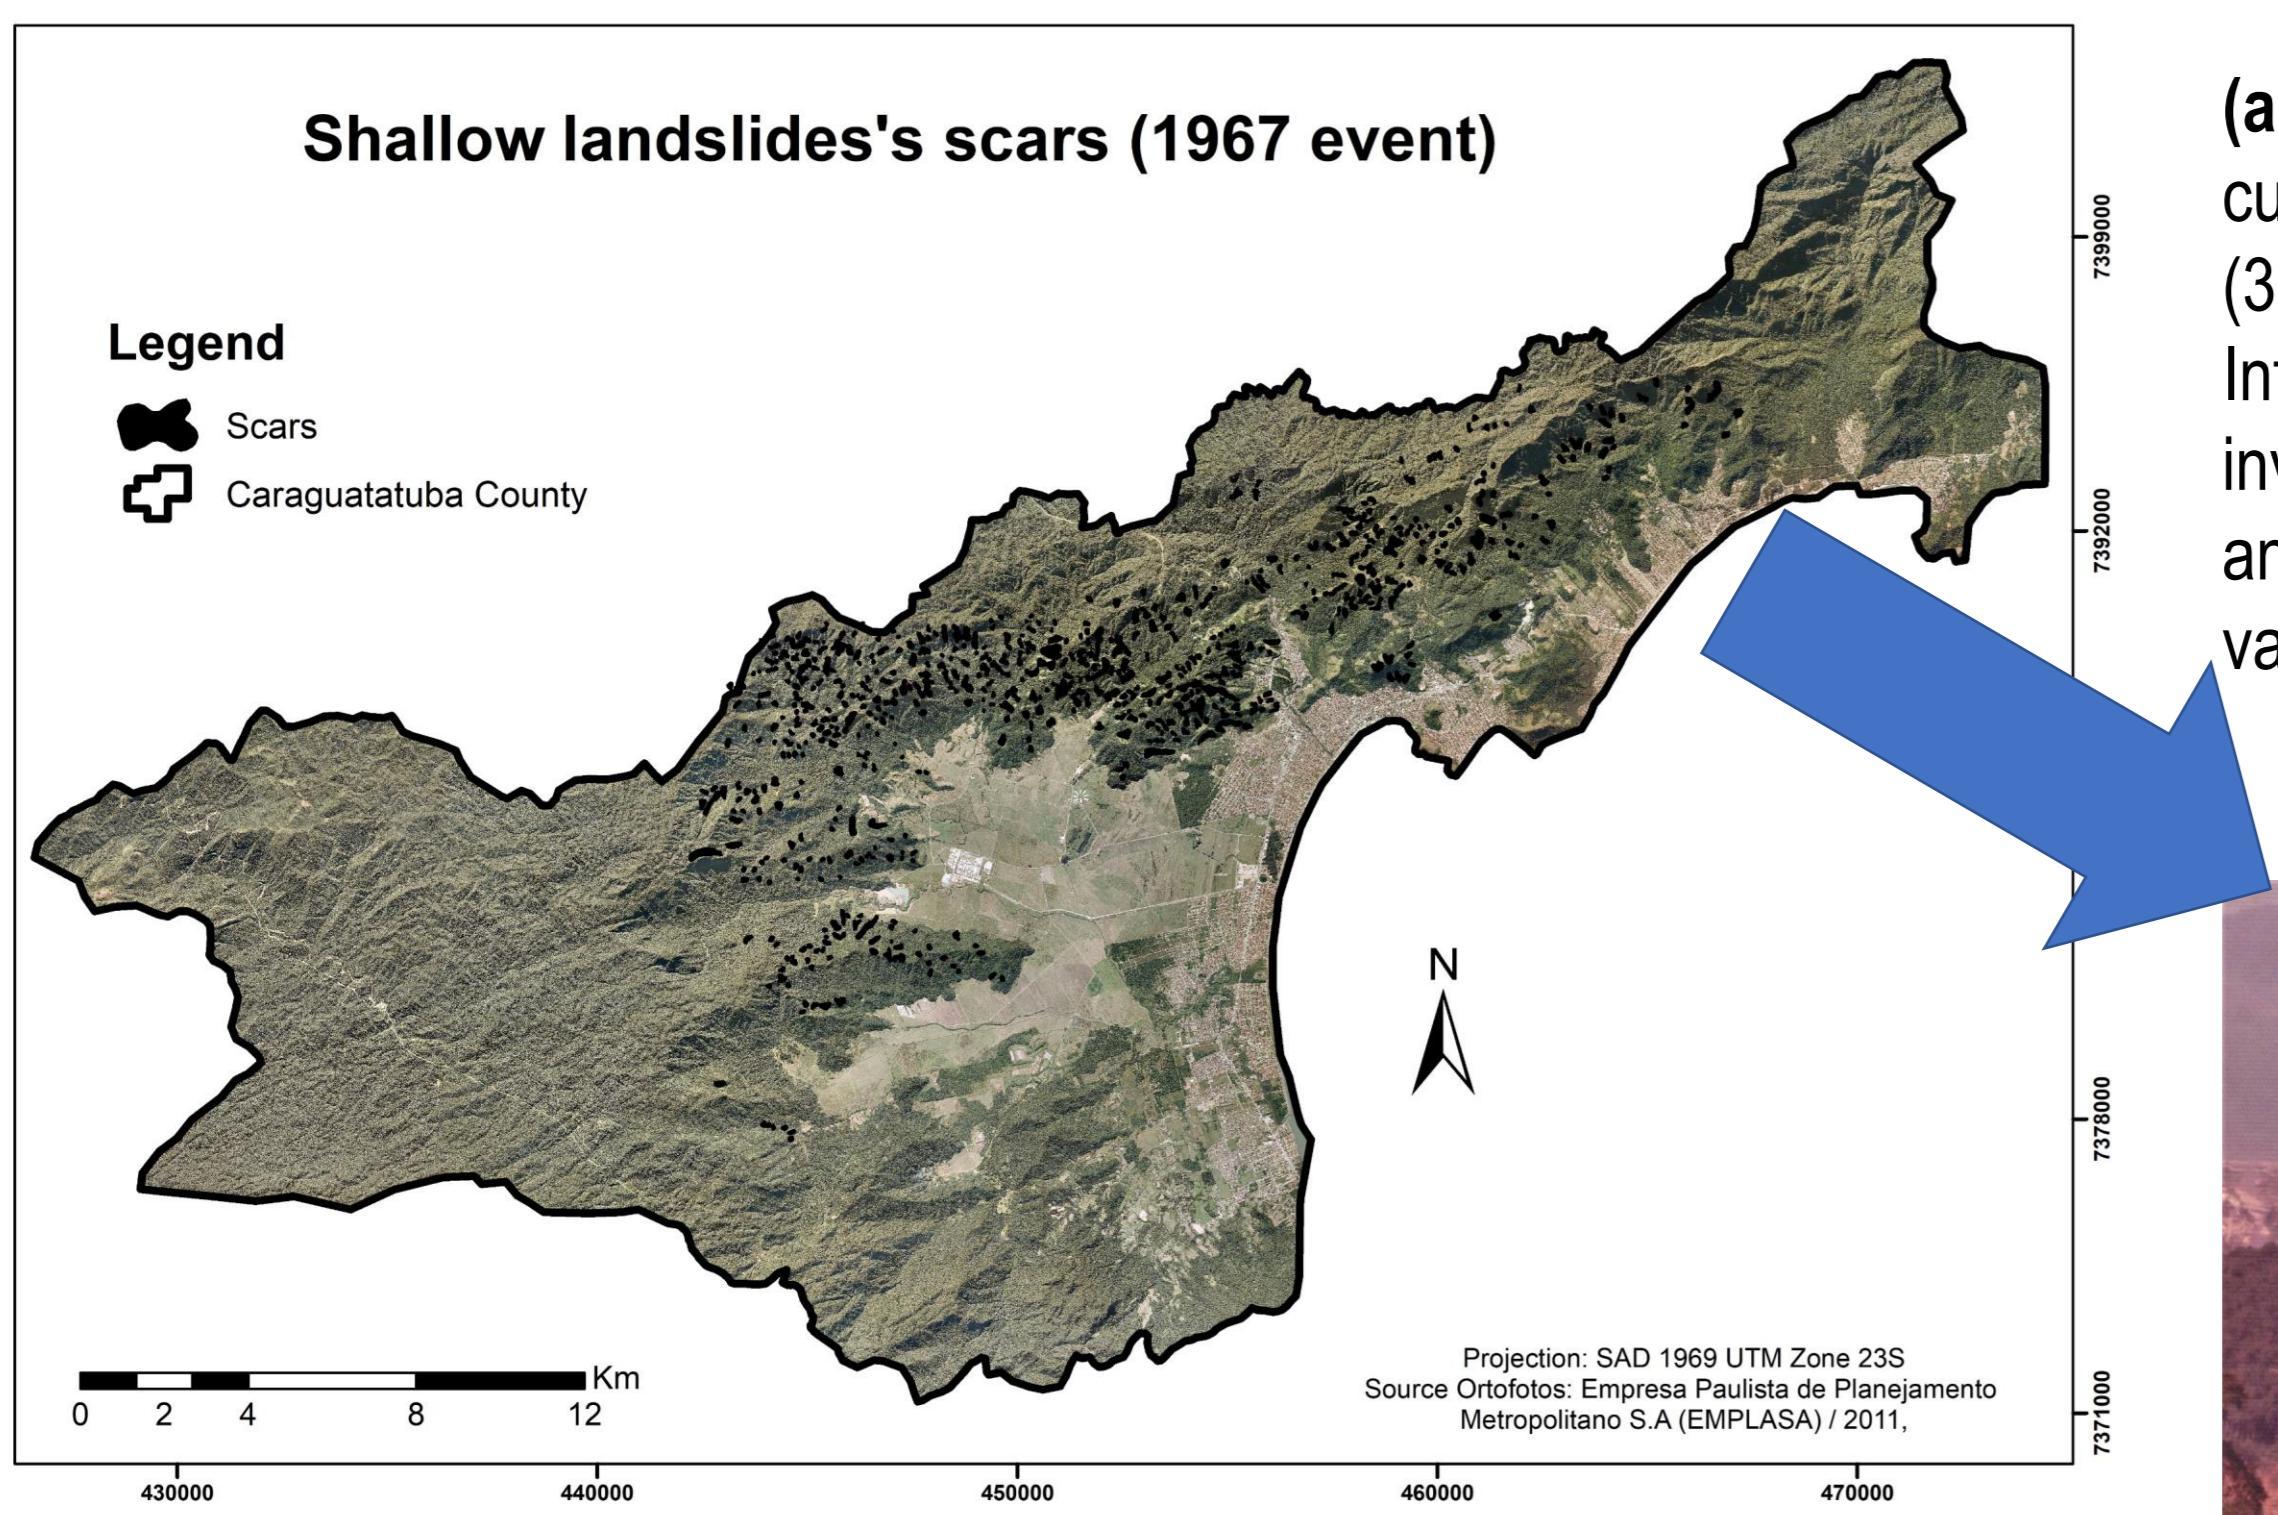
Figure 7 - Inventory of shallow landslides of the 1967 event.

(a) Morphological maps construction (Elevation, curvature, slope and aspect) based on SRTM (30 m); (b) Bivariate statistics aplication by Informative Value for each factor, using the inventory of scars from the 1967 event (Figure 7 and 8) and (c) Definition of susceptibility and validation.

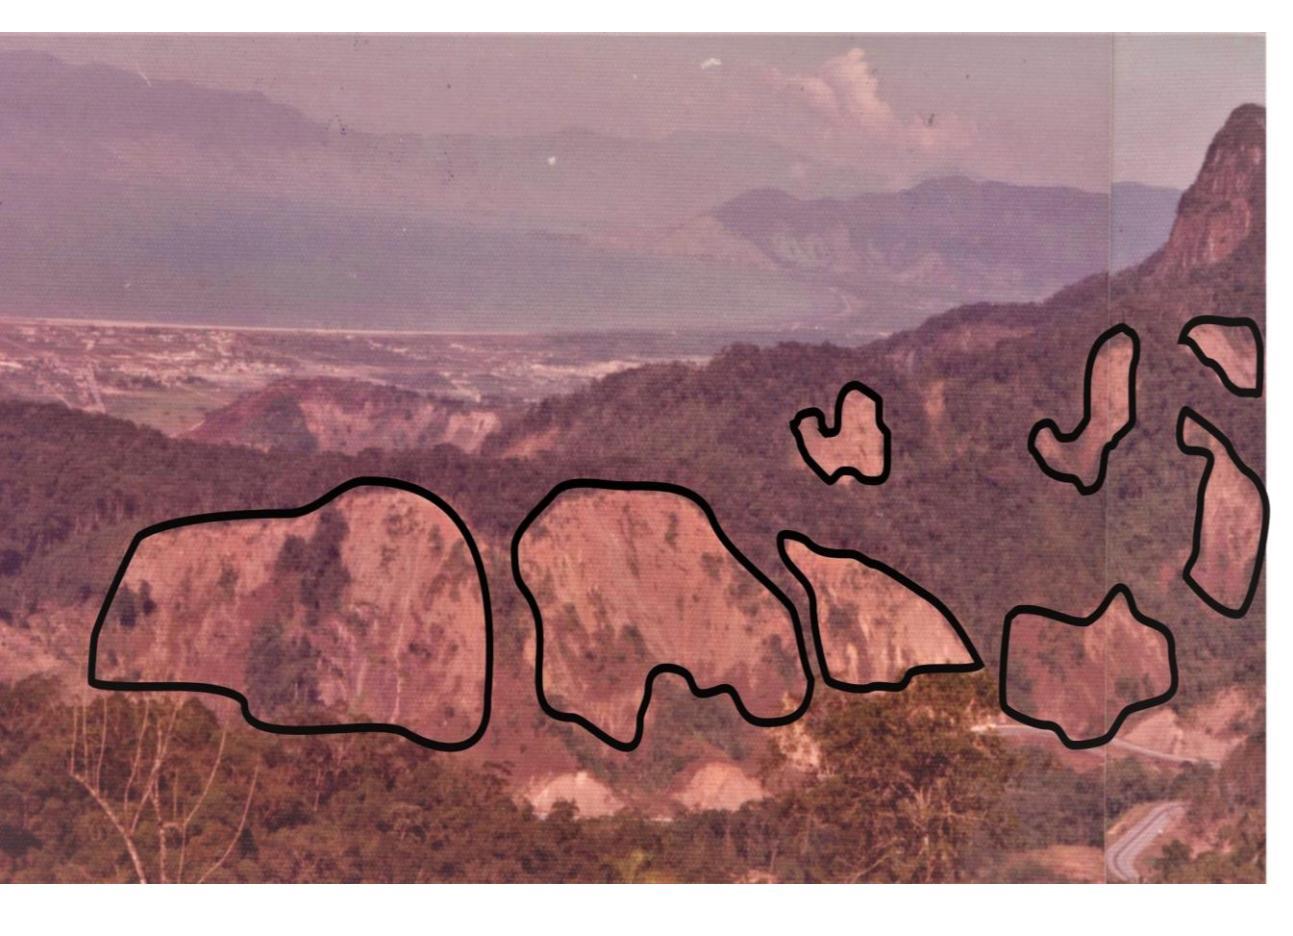
Figure 8 - Scars of shallow landslides of the 1967 event in detail (Photo: Olga Cruz).

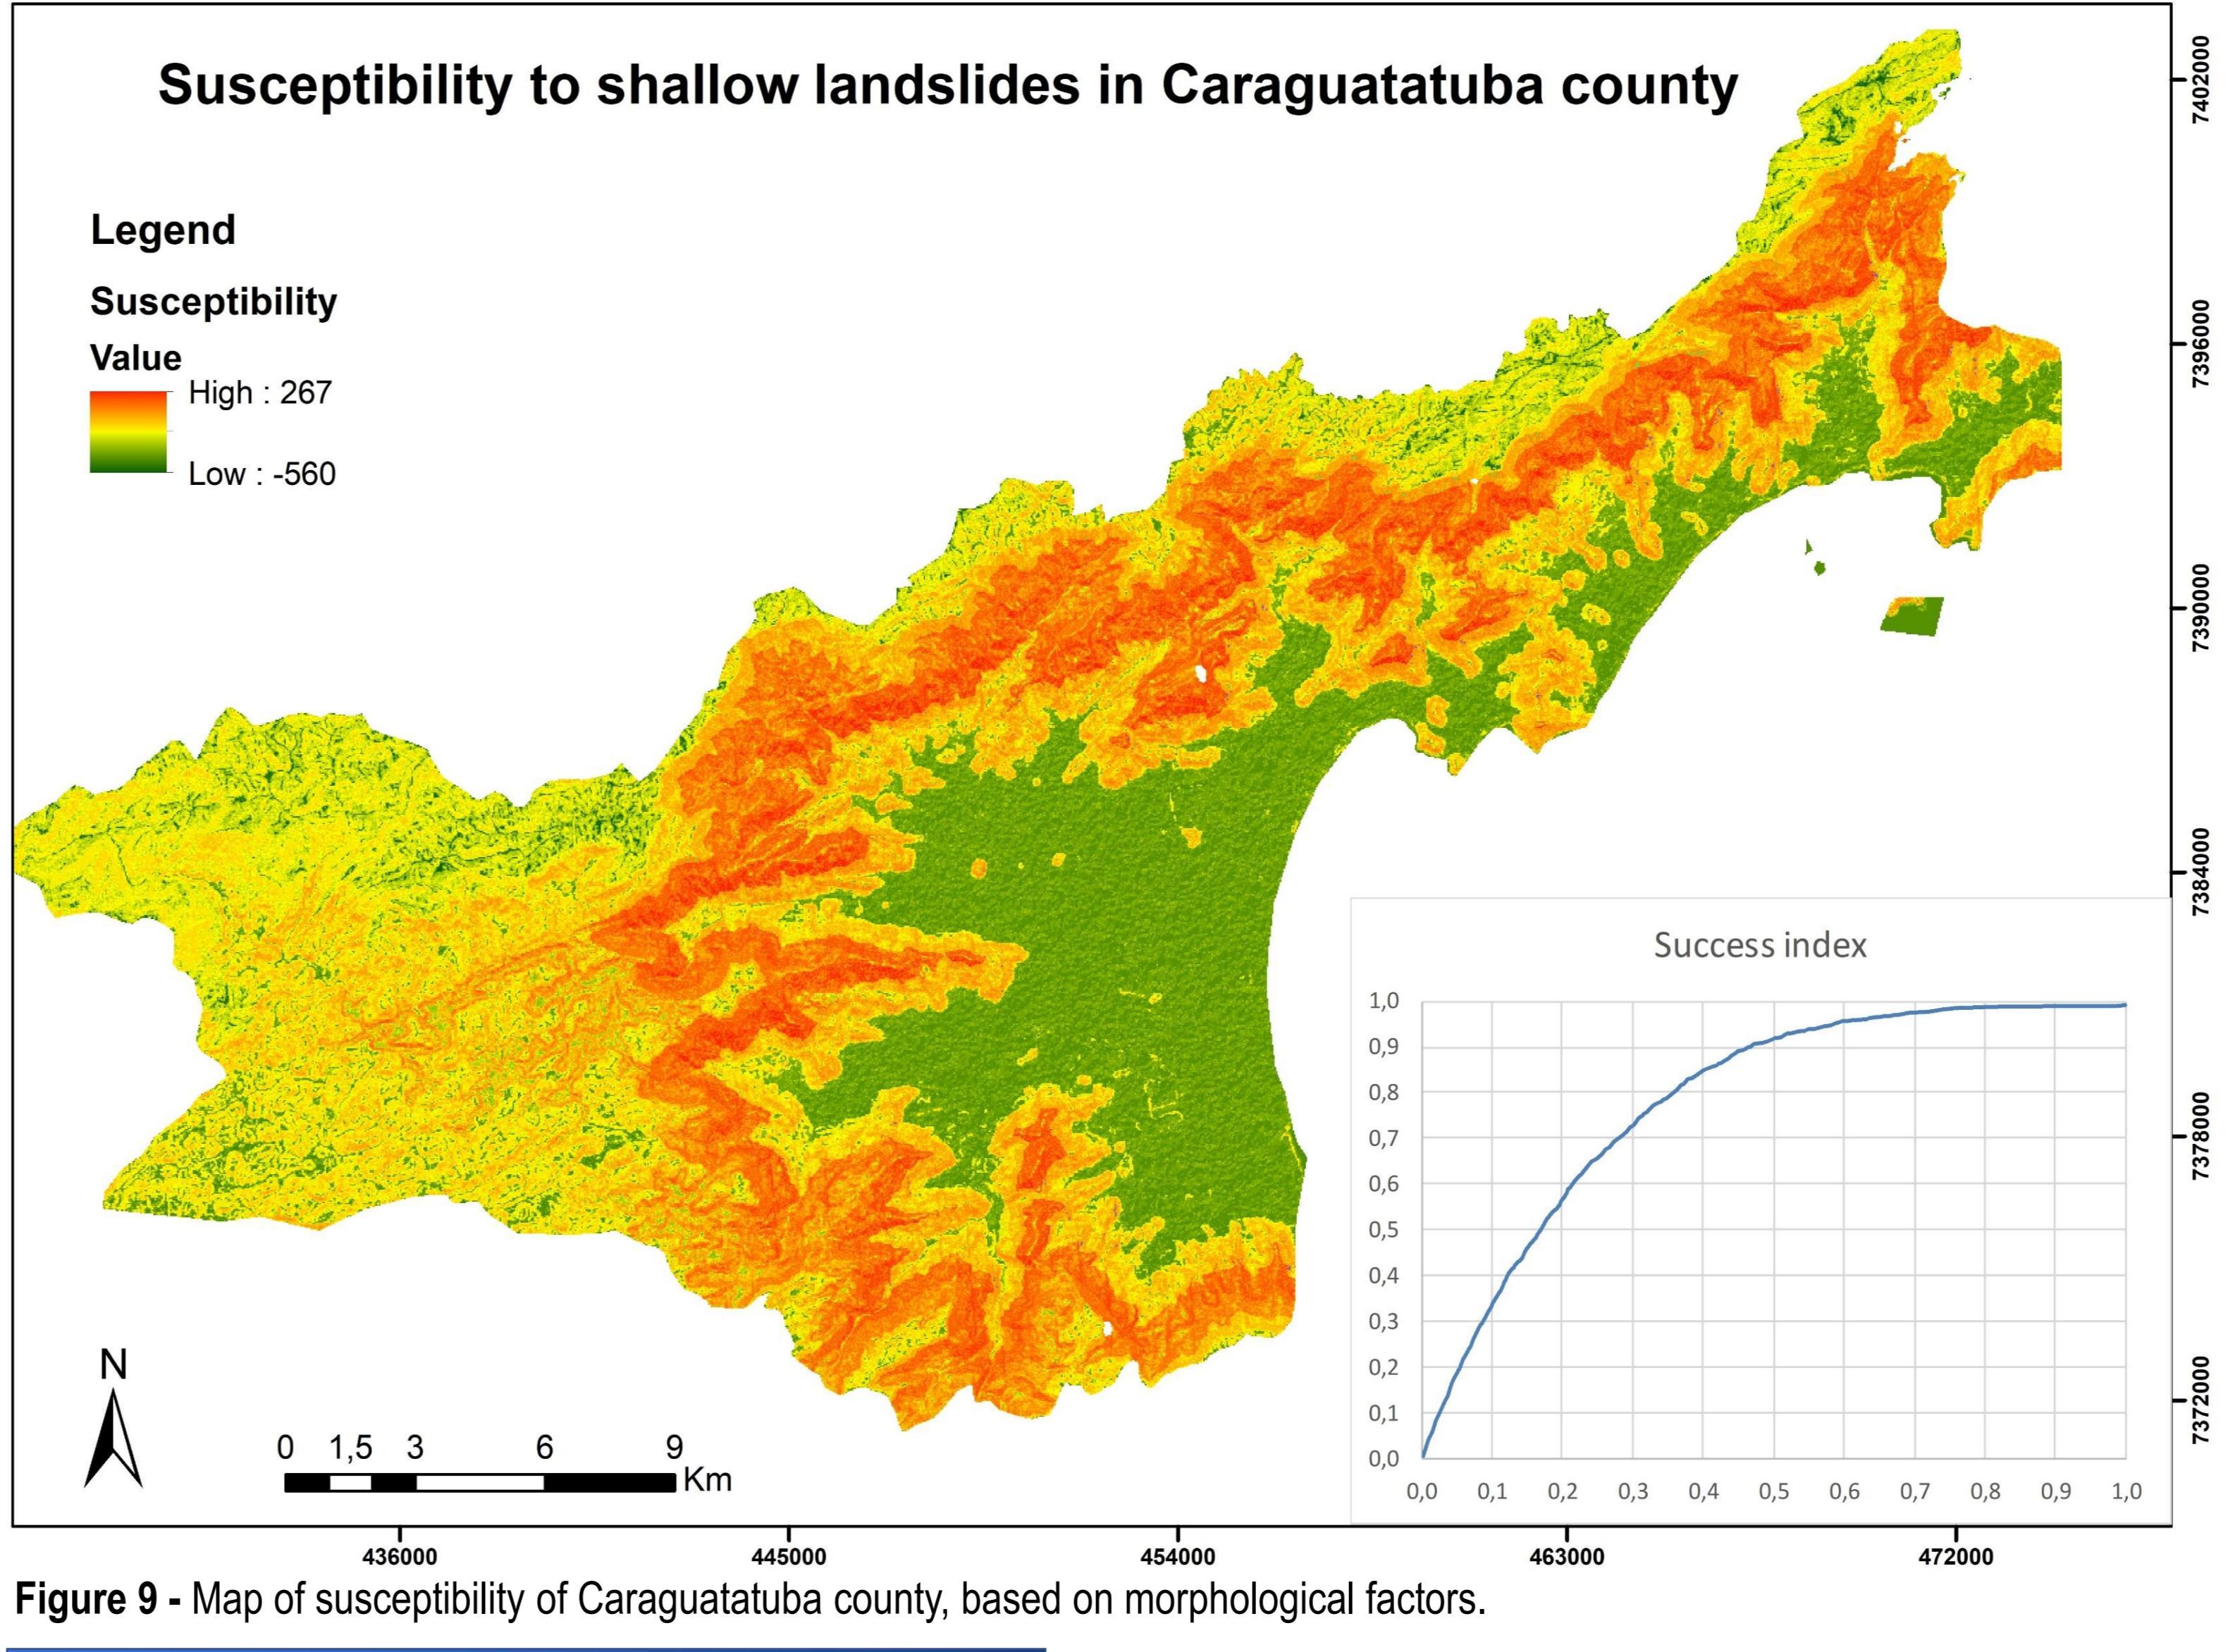
The susceptibility map generated (Figure 9) identified steep areas as more susceptible to shallow landslides occurrence. The results showed that some morphological caracteristics are associated to the occurrence of shallow landslides, with a 78% confidence in the map validation through the Area Under the Curve (AUC).

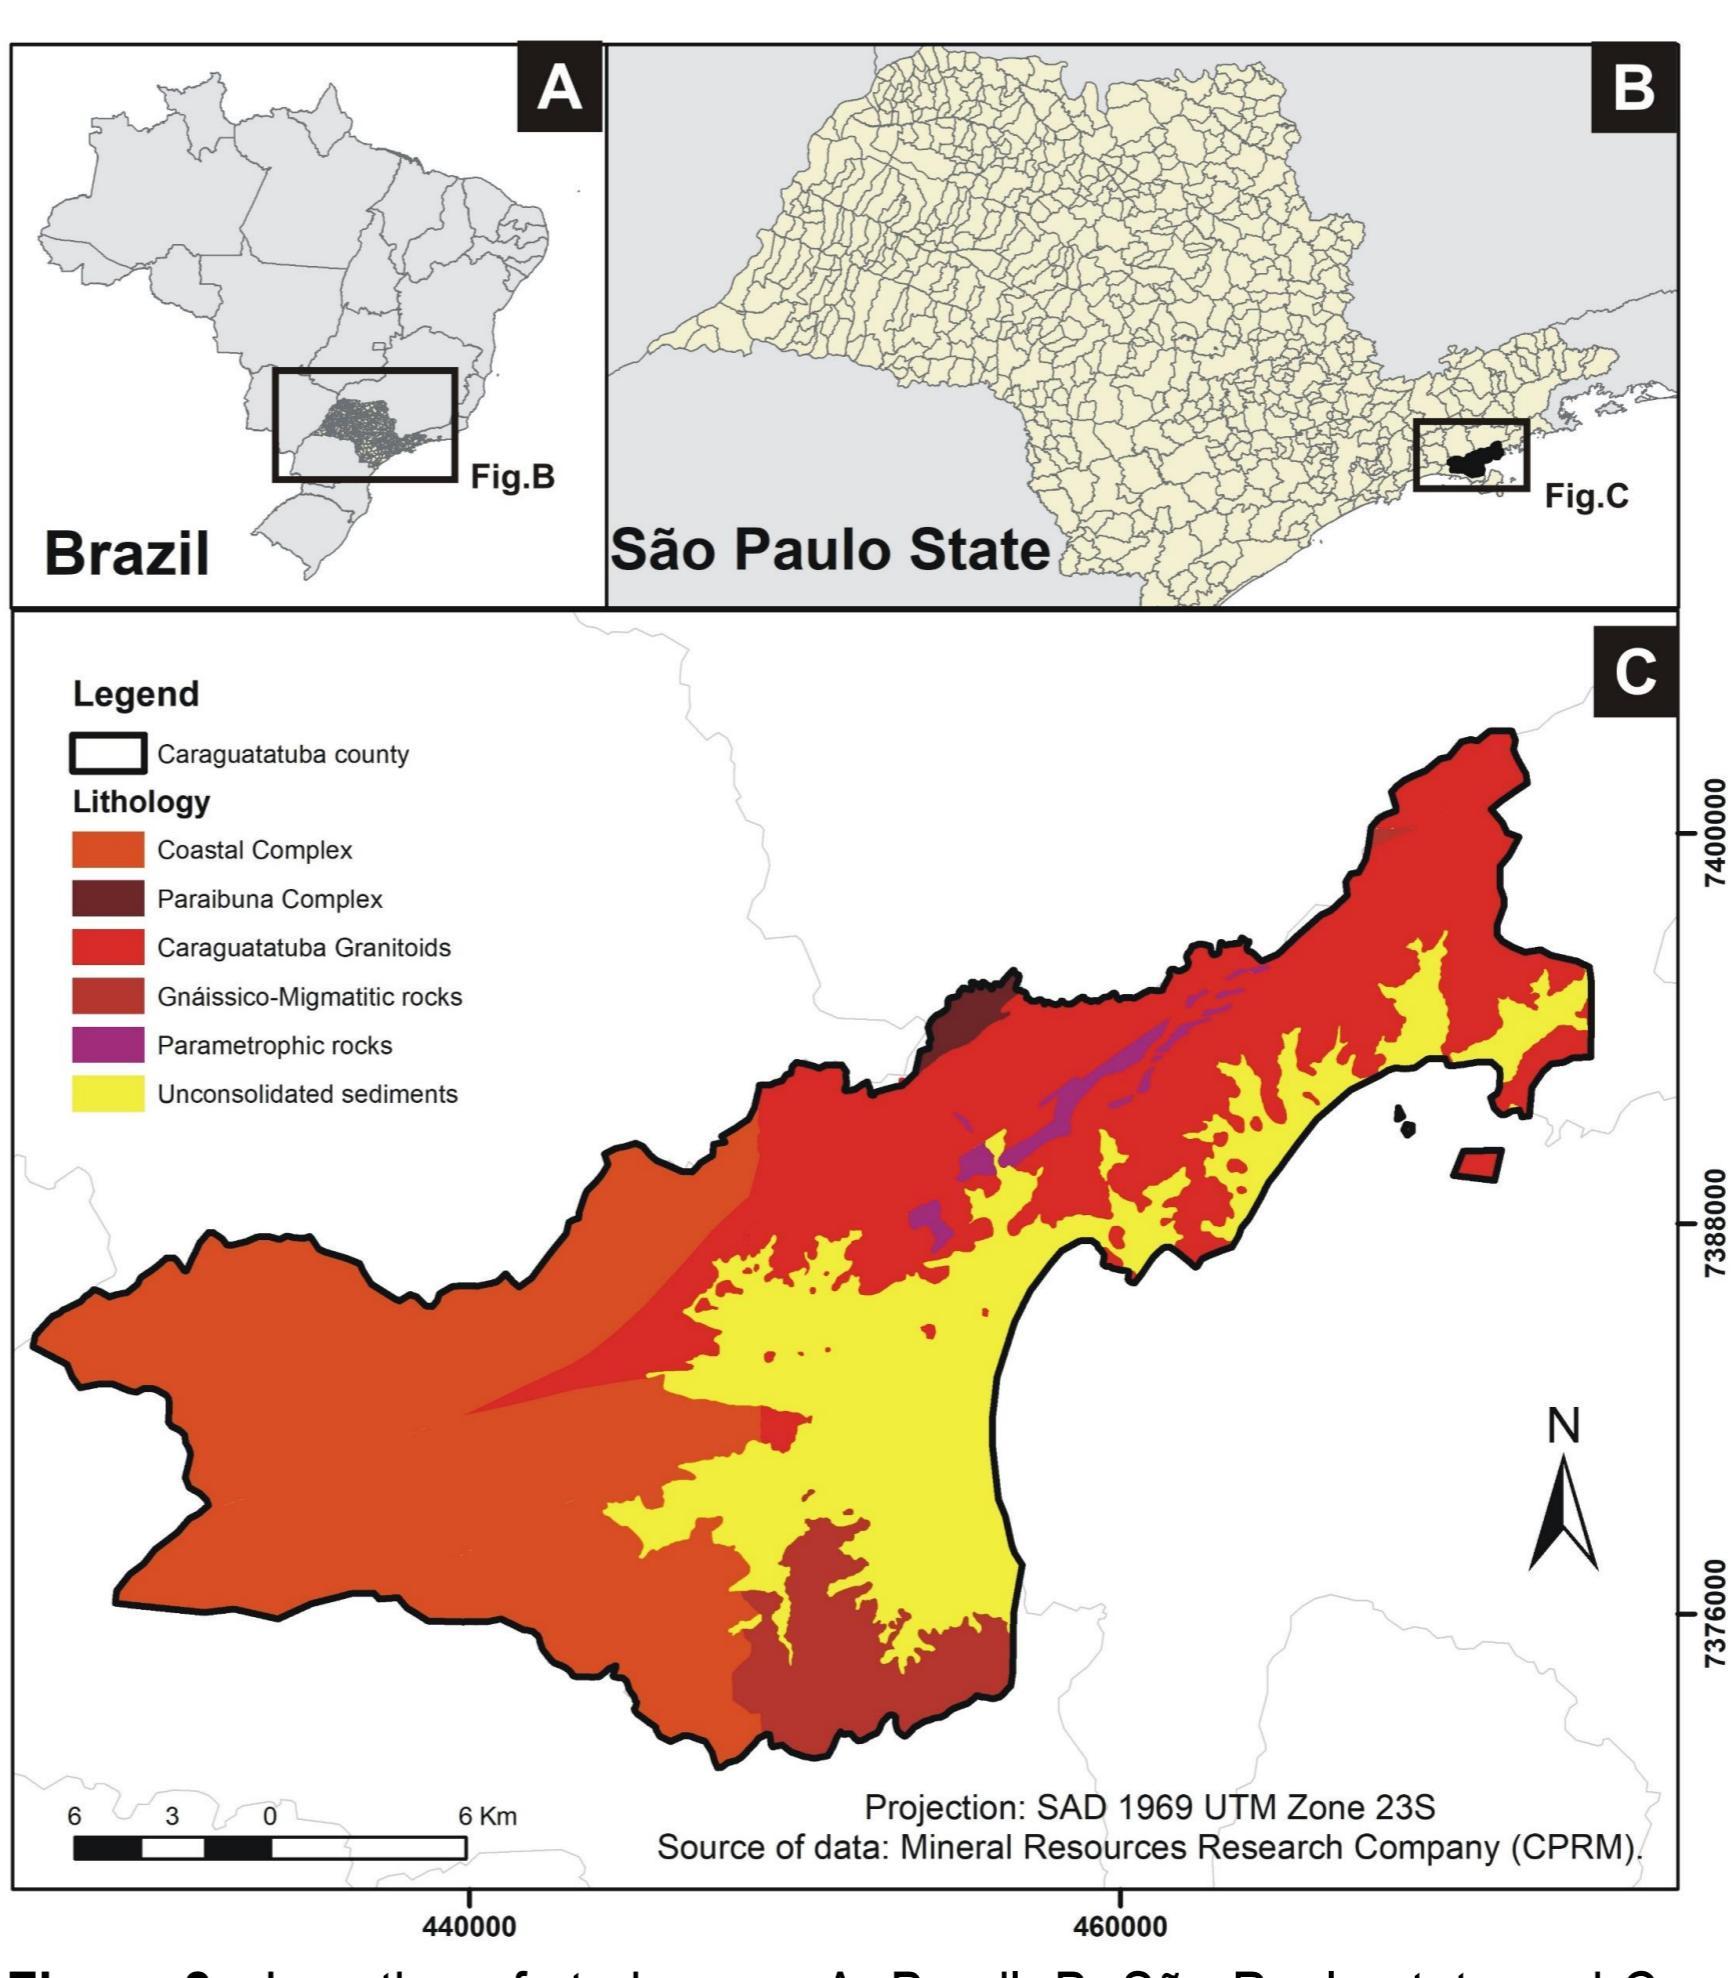
Figure 2 - Location of study area. A: Brazil; B: São Paulo state and C: Caraguatatuba county and its lithological characteristics.

Caraguatatuba county (Figure 2), is located in Serra do Mar, a mountain range with top level in altitudes between 800 and 1800 m, in the coastline of the south and southeast regions of Brazil (ALMEIDA and CARNEIRO, 1998). It presents favorable structural and morphological conditions to shallow landslides occurrence, predominating the metamorphic and igneous rocks; faults and fractures (CRUZ, 1974), besides of high pluviometric volumes between 1,600 and 2,000 mm, specially in summer season (Dec to Mar).

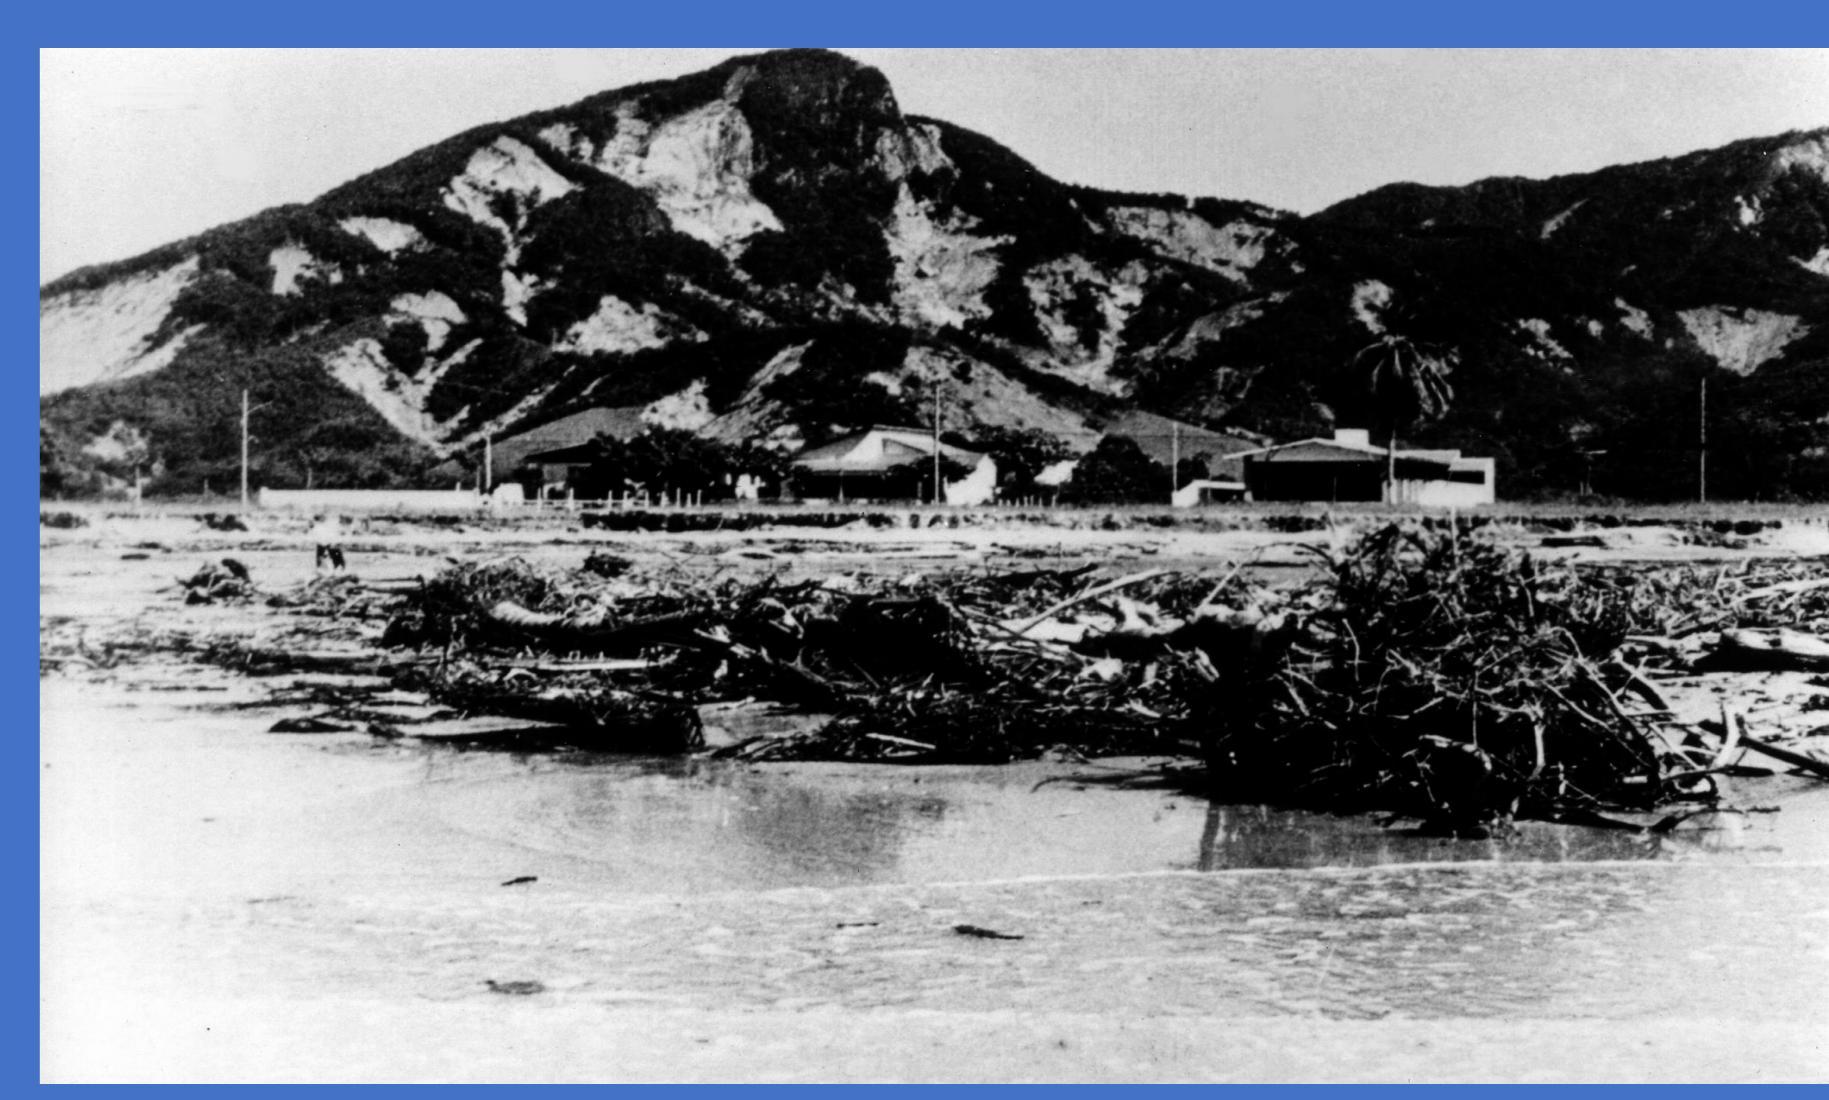
Figure 3 - Shallow landslides on the hill of Caraguatatuba county (Source: Public Archive of Caraguatatuba).

In 1967 at Caraguatatuba county occured a high magnitude event, which was characterized by rainfall above average in a short period of time (584.8 mm / 48 h), triggering landslides and debris flow in the area, affecting the city's infrastructure and resulting in 120 deaths (Figures 3 to 6) (CRUZ, 1974; DE PLOYE and CRUZ, 1979).

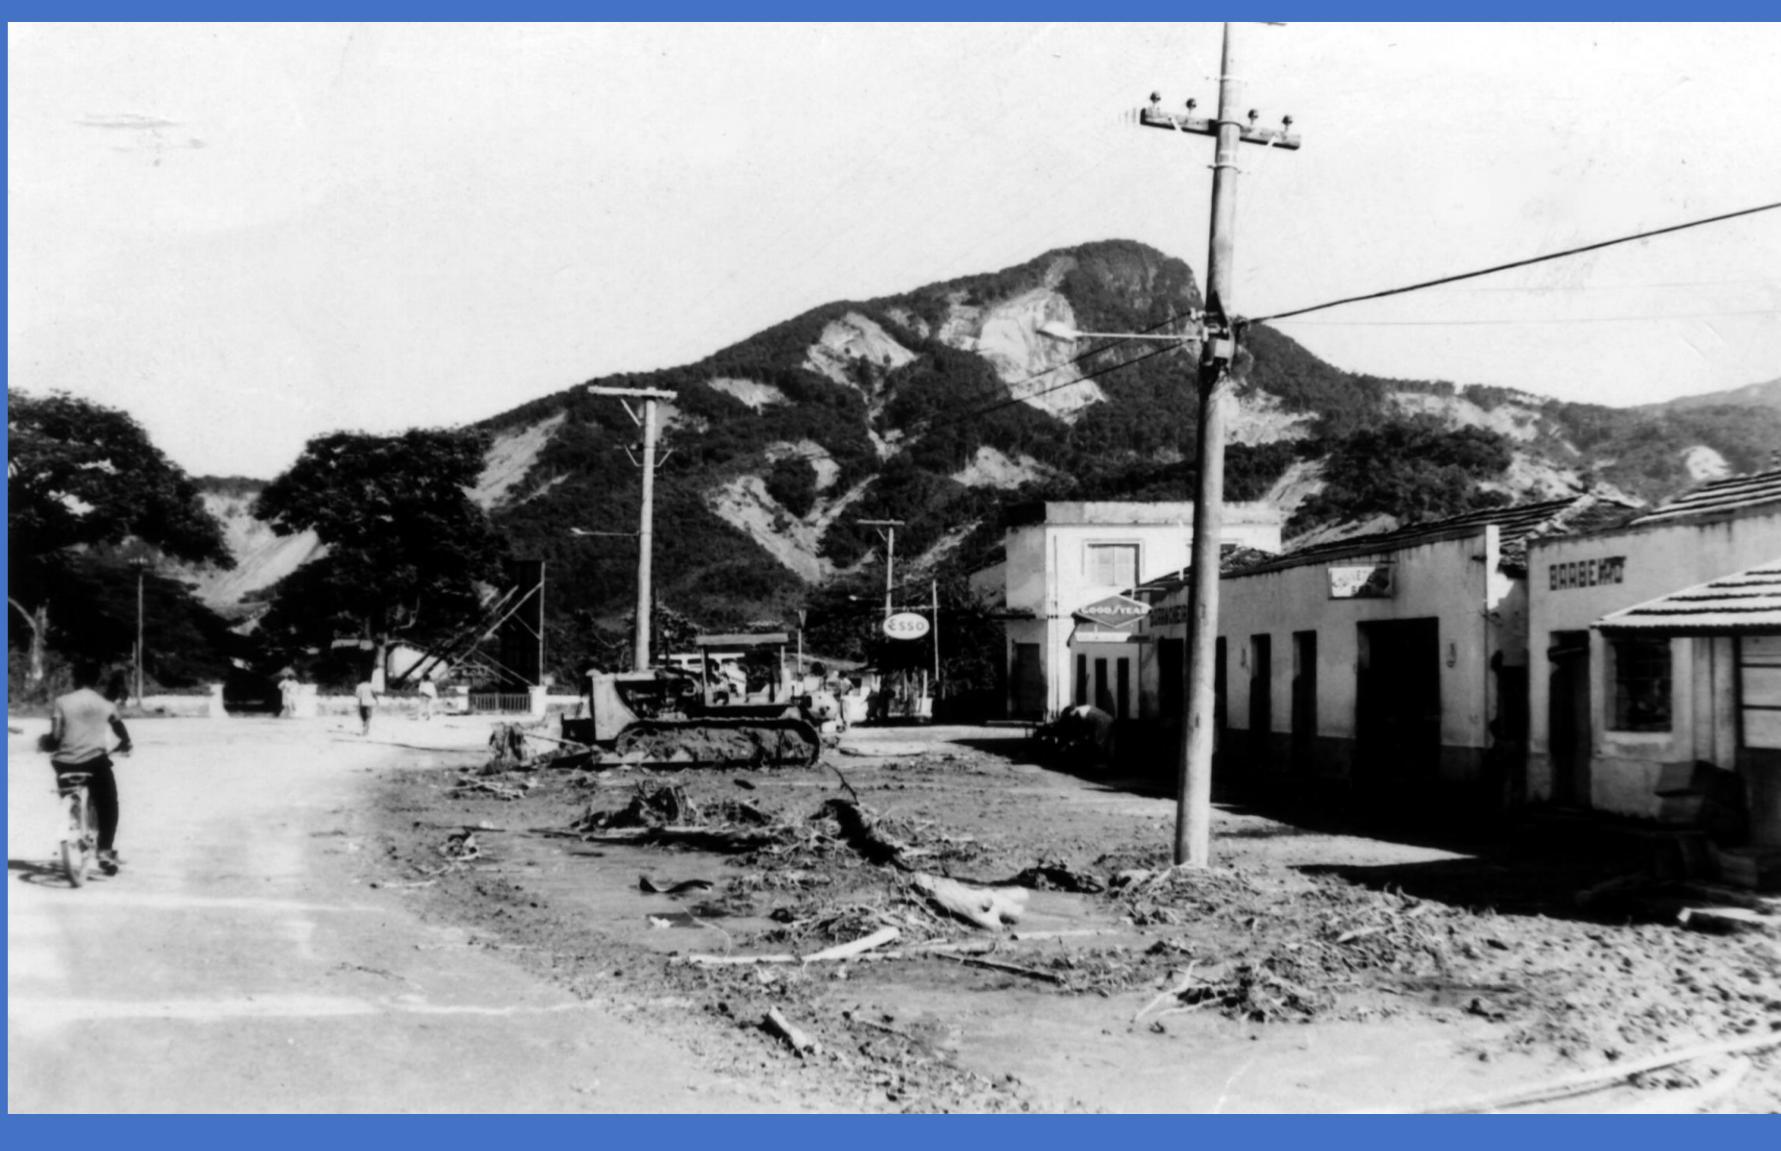
Figure 4 - Material mobilized in the streets of the city (Source: Public Archive of Caraguatatuba).

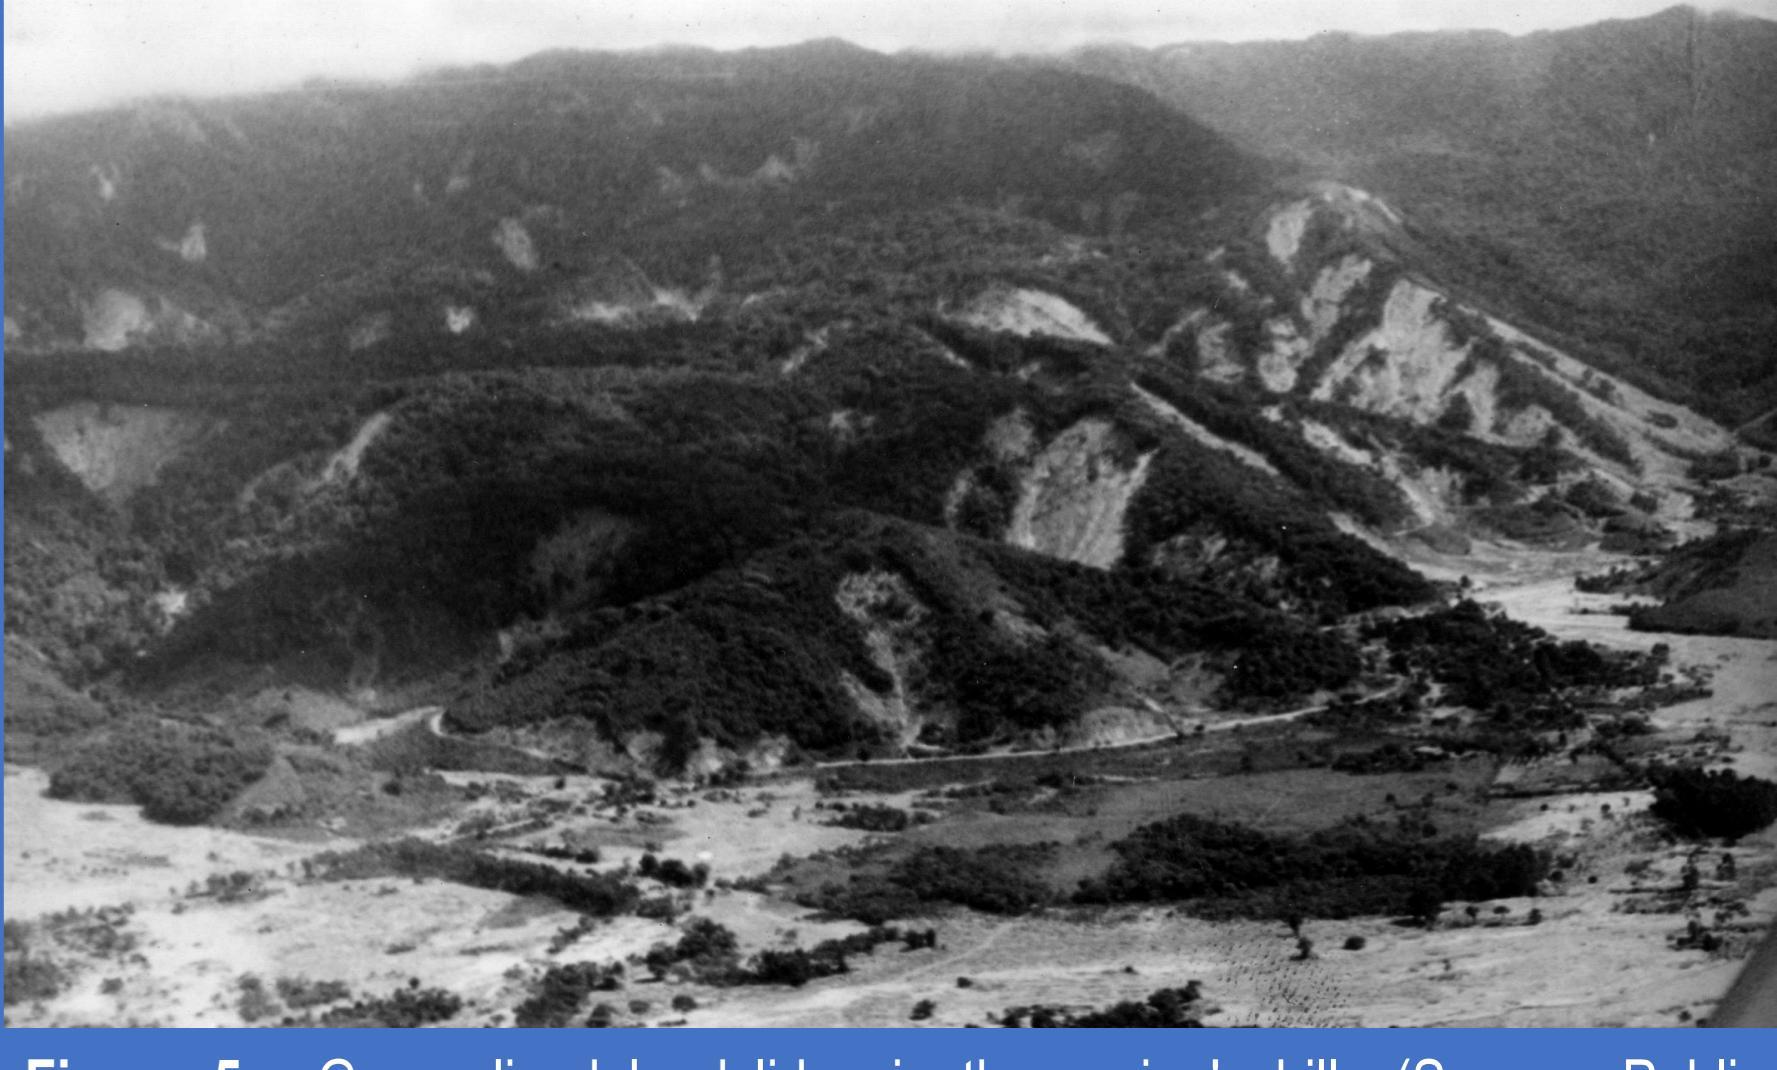
Figure 5 - Generalized landslides in the region's hills (Source: Public Archive of Caraguatatuba).
