Modeling shallow landslides susceptibility based on statistical analysis

Helen Cristina Dias *(1), Carlos Bateira (2), Marcelo Fisher Gramani (3), Rebeca Durço Coelho (1), Vivian Cristina Dias (1), Tiago D. Martins (4) and Bianca Carvalho Vieira (1).

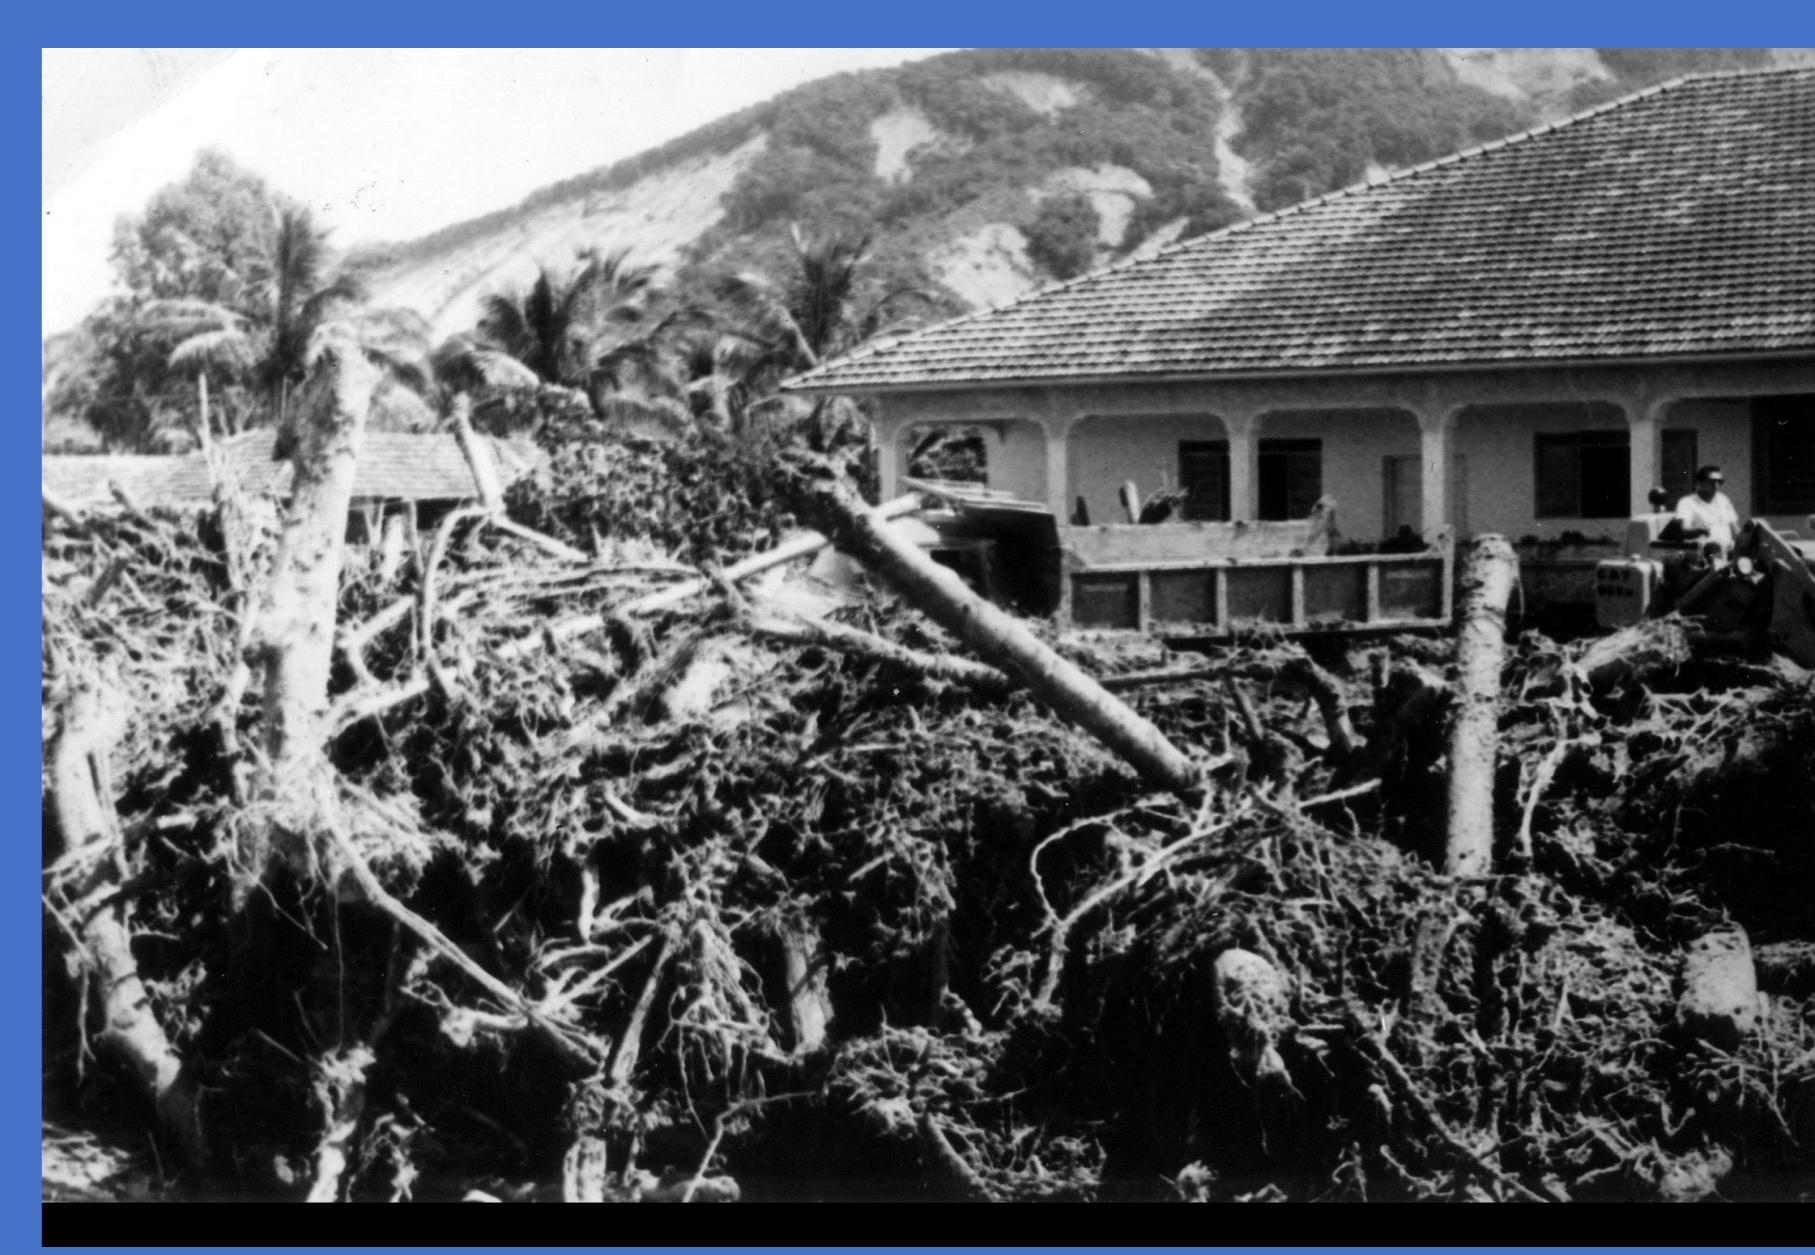
Figure 6 - Material mobilized by debris flows (Source: Public Archive of Caraguatatuba).

In 1967 at Caraguatatuba county occured a high magnitude event, which was characterized by rainfall above average in a short period of time (584.8 mm / 48 h), triggering landslides and debris flow in the area, affecting the city's infrastructure and resulting in 120 deaths (Figures 3 to 6) (CRUZ, 1974; DE PLOYE and CRUZ, 1979).
