EGU Session NH6.3

AIRBORNE SFM MODELLING FOR AVALANCHE AND DEBRIS FLOW PATHS IN STEEP TERRAIN WITH LIMITED GROUND CONTROL

Sean E. Salazar¹, Helge C. Smebye¹, Regula Frauenfelder¹, Frank Miller¹, Emil Solbakken², Tore Humstad², Edward McCormack³

¹Norwegian Geotechnical Institute, Oslo ²Norwegian Public Roads Administration, Norway ³University of Washington, Seattle, USA

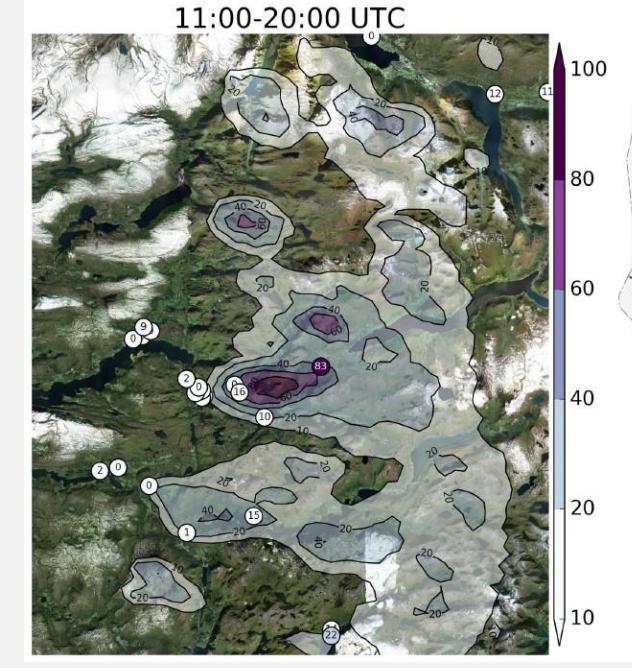
[Top] Precipitation map indicating torrential rainfall in the Jølstravatnet lake area on July 30, 2019 (map: Norwegian Meteorological Institute); [Right] False colour satellite image from August 2, 2019 (imagery: Copernicus Sentinel).

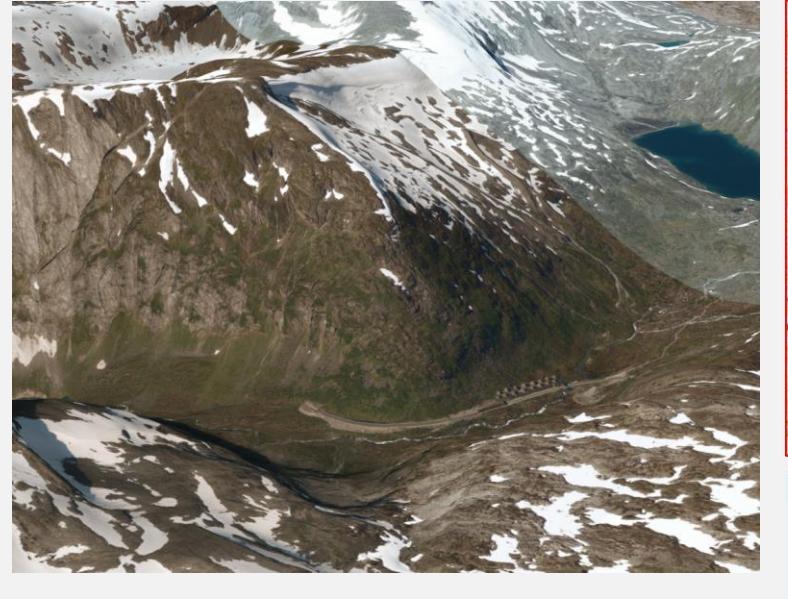
[Top] Orthoview and **[Right]** Map view of East facing avalanche path on Sætreskarsfjellet above National Road 15, in Strynefjellet area, western Norway (imagery: Geodata AS, Kartverket)

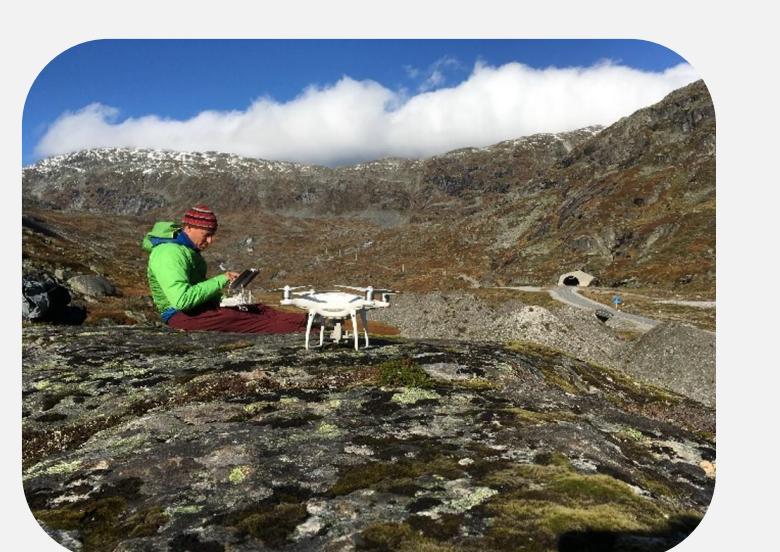
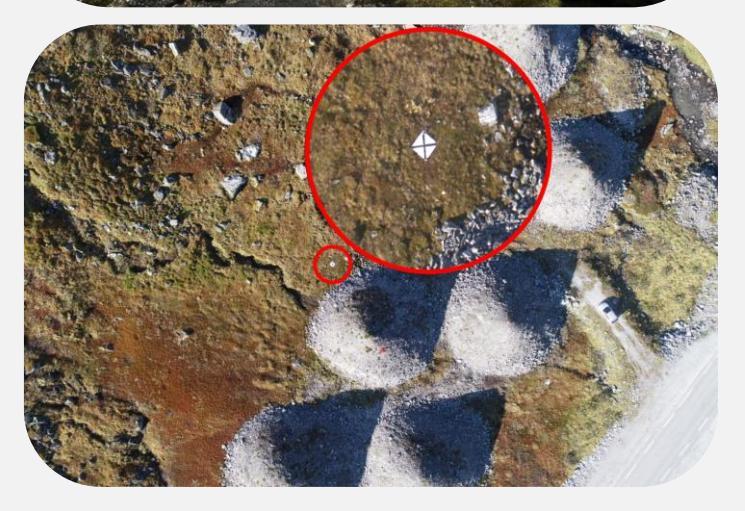
[Top] Flight lines displayed on top of SfM-derived orthophoto product, draped over a terrain model; ground control points displayed in red (background imagery: Geodata AS, Kartverket); **[Right]** Example of survey image at the foot of the avalanche path; area encircled in red is enlarged (inset) to illustrate ground control placement in the scene.

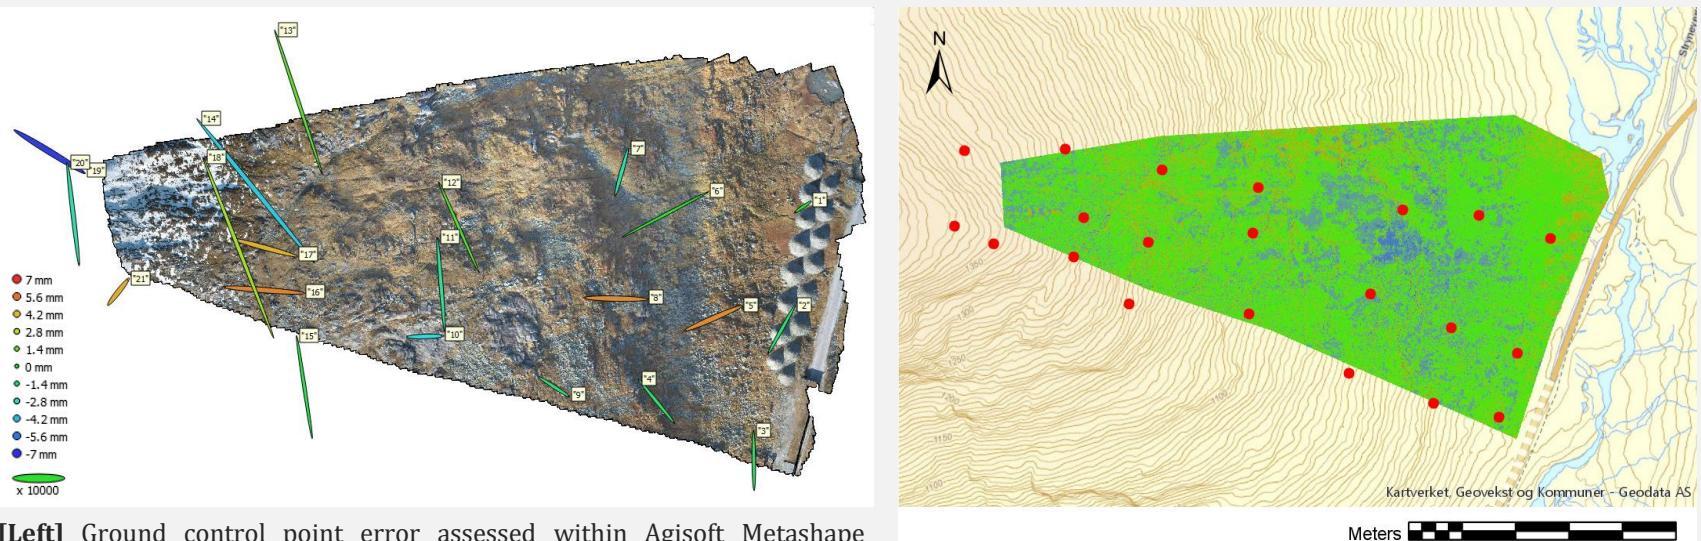
[Left] Ground control point error assessed within Agisoft Metashape software; **[Right]** Comparison of RPAS-SfM-derived and LiDAR-derived surface models (ground control points shown in red).

GCP	Photogrammetric error		Surveyed elevation (meters)		Difference
	Total (cm)	Image (pixel)	GNSS measurement	2012 LiDAR DTM	(cm)
1	0.20	0.25	879.86	879.89	2.29
21	0.56	0.67	1355.78	1355.70	-8.58
Total	1.11	0.61	-	-	2.31
